Vernacular Buildings Research Section

Report No. 49/1987. SU 672 9315.

'FLINTS'
Britwell Salome,
Oxon.

Listed Buildings Grade II. House and Barn.

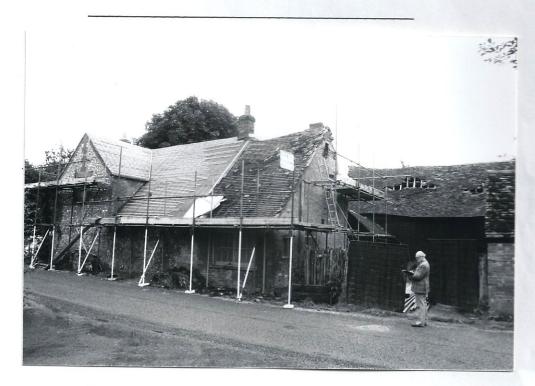
East side of house before demolition of $20 \, \text{th} \, \text{C.}$ kitchen extension - barn in the background.

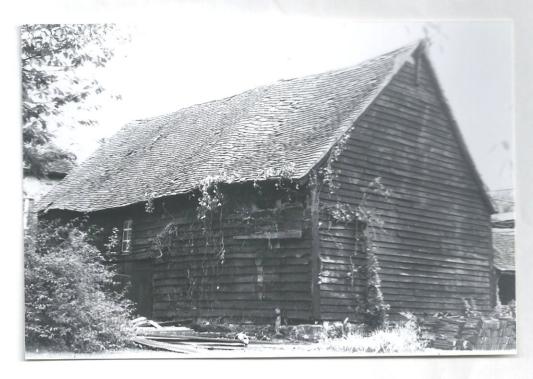
South gable and west side of barn.

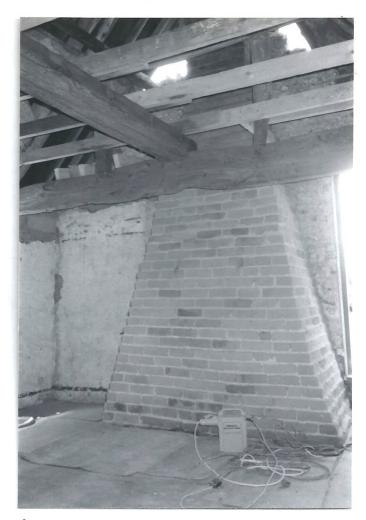
"FLINTS" BAY I repointed chimney stack

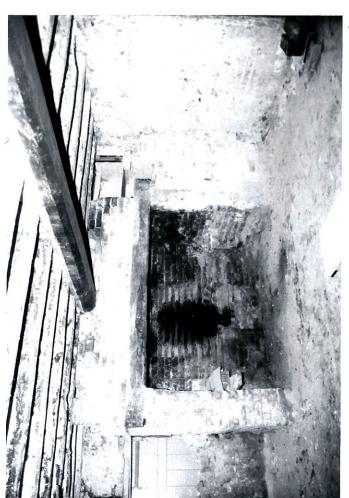
A further arch at the back of the hearth is a puzzle. It goes through to what used to be the kitchen extension and could have provided access for the flue of a copper. It is, however, also built of $2\frac{1}{4}$ " bricks, which may point to its existence prior to the kitchen extension, but can equally just show that re-used bricks were employed in its construction — in very much the same way as the present builder has been at pains to find matching bricks for the repair of the jambs as well as for the bricking up of the said arch.

14 I before restoration AB. blocked opening with arch at back of fireplace Groundfloor SLN17±, BAY I

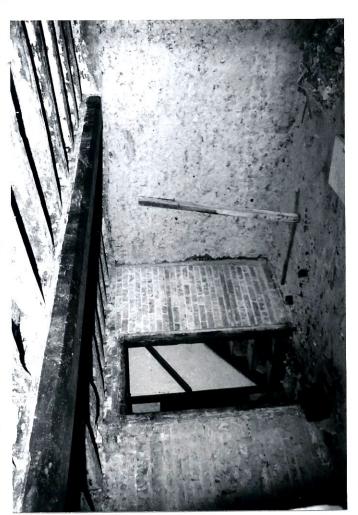
BAYI, access to outshut and stains

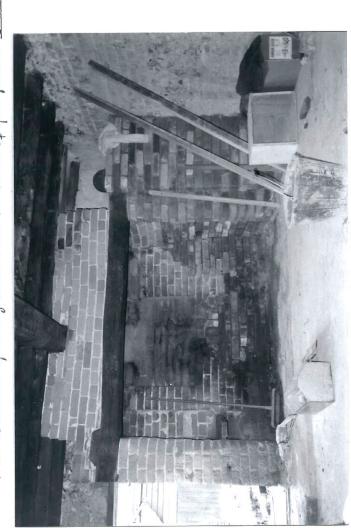
BAYI during restarration

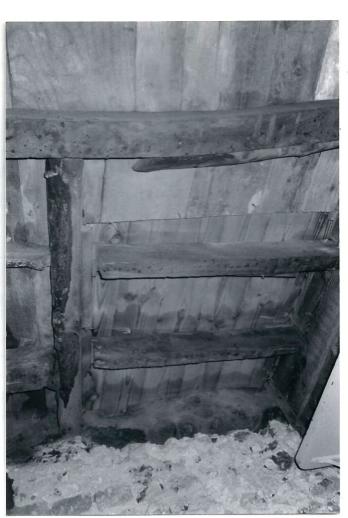
BAVII, ceiling timbers, postormer access to 12 + floor.
