**VERNACULAR BUILDINGS RESEARCH
HENLEY ARCHAEOLOGICAL & HISTORICAL GROUP**

Parish/County: Rotherfield Greys, Oxon
Street and House name: 'Thatched Cottage'
Shepherd's Green

Recorded by: Ruth Gibson
Cynthia Robinson
Date: 25.10.2013

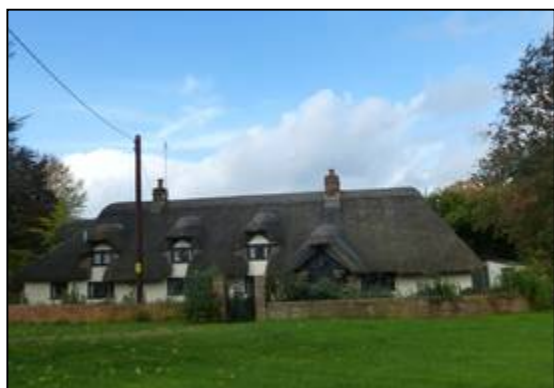
East front with modern dormers & porch

There are small, mullioned, leaded light windows. These are modern replacements, but their size and design indicates that some of the window openings may be original and the design of the replacement windows is based on traditional cottage fenestration. There is a modern porch over the front door. All front walls are brick, painted; certainly replacing the earlier timber framing, still in evidence at the rear.

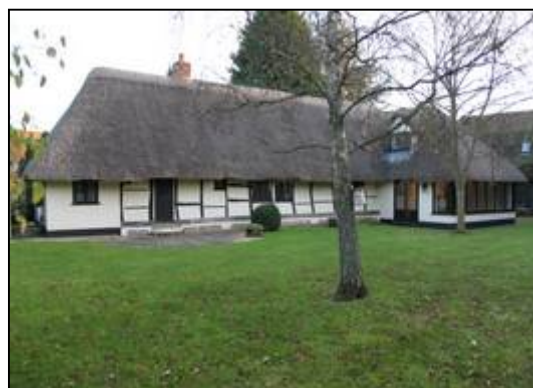
West rear elevation, square panel framing

Description of rear elevation: Here the square panel framing is exposed showing the extent of framing of bays I, II and III, although the usually distinctive main posts of the individual trusses are not distinct here; all timbers being of relatively small and varied scantling. The 1 m deep thatch eaves come low down to just above the windows. A small window, (below left) lighting the former stair space at the side of the stack (below central photograph) still exists.

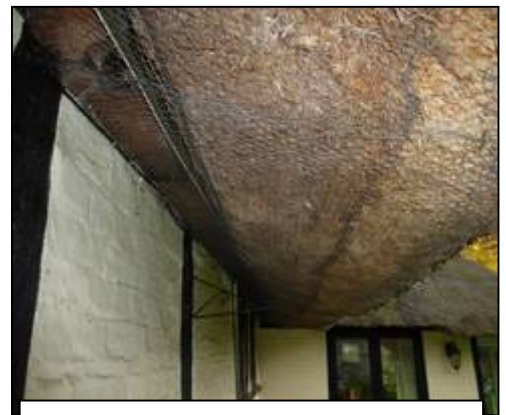
1 m thick thatch at rear/west wall

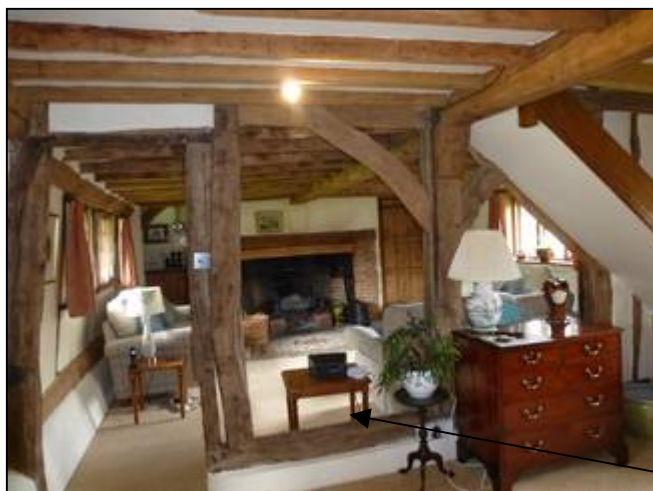
Ground Floor: The principal room consists of two framed bays (Bays I & II on plan). The central sill plate and some studs still exist. The plate has been cut on the west side to make an opening, but retains a very distinct groove for the staves of a former wall. However the transverse beam above does not show the equivalent holes or groove for fastening any staves, so may not be original. Other timbers of this cross wall also appear to be second-hand.

Above: Sill beam with groove between Bays I and II

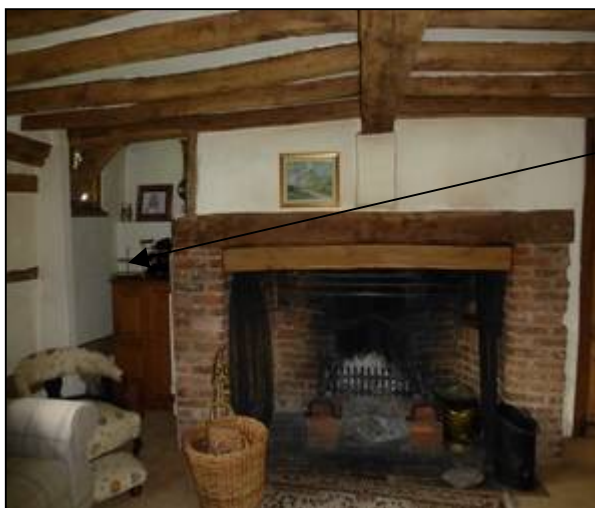
Below: Spine beam with chamfers and stops in Bay II

Bay II This bay appears to retain most of its original framing including the ceiling beams. The spine beam is chamfered with simple run-out stops near the corbel, which supports it above the brick fire place. This is built out of a variety of bricks, those of the east pier are 2” ones. However these ‘Tudor’ bricks do not help with dating, as recycled bricks were often used.

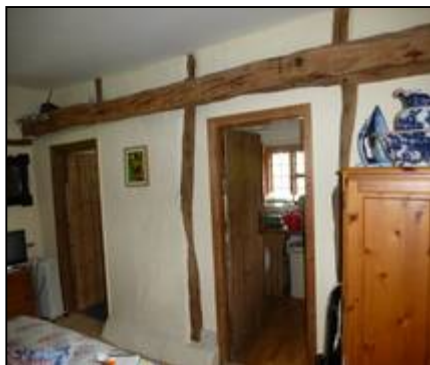
Bay III houses the stack, the lobby entrance hallway on the east side and former stair well on the west side. The timbers in its north gable wall are heavily weathered. There is a narrow doorway in the west wall located above the sill beam, a very unusual location and v. likely inserted once the house had been subdivided into 2 cottages. There are two further doorways in the north wall giving access to the later lean-to now under the hipped roof.

North wall of Bay III

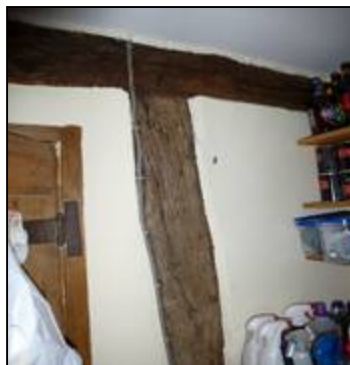
West wall with door

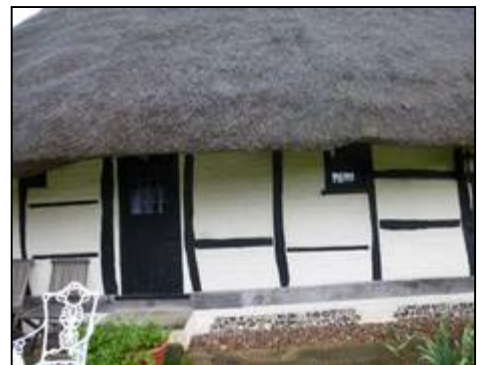
External view, west wall of Bay III

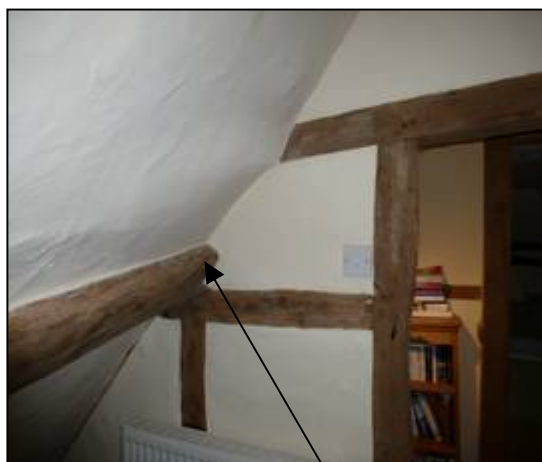
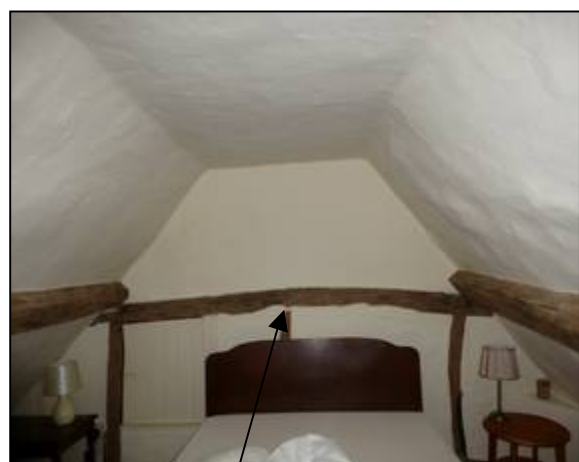
Clasped purlins and the three queen struts between tie beams (not visible here) and collars

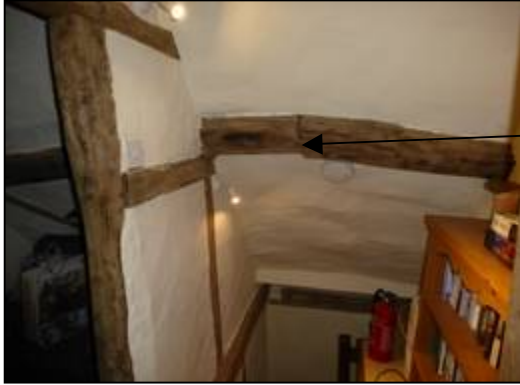
Queen strut trusses in Bays I (right) and II, (left) where the collar is interrupted by a door frame. Searf joint in unusual location of purlin. . NB heavily weathered timbers of Bay II, south wall. Weathered plank door, hung on iron pintels'. NB old key holes below iron latch.

The rather clumsily executed scarf joints, extending the purlins from Bay II over Bay I are another indicator of a need to carry out in situ carpentry work for an existing structure, rather than preparing the timbers and carpentry work in the framing yard first.

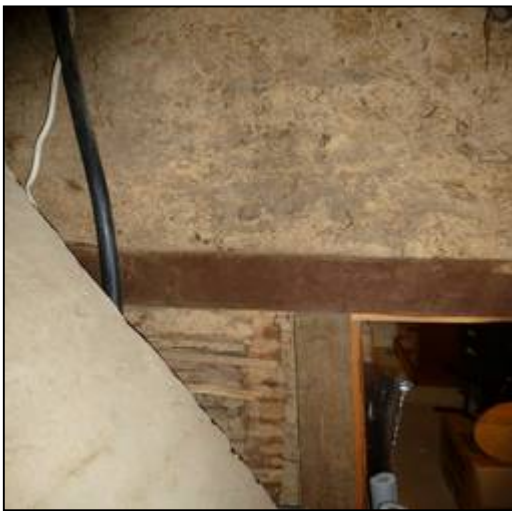
View of north facing queen strut truss in attic of Bay III; NB no weathering of collar or struts

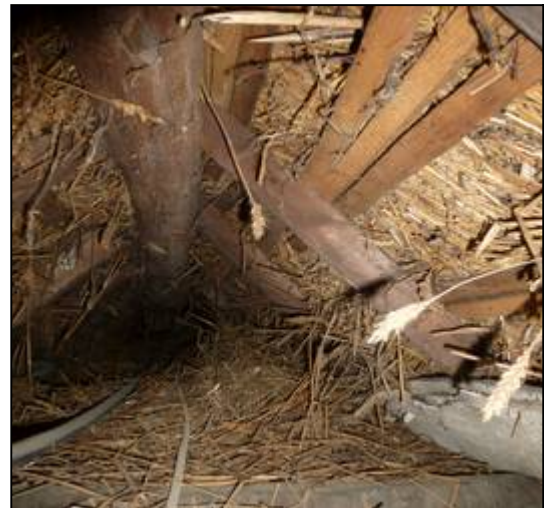
View into roof space above Bay II showing ridge beam, narrow rafters, long-straw base coat of thatching

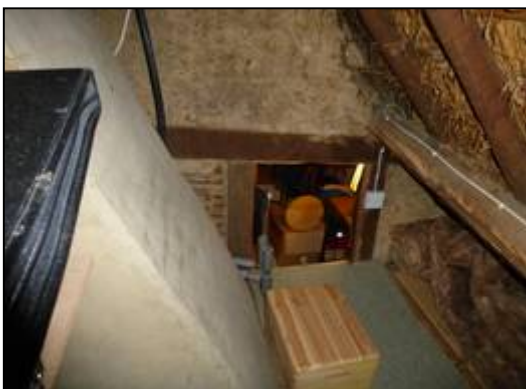
Attic of Bay III, rendered brick stack in the foreground. NB floor is higher than that of Bay II.

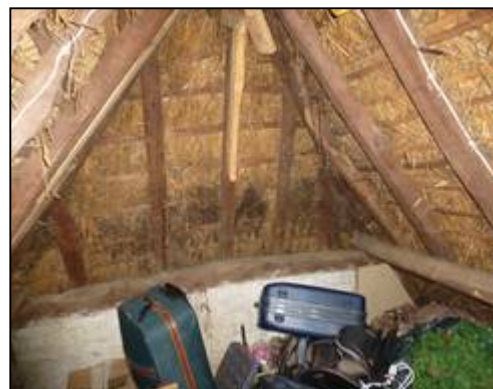
Attic of Bay III view of hip, which may be a rebuild or heavily repaired.

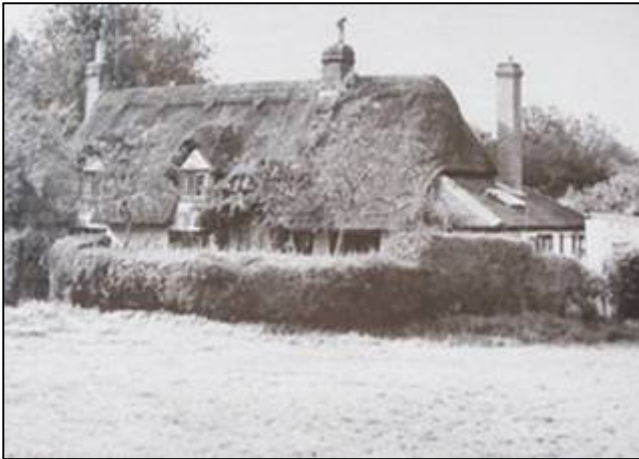
Left: ‘Thatched Cottage’ with outshut extension under a slate roof with tall brick stack (unknown date)

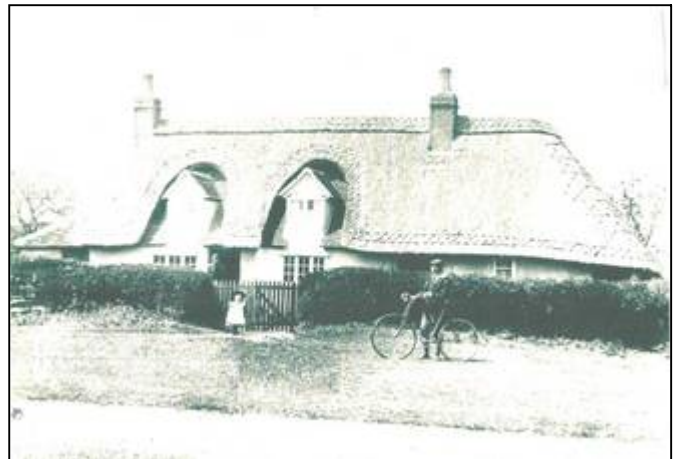
Right: ‘Thatched Cottage’ newly re-thatched with long-straw detailing (circa 1900 ?). The outshut is now covered by the extended thatch hip; the tall brick stack has gone. There is also a small extension to the left hand gable.
