**VERNACULAR BUILDINGS RESEARCH
HENLEY ARCHAEOLOGICAL & HISTORICAL GROUP**

Street and House name: 'The Old Bell', PH No. 20 Bell Street: briefly called La Campana'; since 1920s 'Ye Olde Bell', before this 'The Duke of Cumberland' .
SU 761 827

Owners: Brakspear Pub Company
Tenant: Bill Dobson
Recorded: Ruth Gibson & members of the HA&HG and OBR
Dates: June-October 2009

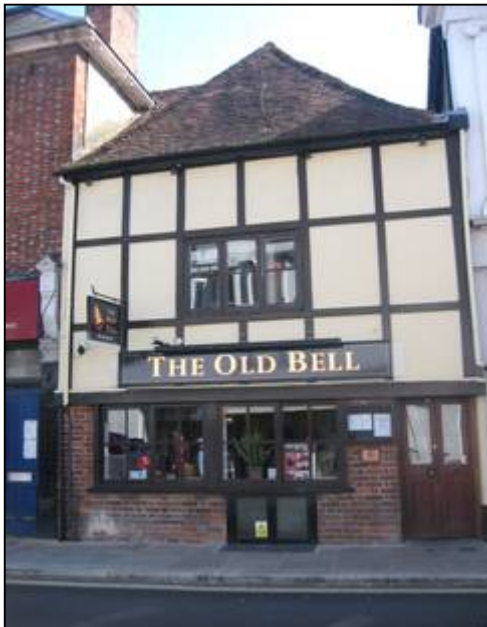
20 Bell Street, west/front elevation showing hipped roof, which replaces gable of 1325 date

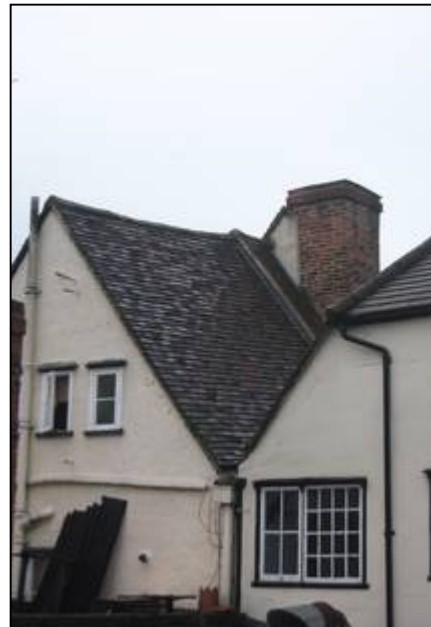
20 Bell Street, l.h.side, east/rear elevation.
N B difference in roof heights

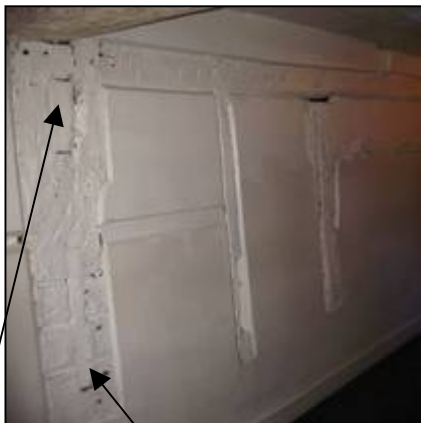
G.f. post in north wall. This wall post is 8" thick, c.10" at the splayed head with a cut off, large tenon for an earlier ceiling beam which must have supported a considerably lower ceiling, now at only c. 1.26 m above the present floor level. There is also evidence of two braces springing from this post from peg holes and the sawn off tenon, which indicates a former dividing wall across this room.

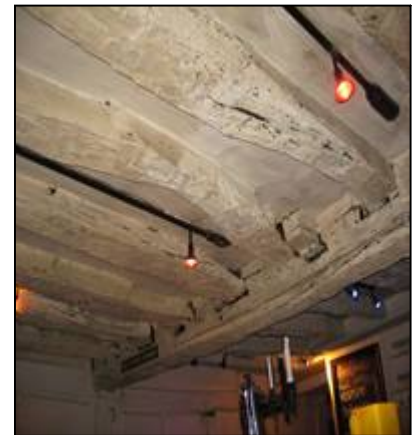
Transverse beam in g.f. bar with flat laid ceiling joists measuring c. 8" at 10" – 13" centres.

All timbers show signs of re-use; they have also been severely hacked back, probably to accommodate a plaster ceiling underneath or to increase head height. These beams replace the originally lower ceiling, but their size suggests that the joists were re-used.

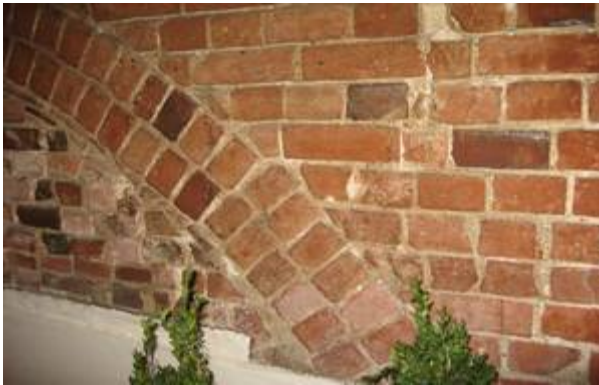
South wall, built in 3" bricks, laid in irregular English bond. The size of the bricks indicates a date post 1784, the date of the introduction of the brick tax and before 1850 (when it was abolished and when the standard 2 1/2" brick increasingly became the norm). The 3.50m wide relieving arches have been filled with smaller, irregular brick work. Were they originally open arches between the maltings next door and the public house ?

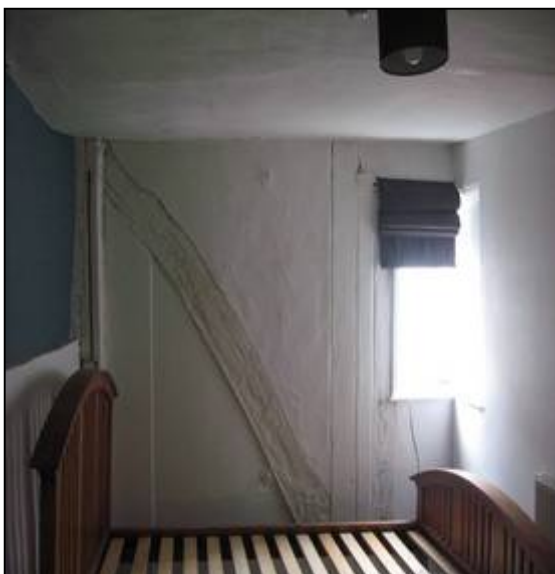
Long tension brace in 1st floor front west wall; one of a pair bracing the posts which frame the window.

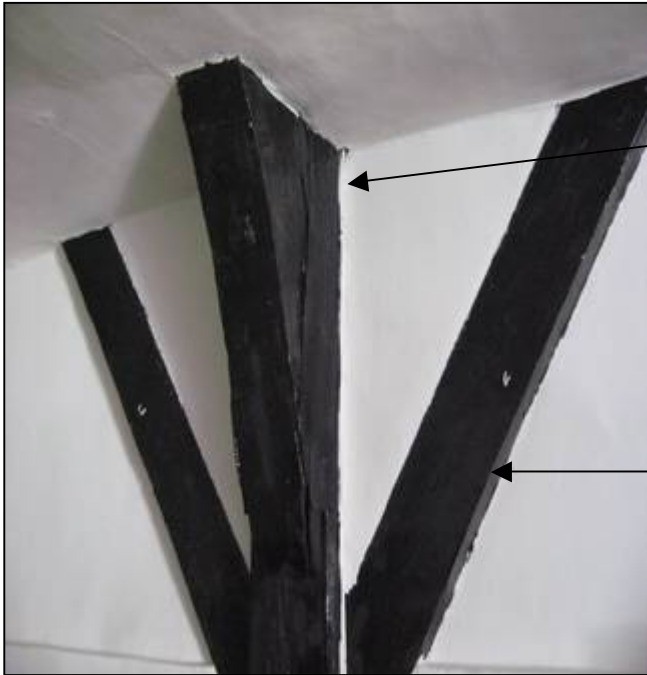
South wall post which supports the surviving complete crown post (truss 2) in the attic above the later ceiling.

The curved arch brace, which springs from the face of the post, helps to support the tie beam.

The straight braces are mortised into the wall plates above (out of sight) stiffening the wall frame

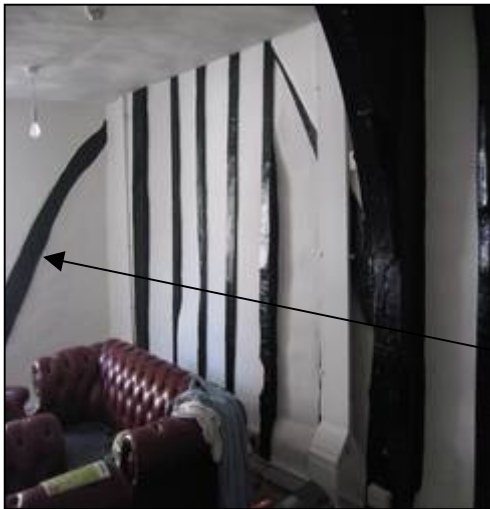
North wall: Wall post, studs and post with arch brace of Truss 2 seen in first floor front room. The other post seen at the end of the row of narrow wall studs is also 20 cm wide and is an additional wall post, set back from the front wall corner post (which is not visible here) by over 2 feet (67 cm)

Note long, curved tension brace in front/west wall – one of a pair, its partner is shown in the photo p.5

This slot in the south/ west wall post (seen here at 1st floor level) may have been a window shutter groove or part of a 'stud and panel partition', a sophisticated double skin wall.

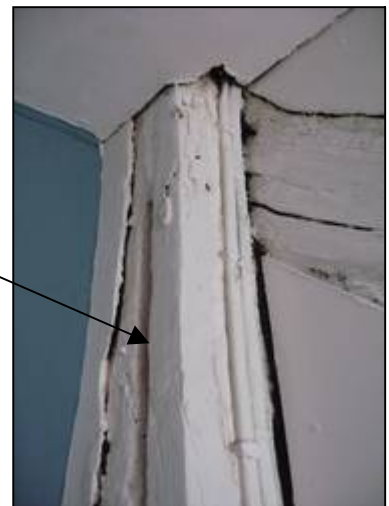
Post and arch brace of truss 3, north wall below on left. Note the existence of an apparent second post and brace directly behind it, which is also visible in Bay III.

The north wall of this bay with inserted ceiling below on right. This ceiling may be a 17th C. insertion and is quite different from that in Bays I and II, which is hidden under plaster and consists of very narrow ceiling joists supported by a transverse beam, which has been inserted rather clumsily under the tie beam by cutting into the underside of the two large arch braces.

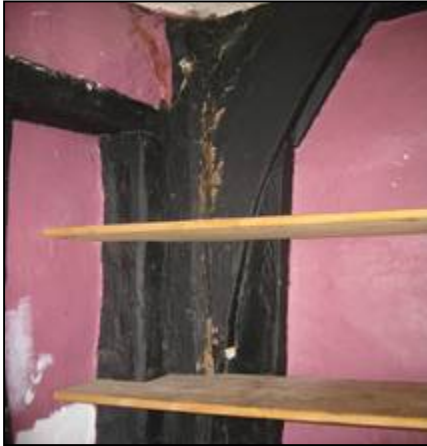
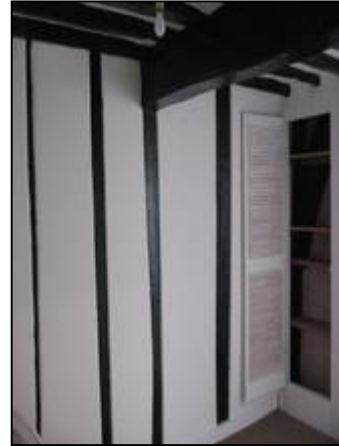
Low tie beam of Truss 4 in east wall of Bay III, attic; the brace is also just visible behind the pipe work.

In the first floor, rear bedroom one can see the lower part of the arch brace springing from the north-east corner post, now partly hidden behind shelves and cupboard doors.

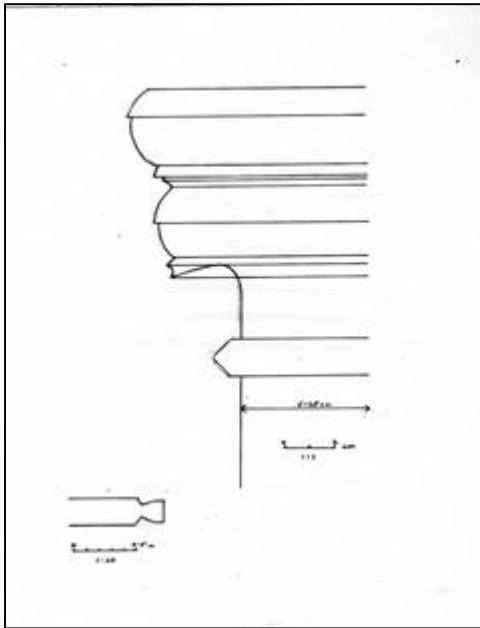
Profile of moulded capital above octagonal shaft. Dove tail detail of tie beam on left.

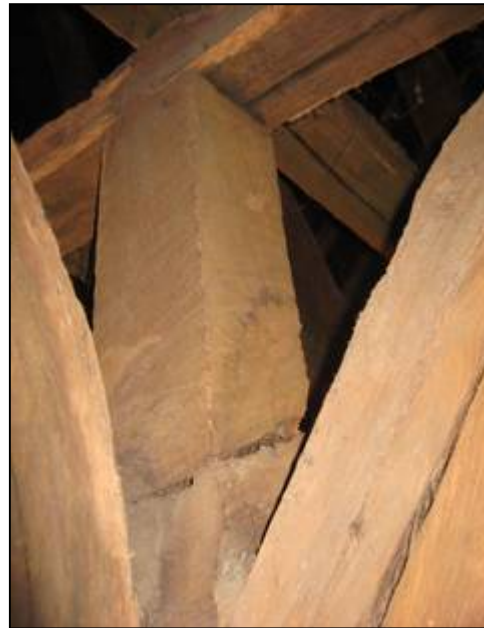
The roof space of Bays I and II is dominated by the complete crown post assembly of Truss 2. This consists of a 5.65 m long tie beam, supported by arch braces, the tops of which are visible here, whilst their springing from the wall posts was observed in the rooms below. A slender, octagonal crown post rises from a moulded base located in the centre of the tie beam and held in place by a single peg. The shaft ends in a richly ovolo moulded cap; the very fine, crisp detail of a paper-thin lip on the underside of the lower moulding is a remarkable detail and its survival over nearly 700 years is amazing. Above this the post is simply square cut and from it spring the four braces. These in turn support the horizontal timbers which form part of the triangle of the roof structure; i.e. two braces support the long, horizontal collar purlin, which runs below the line of the ridge, and two support the collar, which sits across the purlin and which in turn support the rafters. An ingenious solution for a very well framed roof, although somewhat extravagant in its consumption of timber. - Unfortunately the removal of the eastern crown post and connecting collar purlin has resulted in a great deal of stress and racking of the roof, which in turn has caused a deep crack in the upper, square section of the central post.

Square shaft with deep crack above capital. It still supports the 4 braces & collar purlin.

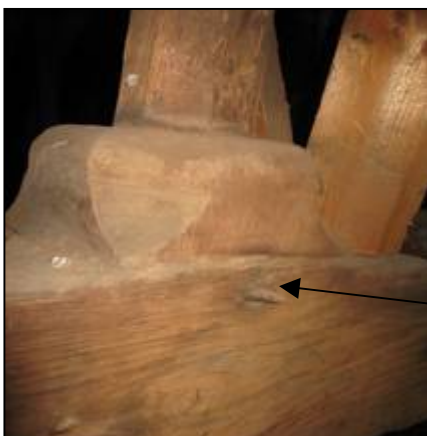
Above: This view shows the severe racking of the roof due to the removal of a large part of Truss 3 which damaged the structural integrity of the medieval roof.

Left: Moulded base with deeply chamfered corners supports the octagonal shaft of the crown post; view of east face. It is held in place by a peg driven in from the west face. (Modern repair timber on right side of picture)

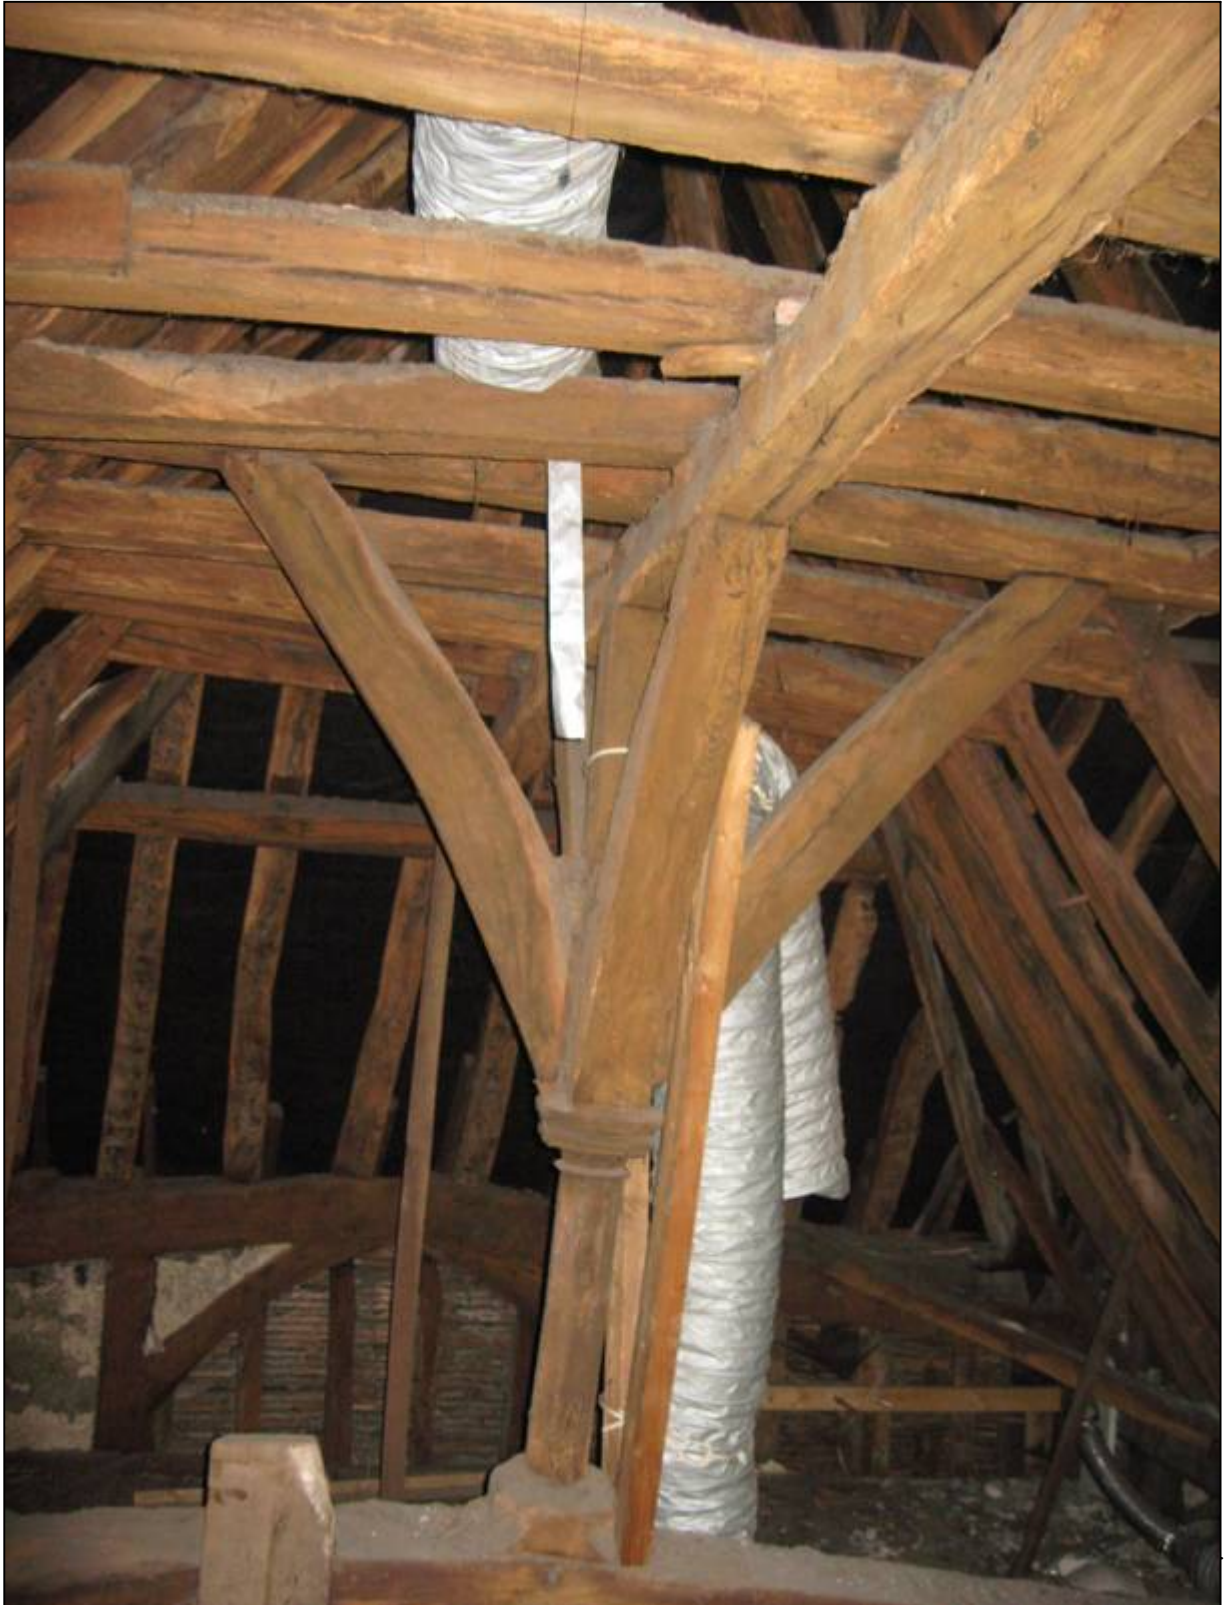
Complete crown post of Truss 2 between Bays I and II with longitudinal collar purlin supporting the collars which are paired with the rafters; all still forming a perfect roof as built in 1325.

Looking west the two-centre arch set under the tie beam of Truss 1 is visible in the lower part of the picture. This is the top part of the large opening in the west gable which once would have lit the first floor chamber but became redundant once a ceiling was inserted below.

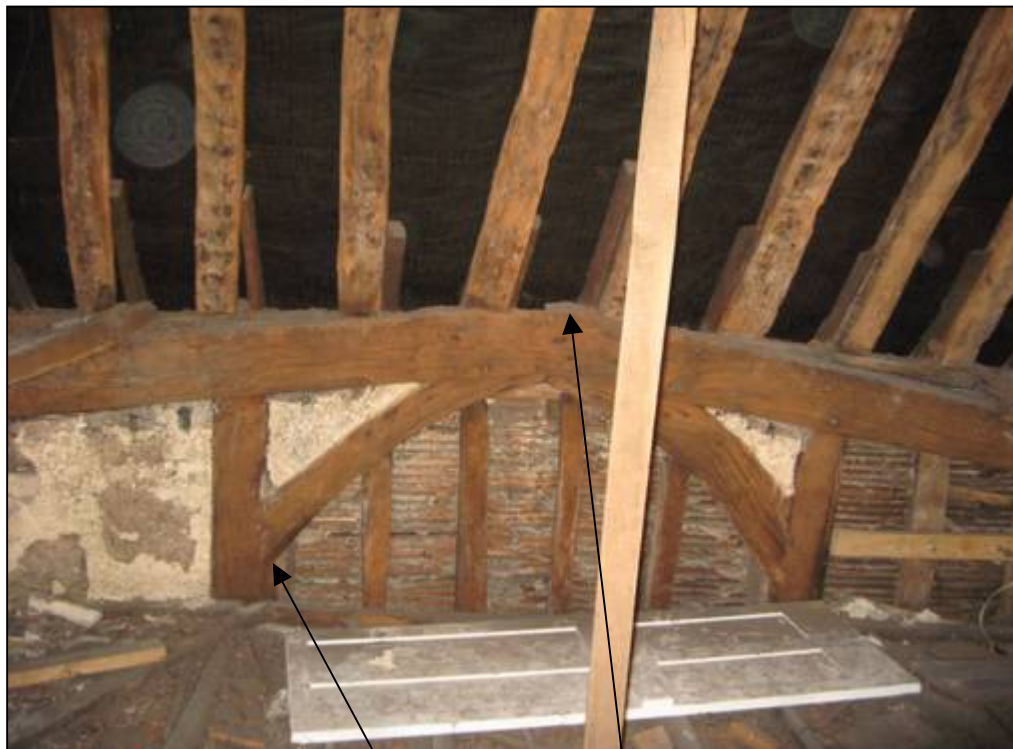
Truss 1 in west wall with arched opening & seating of former crown post. Rafters of the hipped roof are a later alteration as are the studs and laths; these support the exterior render. Also note the colour washed plaster of the side infill panels. The 15-16cm (6") deep reveals in the posts from which the arch braces spring strongly suggest an opening rather than just a decorative feature.

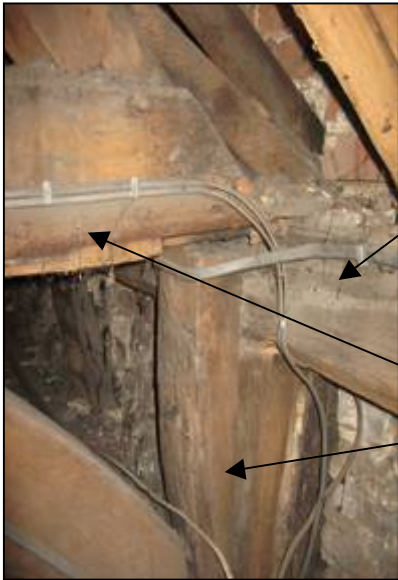
South wall, Truss 2. Post/tie/plate and principal form a lap dovetail assembly, but with the plate sitting on top of the post rather than being jointed into the back of it. The joint of the tie has slipped from its seating on the plate. This has been repaired with an iron strap and cleat.

View of brace tenon having slipped out of its wall post mortise.

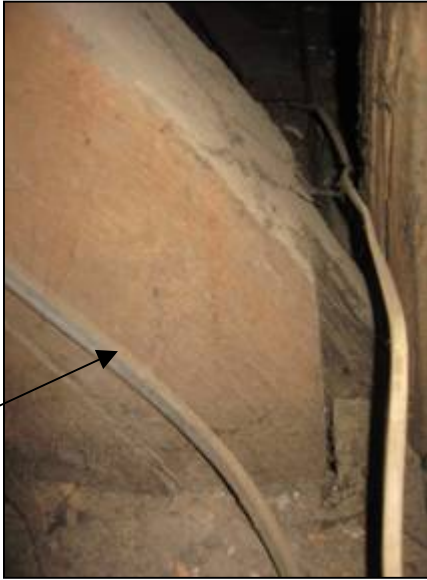
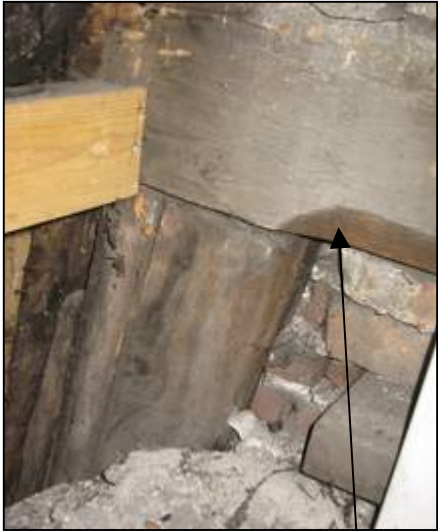
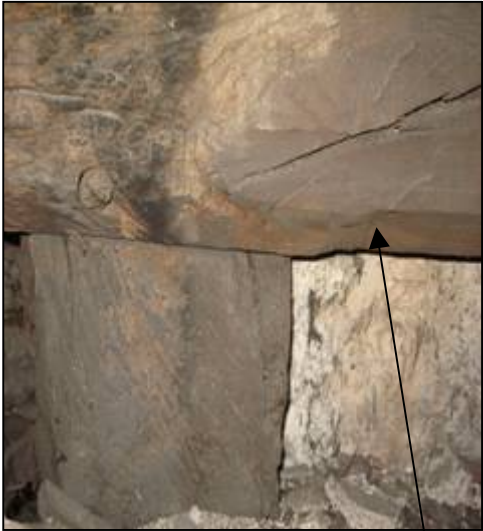
North/west corner post with wall plate and chamfer stop where they are jointed

A second post, 54 cm from the corner post, is also respected by wall plate chamfer stops and therefore part of the primary structure.

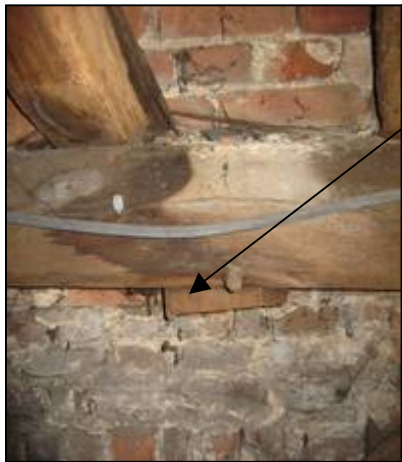
On left: South wall, stub of post, 55 cm from the corner post. No studs survive in this wall, only their mortises in the wall plate soffit. (*Appendix 6*)

On right: North wall. Wall plate with post (shown above in more detail) and one of the three wall studs surviving here are 11-12 cm wide (4 1/2").

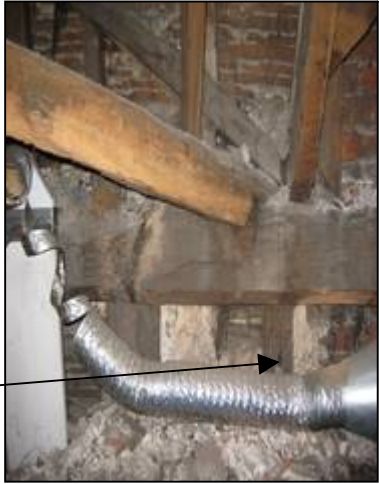
A brick stack has been inserted into Bay II just west of Truss 3 (*Appendices 4, 8*) It is constructed from bricks of irregular sizes up to 2" thick, with wide lime mortar joints. The bricks are of bluish/pink colour with a number of over fired, slightly glazed ones. It could have been installed as early as the mid 15th century, as locally bricks were produced, but equally narrow, irregular bricks were still being made throughout the 16th and much of the 17th centuries. Bay II also contains an original c.1 m square opening in the roof framing next to the tie beam of Truss 2. This is defined by a trimmer. Dan Miles interpreted this as a chimney/ smoke hood opening. No other evidence has been found to substantiate this as all timbers around the opening lack signs of former fixings or sooting nor can any evidence be found on the floors below, but then much of the structure has been altered, lost or is hidden. It is also possible that a smoke hood had been planned but was never installed.

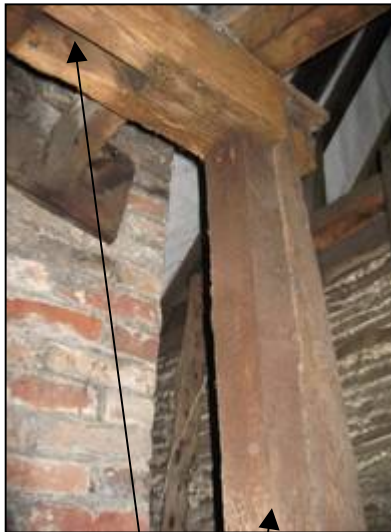
Collar purlin next to inserted brick stack with mortise slot of former crown post brace in the soffit (under side).

This purlin was cut and then supported by a stud inserted below.

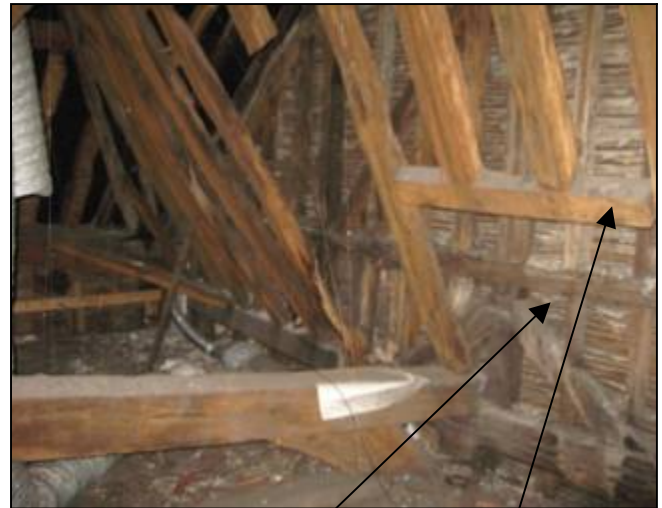
North side of roof. Central tie beam with top of brace rising through the floor. N.B, former opening in the roof defined by trimmer, part of the original framing.

Stud work and laths of adjoining gable of No22 are visible on the right/north side. The studs use the medieval wall plate of No.20 for support.

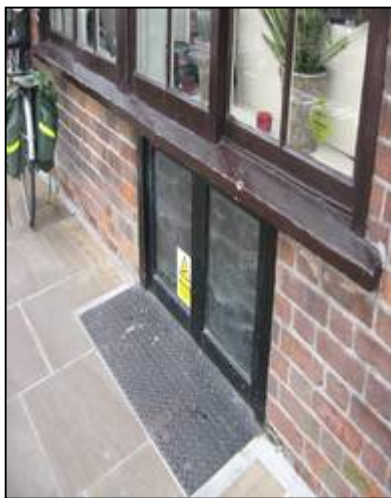
Cellar access from the street

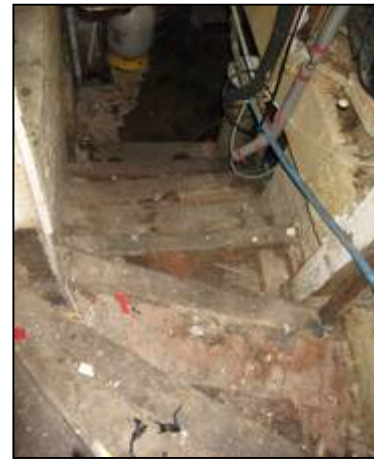
and from passageway door
