**VERNACULAR BUILDINGS RESEARCH
HENLEY ARCHAEOLOGICAL & HISTORICAL GROUP**

Street and House name:
20 Hart Street

Owner/Occupant:
BALLARDS Estate Agent
Tel No:
Recorder:
Ruth Gibson
Date: June 2007

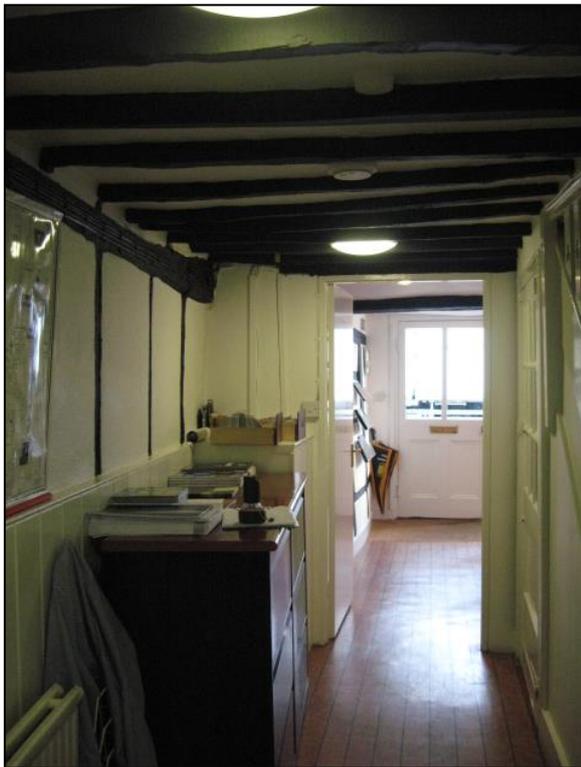
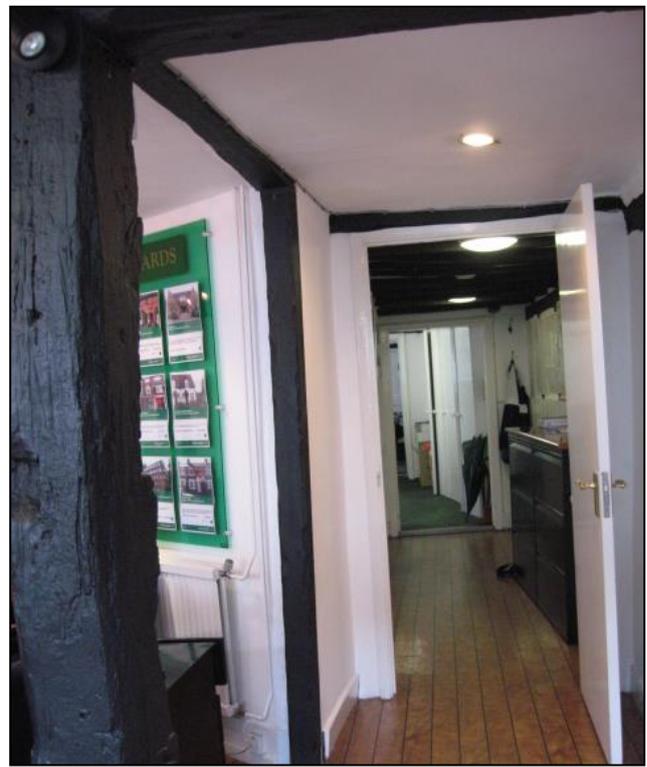
The ground floor was originally divided into a passageway which ran between the still existing front and rear doors and a room to the left with a F.P. at the back wall (which may have been a later insertion). At the back there are now two rear extensions, built at right angles to the front. The western one houses the extension of the passageway and the staircases to the cellar and first floor. The eastern one houses a back parlour, now an office.

Former through passage seen from the back

and from the front entrance

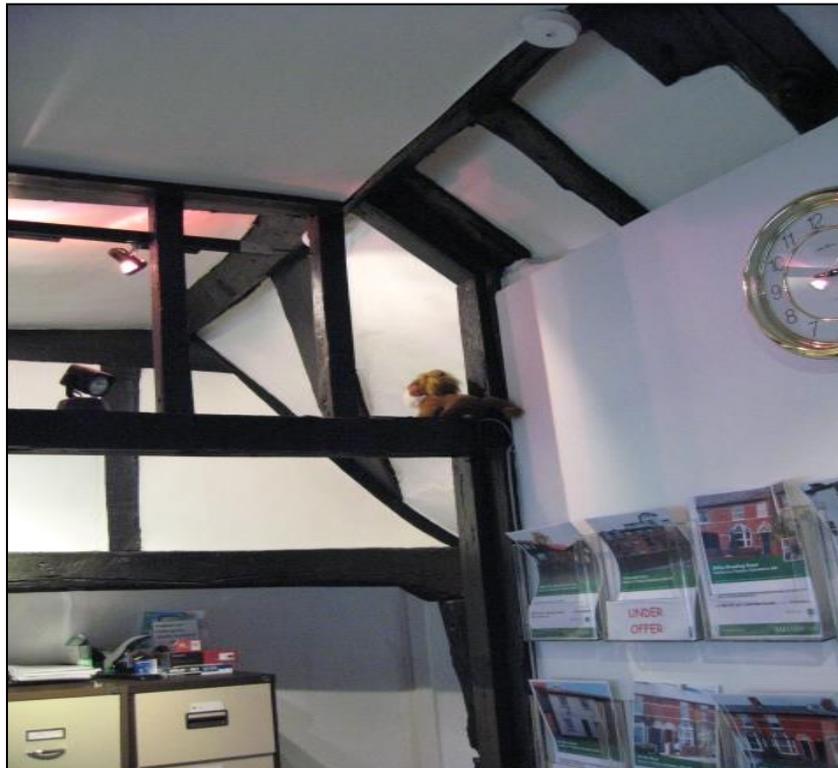
First Floor and Roof structure: The front room preserves much of the timber framing, which defines the bay divisions, already seen at g.f. level. The eastern tie beam still exists, located at a slight distance from the boundary wall to No. 22 at the front; this increases to some 3 feet at the back. This gap has been used to create an access to the later rear extension, but it was necessary to cut away some of the thickness of the tie as well as to remove some studs and a brace to achieve this. The collar, clasping the purlins, above the tie is supported by two queen struts, a very traditional roof construction. Above the rear wall the lower parts of the original rafters can be seen, providing more evidence for the one room depth of the earliest part of the building. A main post in this wall has a wide empty slot, where once a long brace would have existed, giving strength to the wall frame.

First Floor, east truss with curved wind brace and rear rafters on the right. Ignore the later inserted truss in the centre of the picture (with fluffy toy); this is not part of the original structure. Note how the tie beam of the east truss stands proud of the wall of No. 22 and how its underside as well as part of the wall post have been cut away to create an access, once the rear room had been added.

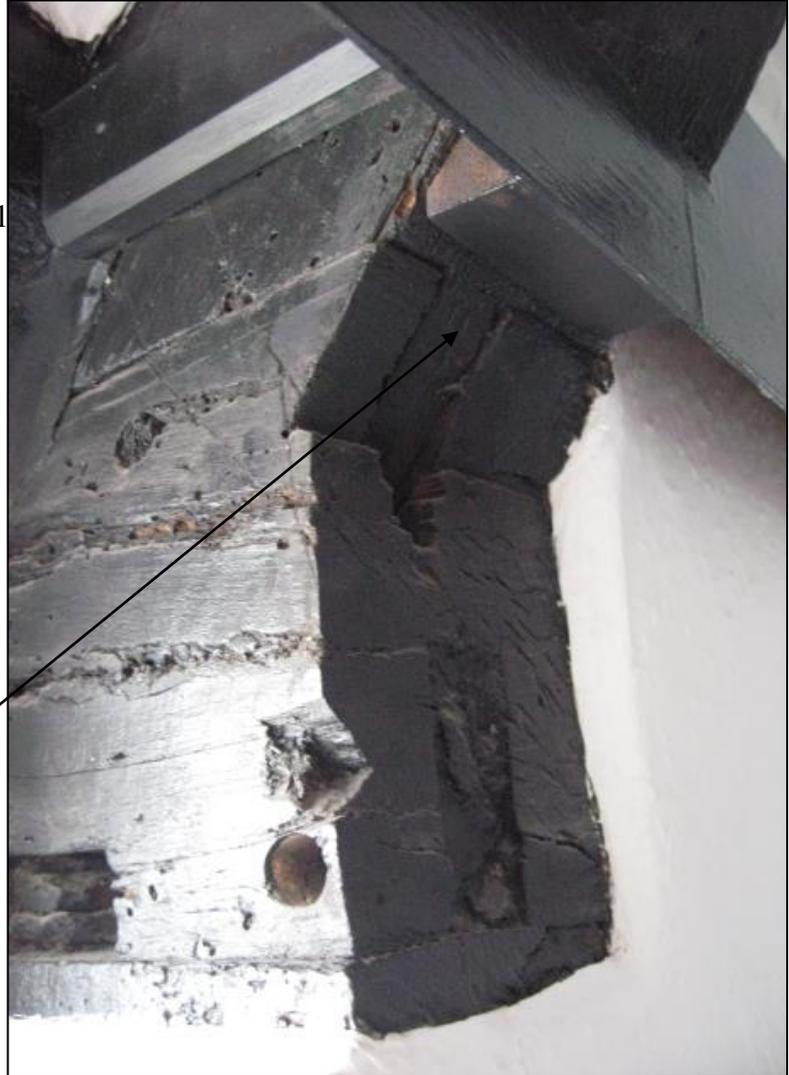
The stub of the former tie beam assembly remains in the north wall between two windows. Where the principal rafter and the tie beam meet was the location of the original roof eaves; the window height above this point shows by how much the eaves height was increased to allow for the insertion of new fenestration for the chamber over the hall.

Sawn off tie beam stub and tenon of the principal rafter foot, just visible above, partially hidden behind new timber trimmers
