VERNACULAR BUILDINGS  
RESEARCH SECTION

SU 762 825  
Report No 54/1989

Nos. 17, 19 and 29 Friday Street  
Henley-on-Thames / Oxfordshire

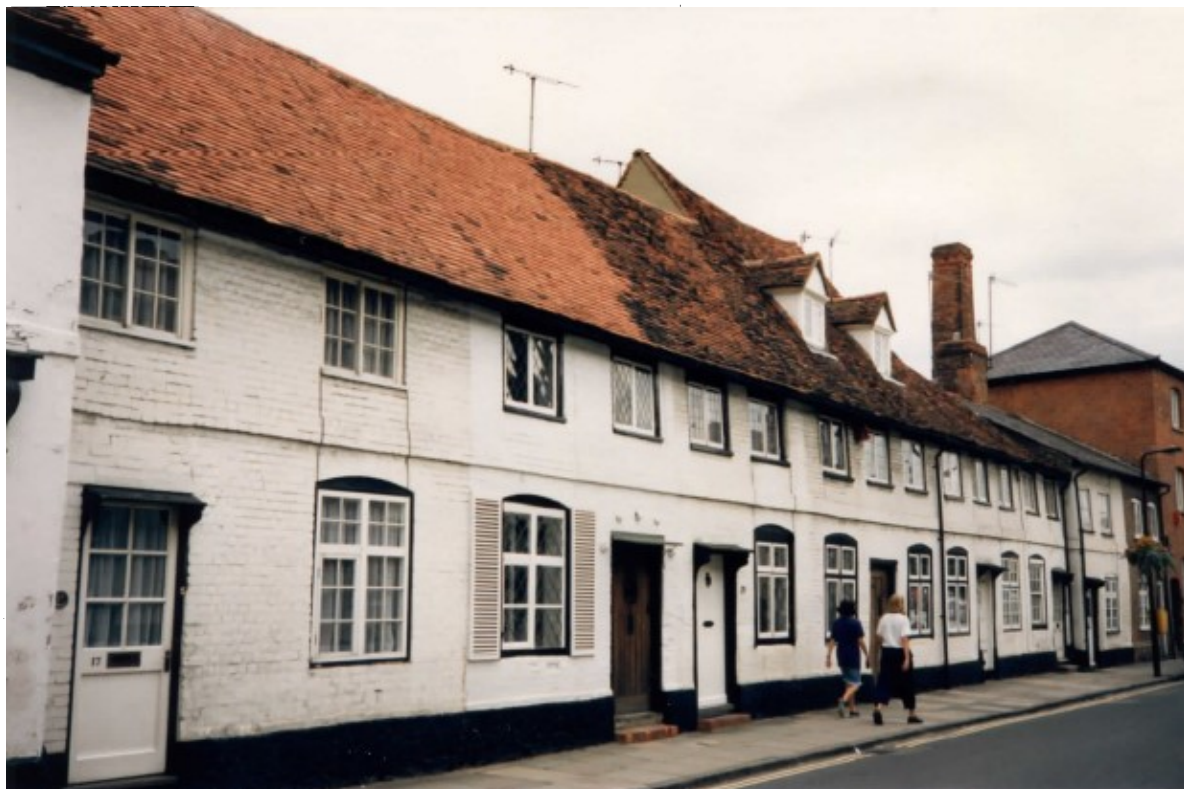
Nos.17 to 29 Friday Street ( slightly set back )

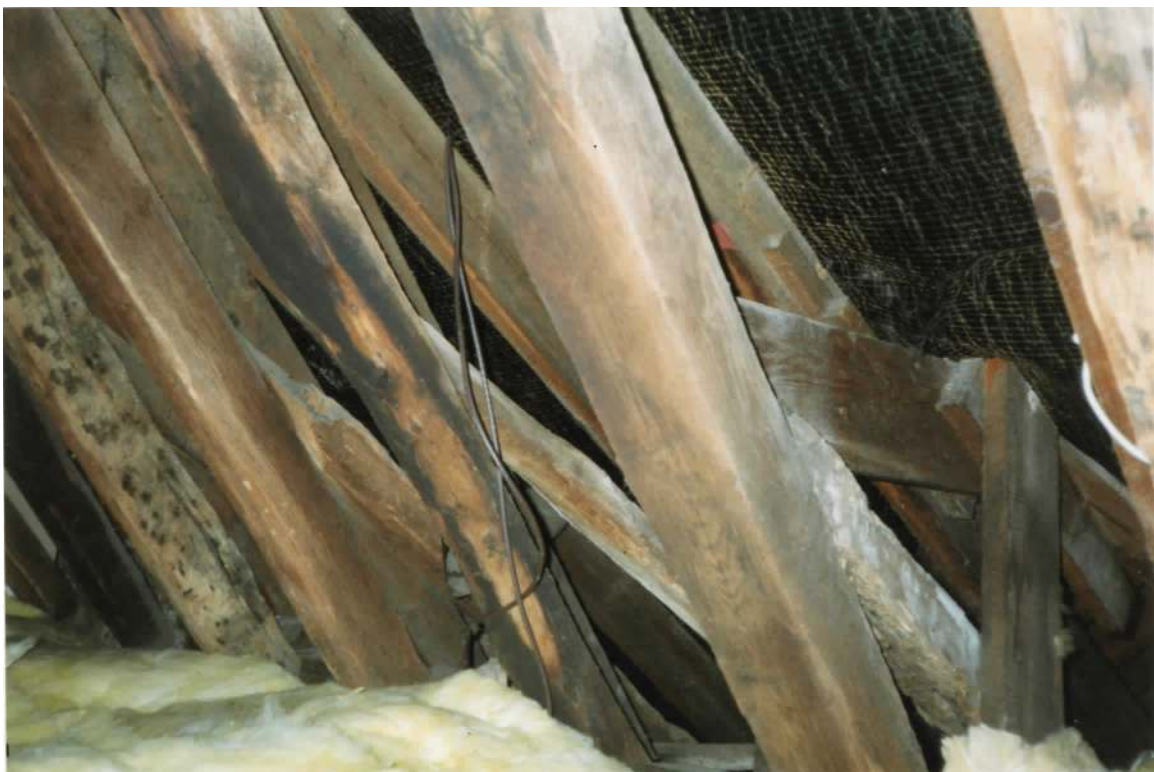
Loft of Nr. 17

The evidence of smoke blackening in the loft mainly in the narrow bay of No. 17 helps to reconstruct a buildings sequence for these houses, or single house as it originally probably was. A one room deep house, but consisting of several rooms or bays, was built running parallel with the street, forming part of a development of good quality timber-framed houses. Nos. 17, 19 and probably also 21 formed one unit (21 has yet to be investigated, but the partition wall which seems to lack substantial timbers as well as the formerly open loft indicate this).

Central Principal Rafter & Windbraces  
- all showing smoke blackening.

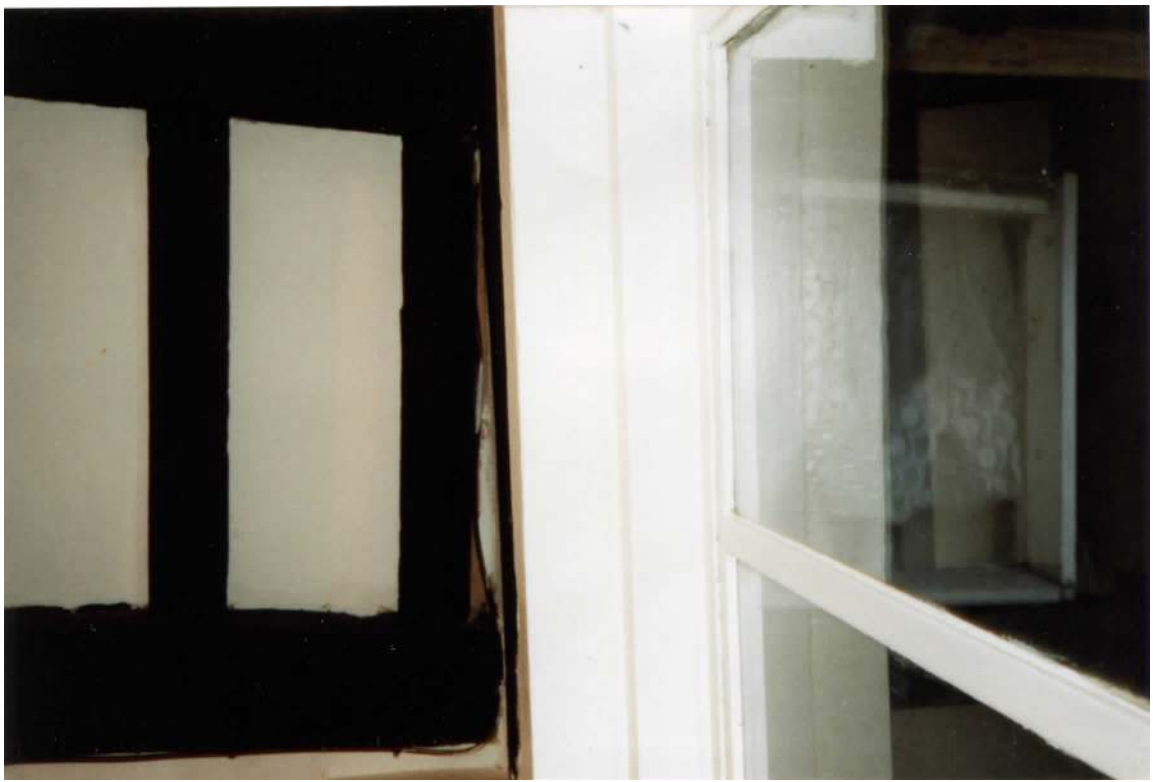
A very interesting feature was discovered in the west wall of the back bedroom during present restoration work. When the plaster was removed a stud wall with part of a diamond mullioned window were found. This belongs to the back wing of neighbouring house No. 17, where part of it still exists ( but without mullions ). It was obviously partially covered when the outshot was extended.

Blocked window with two diamond mullions in first floor back bedroom of No. 19. To the right, seen through the glass pane, the continuation of the window. This is situated in the rear extension of No. 17 and belongs to that house. It was partially blocked when the outshut of No. 19 was extended.

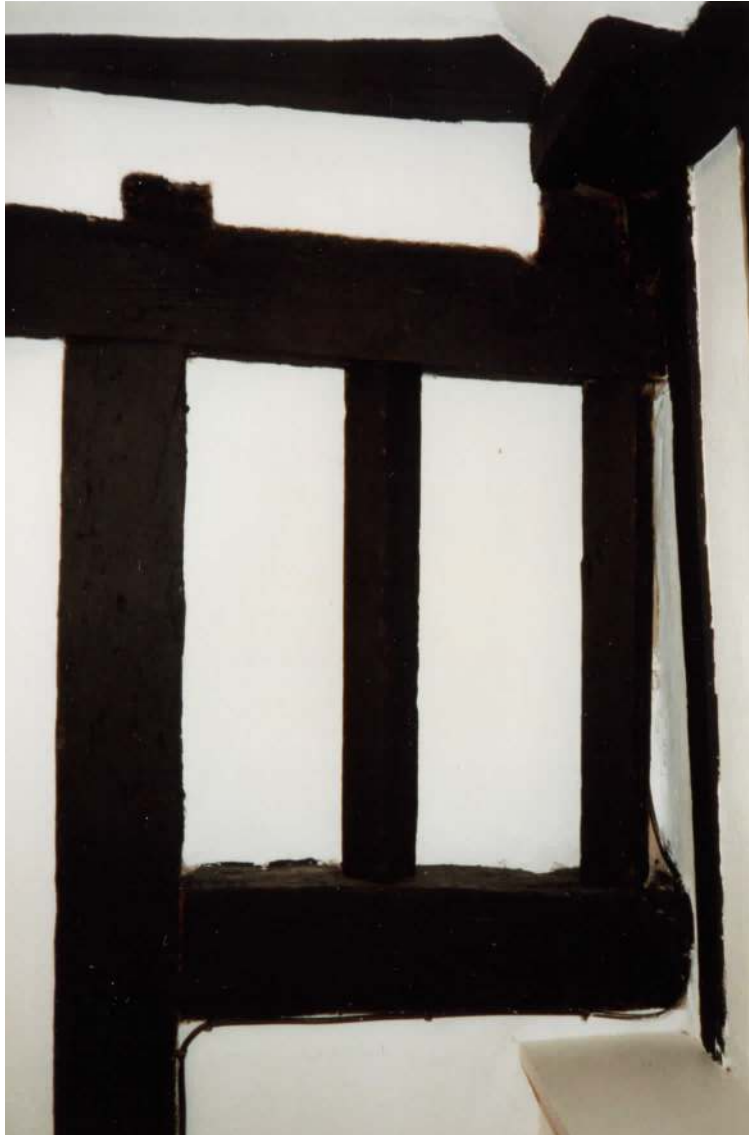
Half of Mullion Window in West Wall of No. 19. This Window belongs to No. 17 and was Partially Blocked when the Back Bedroom of No. 19 was built over the Kitchen. The other half still serves as a Window in the Rear Wing of No. 17

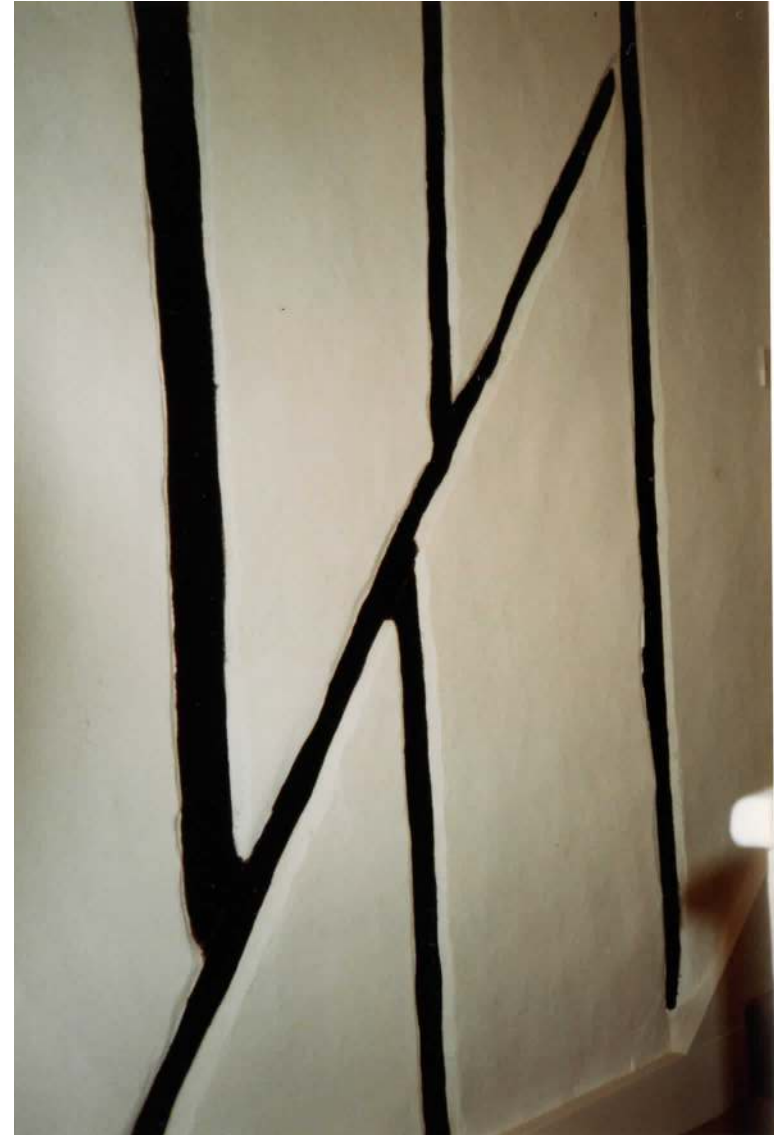
Studs in the East Wall of the Upstairs Rear Extension of No. 19 (denoting the former Roofline of the Cat's Slide Roof.)

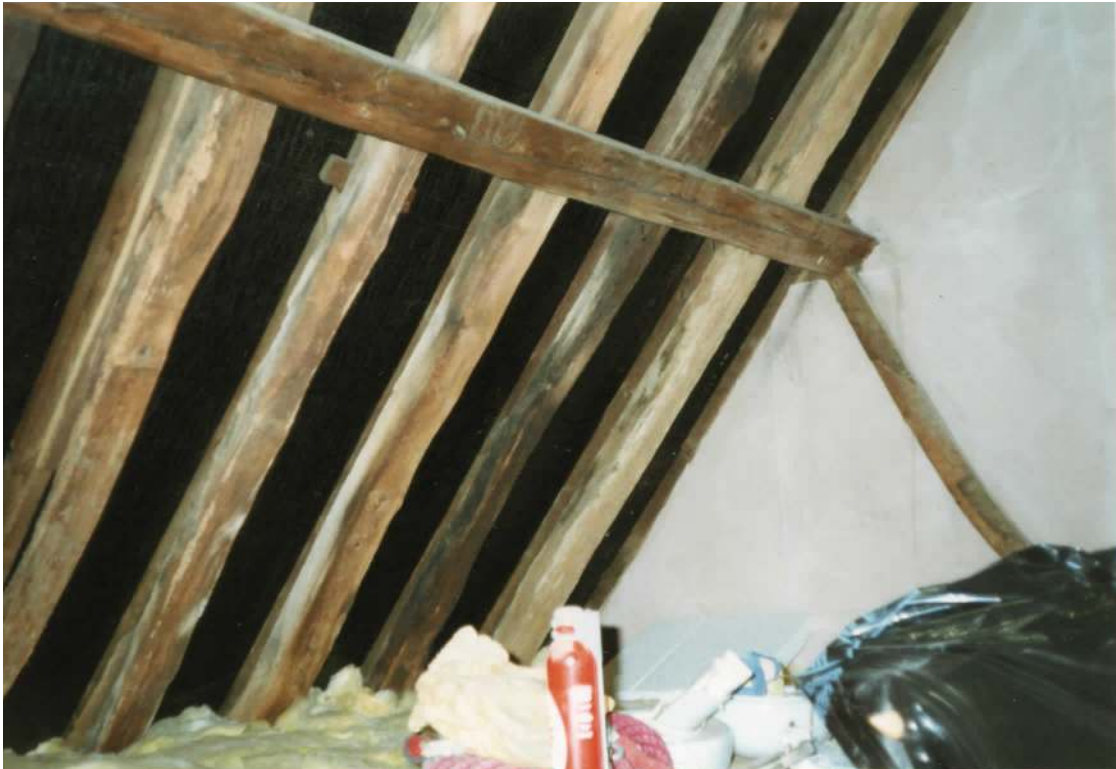
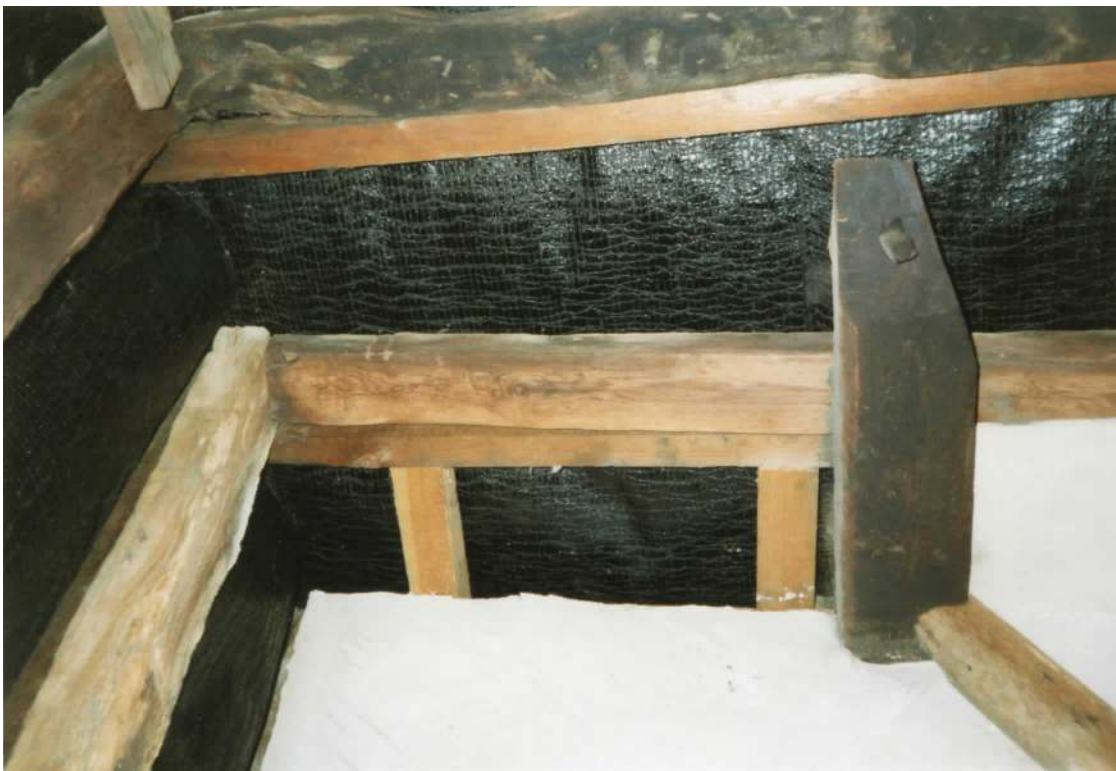
Above: Looking into the Apex of the Roof of No. 19

Below: Part of a Purlin is projecting from the Loft of No. 17  
This and some of the Rafters are Smoke-Blackened

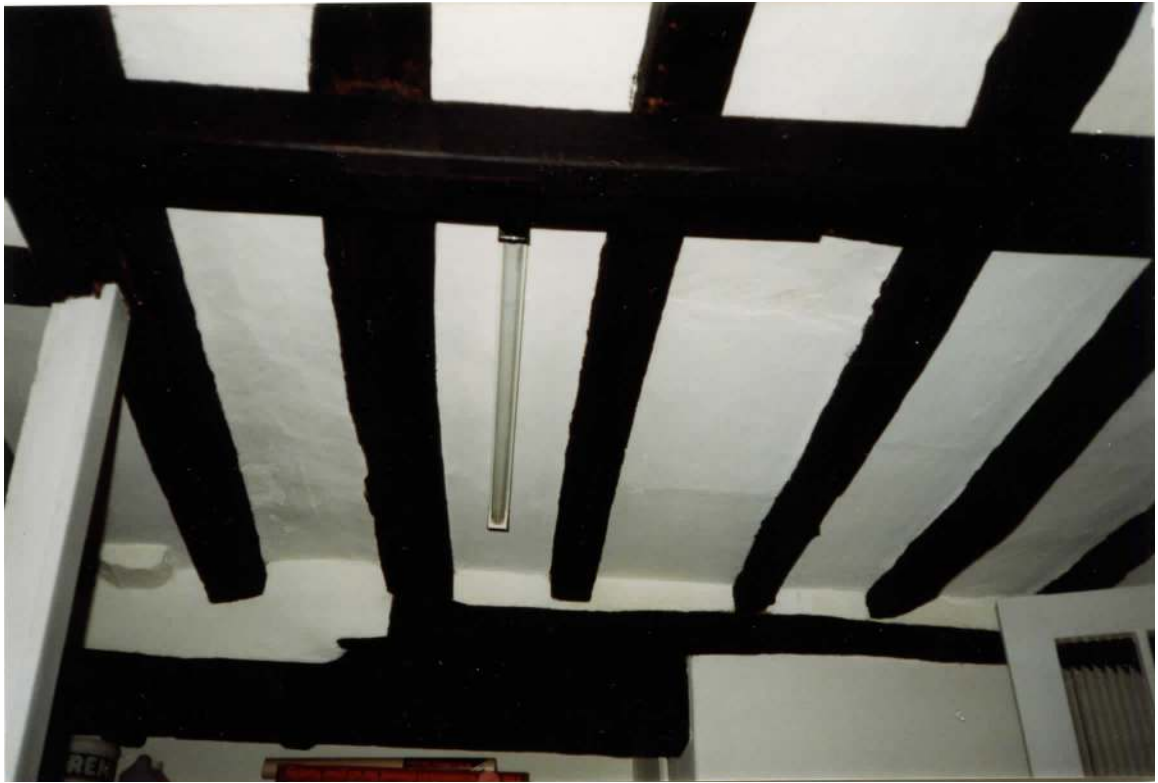
Kitchen Ceiling in No. 19

The Lower horizontal wall timber is the middle rail of the rear wing of neighbouring No. 17. Several cut-off tenons in its underside show that it used to be a partition wall. The upper timber was probably added when the outshut at No. 19 was enlarged.

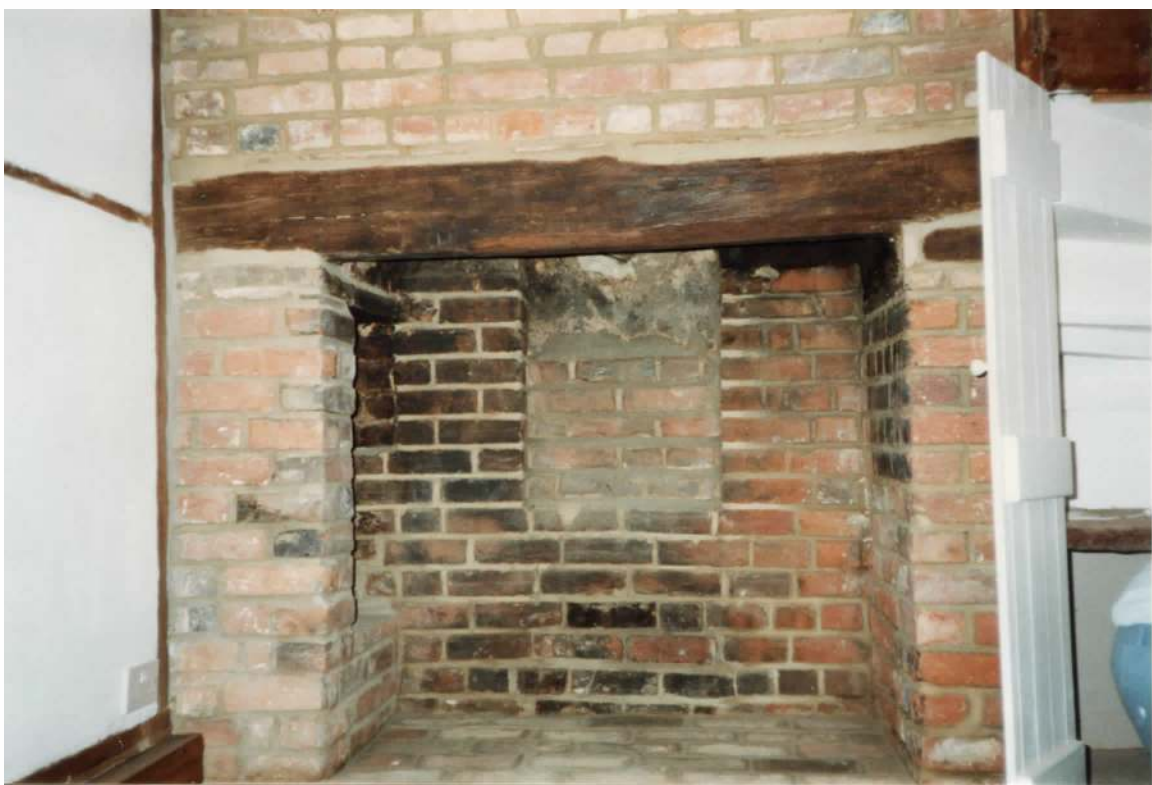
Fire-Place in Ground-Floor Front Room of No. 19  
- Cleaned and Restored during present Renovation Work -
