**VERNACULAR BUILDINGS RESEARCH  
HENLEY ARCHAEOLOGICAL & HISTORICAL GROUP**

**Parish/County:** Henley-on-Thames, Oxon

'Old Timbers' 67/69 Friday Street

**Date:** May 2010

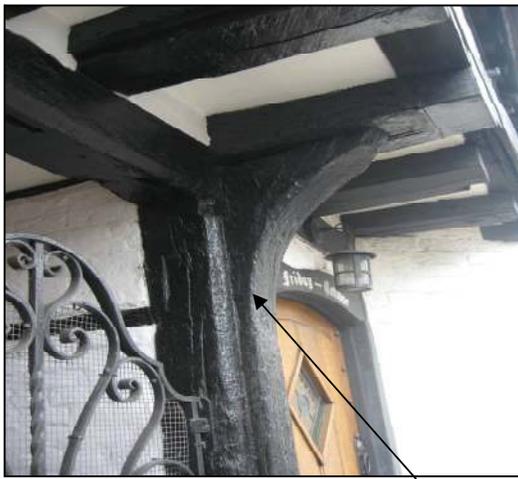
Those of trusses A, D & E have pilaster profiles, which are still visible despite being heavily weathered and worn. Short jetty brackets emerge from these pilasters to support the transverse joists of the jetty. The posts and brace together are c. 48 cm long, which means that if post and brace are of one piece, as they appear to be, the original tree trunk from which they were made, must have been very substantial, unless trunks with suitable projecting branches or roots were used. Posts D & E clearly have one rounded corner (facing each other) and one square corner

View of jetty, post of Truss E, with pilaster and knee brace rising from it next to modern passageway and the door of No. 71.

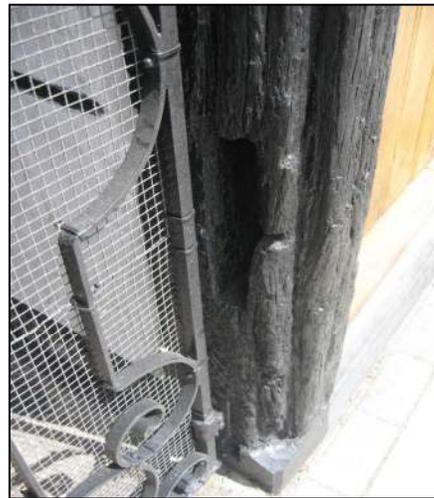
each as well as being heavily weathered, indicating an original opening with a long time of wear and tear.

However, there is evidence in the form of one large and several small mortise slots in the soffit of the jetty beam (although much of this is hidden by the modern garage door frame); the one in the centre appears to be the slot for a substantial post. The side faces of posts D and E also have empty mortises; again indicating the existence of former horizontal timbers. The jetty beam is chamfered here, another indication of a former opening? Or just a modest decorative detail, also noted at the jetty beam in bay I (see drawing ).

Front post of Truss E with 70 cm large empty mortise and peg holes. Also note the rounded and weathered corner of the post.

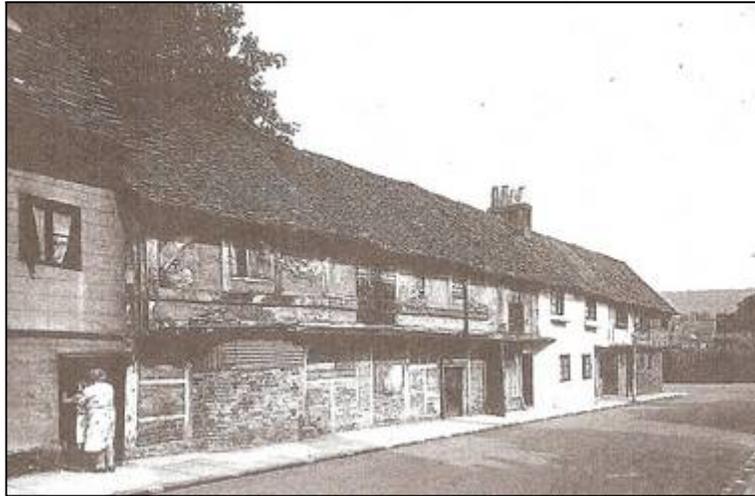
The 1940s picture below shows the building in a very similar run-down condition, probably condemned by now, as had been the case with Barn Cottage and the Thameside, Granary Cottage, before being purchased in 1925 from the Mackenzies by Lady Burke and subsequently repaired and modernized.

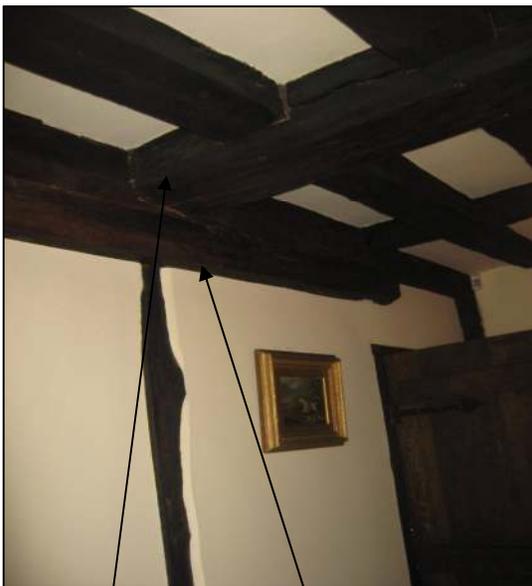
It is also at this point where the transverse beam appears to have a scarf joint (see drawing & photograph below). The ends of this joint are damaged and appear to have moved, making it necessary to support the beam from below. This repair may date from the time when the modern stairs were inserted (during the 1950s work), but may also predate this and be an earlier repair. Putting a mortise into a scarf joint, if that is what it was, is an altogether unusual arrangement and needs further investigation to properly understand what went on here.

Bay III, g.f. east face of wall, Truss C. The axial beam which supports the ceiling joists is tenoned into the transverse beam. Below this sits an additional beam giving support to this damaged area. Also see r.h. photograph for west face of wall.

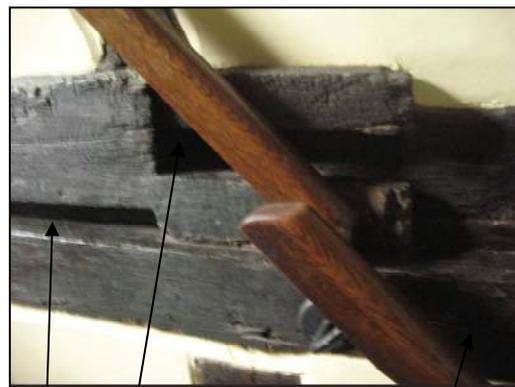
Truss C, west face of wall, Bay II. Close-up of the 6 cm deep, empty mortise of the former axial beam. Is this located what appears to be a scarf joint of the transverse beam? Additional support beam below. Also note chamfer in beam soffit.

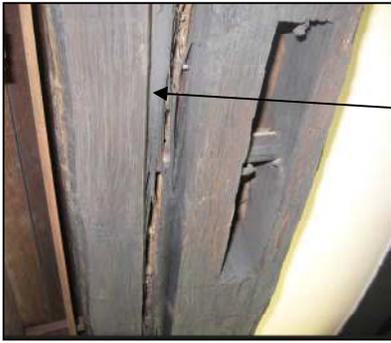
The underside of the jetty plate of the front/south wall is visible where the bay has been built out; here a number of empty mortises show the former framing of the g.f. wall. Of particular interest is a long, narrow groove located at the inner side of the beam, (see drawing and photograph). This indicates the existence of former timber panels or narrow planks; was it a double skin wall? Was the inner face panelled? And does this mean it was a windowless room?

Soffit of jetty plate in Bay I. The 20mm deep by c 15 mm wide groove runs along the whole of the visible length, although it has been widened by a large shake. Next to it, on the outside or south side is the empty mortise and peg of the former post.

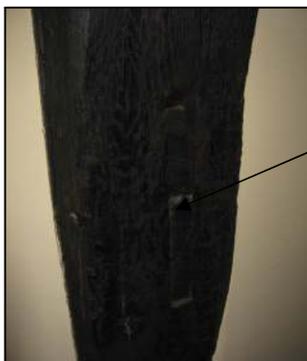
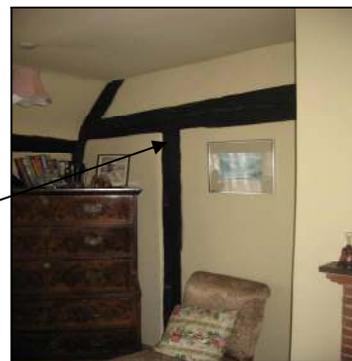
At trusses C and D there is clear evidence of former arch braces and studs, indicating original dividing walls to close off Bay III; these timbers were probably removed so that the rear corridor could be created for access to all rooms from the new staircase. Only the framing of the west gable wall at truss A retain large square panels, consistent with a medieval building date.

Left: Cut tenon of former wall brace in rear wall post of Truss C.  
Right: west gable wall of truss A showing original stud of large rectangular frame.

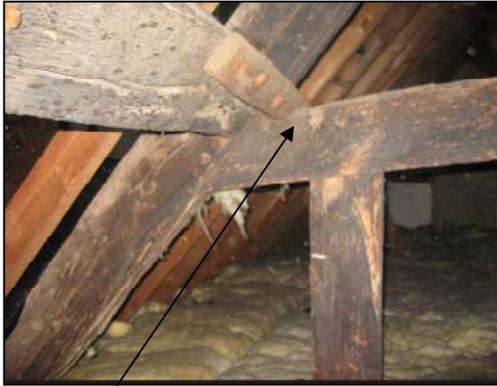
Truss C, looking west into Bays I and II

Both trusses show heavy sooting on their inward looking faces; the outer faces are clean. Both collars have mortises for staves in their soffits showing that both had been closed trusses for the purpose of containing smoke, i.e. a large smoke bay or heated room of c 3.10 m width above the jettied first floor.

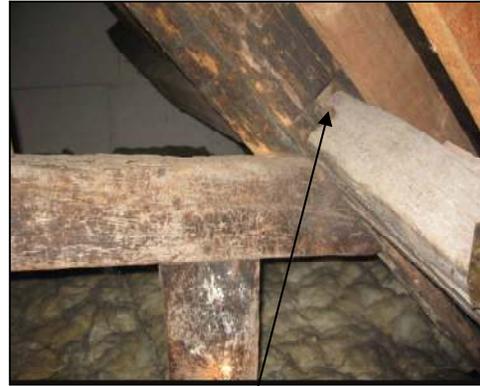
**Bay III** Truss D, looking east into Bay IV, note slipped purlin tenon.

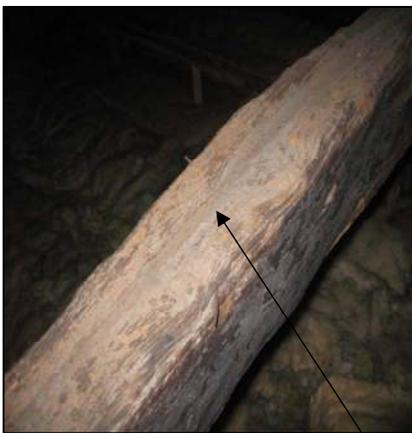
However, trusses C and D are extant together with purlins and wind braces, although all common rafters have been replaced. The two trusses have side purlins, tenoned into the principal rafters just above the collars. These have a slight camber and are supported by two slender queen struts. The top of the collar of truss C has a shallow groove and its soffit has the empty mortises of former staves for an infill panel.

Top face of collar of truss C with groove just off centre

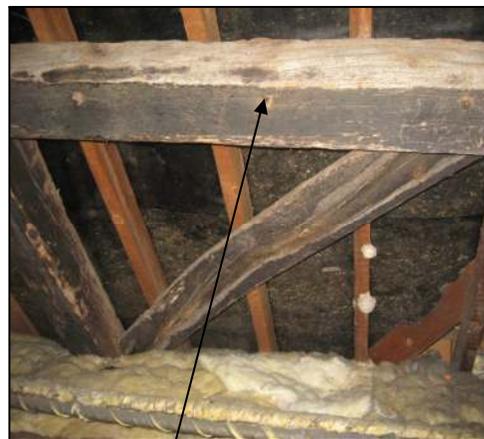
Sooted wind brace in the north wall roof of Bay III with principal of truss C just visible on the left. Pegs and peg holes in the purlin showing the location of the original rafters.
