**VERNACULAR BUILDINGS RESEARCH**  
**HENLEY ARCHAEOLOGICAL & HISTORICAL GROUP**

**Parish/County:** Henley-on-Thames, Oxon  
**Street and House name:** 16 Friday Street

**Owners:** Ian and Tracy Florance  
**Recorder:** Ruth Gibson  
**Site visits:** 4.3. and 6.8.2010

**Listing grade and entry text:** Gd II Late C 17<sup>th</sup> & 18<sup>th</sup>, painted brick façade, tiled roof  
(for detailed description see p. 39 of the DOE Greenback listing document)

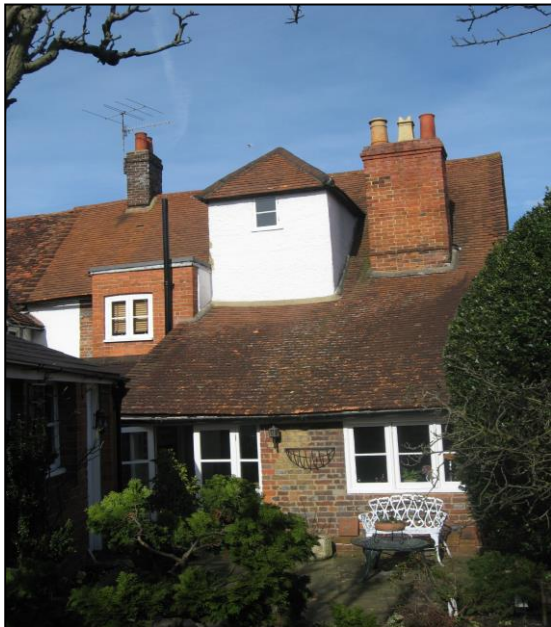
View of rear with the stair turret rising from the lean-to roof of the rear bay.

Adjacent to it is a large, three flue stack, which serves the rear room and the two east front rooms on both levels.

A further, stack is located at ridge level in the western bay, serving the former public bar.

The flat roof covers a modern bath room above a further ground floor extension next to the passageway.

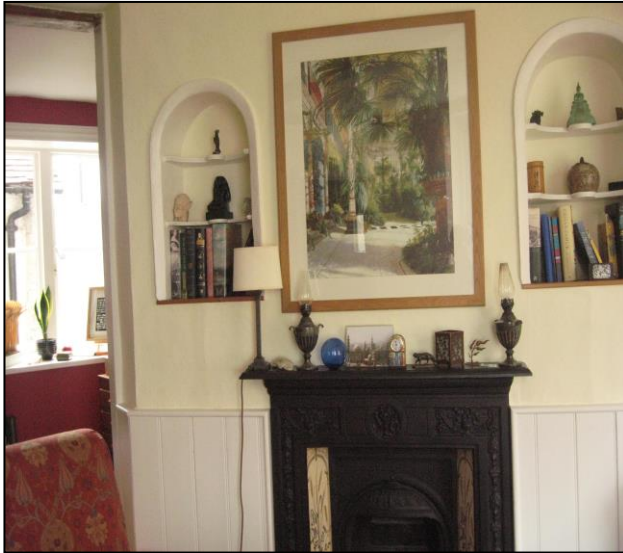
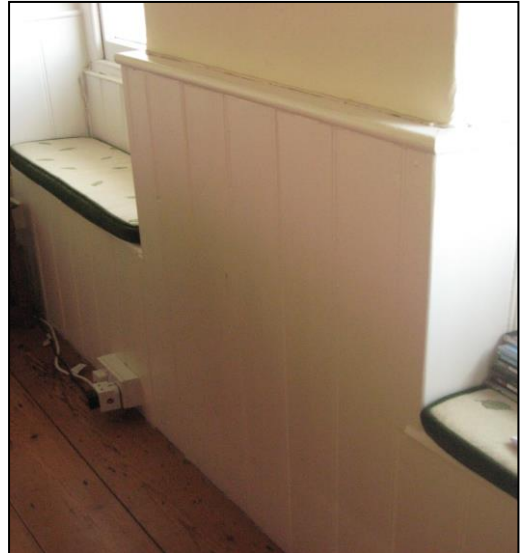
**Ground Floor:** This is accessed from steep steps leading from the pavement to the central doorway, which in turn opens into a small lobby in front of the steep, straight central staircase. A door to the right gives access to the west room, which must have once been subdivided into two, as a triangular, corner type brick stack with fire place juts into it. The room has vertical boarding up to dado height around its walls which includes the window recesses with their window seats. This is a very typical way of protecting the walls of much used rooms after the square, full height panelling of the C18<sup>th</sup> had fallen out of fashion. It is a strong indication that this was the public bar of the Black Horse and probably dates from alterations carried out by Brakspear's in the early-mid 19<sup>th</sup> C.

Ground floor, west room, partly divided by a later fire place, which has the foot print of a triangle. A typical way of introducing fire places into an existing building, found from the late 18<sup>th</sup> C. onwards. The front part of the room, with its stout boarding, would have been the public space, the rear room the bar area with access to the adjoining cellar stairs; see picture below of the divided stable door( top flap is folded up below the slope of the stairs)

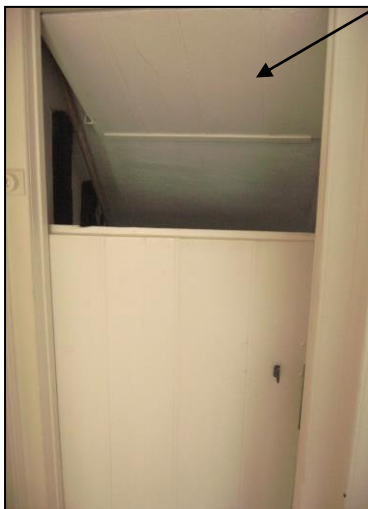
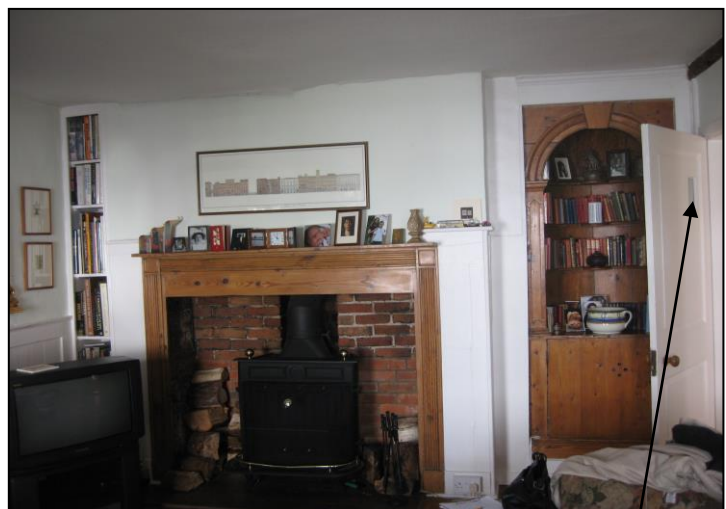
Small glass panel peep hole

small window in the top of the 2-panel door – for keeping an eye on the bar and cellar?; its walls have rectangular panels up to dado height, rather than the hard wearing vertical planking seen in the east room; it also has an attractive, C18<sup>th</sup> corner display cupboard set into the side of the chimney breast. The fire place is located within the main stack of the house between the east front and rear rooms. The central axial beam in the ceiling is chamfered with a stop at each end. Whilst the cupboard and panels can easily have been re-used from an earlier structure, the exposed ceiling beam seems to be in its original position and suggests a C17<sup>th</sup> date of construction.

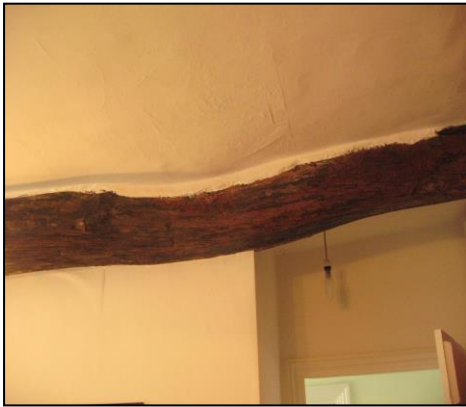
The rear, east room is located at right angles to the front, under a sloping lean-to roof; it shows exposed wall plates on each side, which are rather crudely fashioned from roughly squared tree trunks, especially the west wall one, and were probably not meant to be seen or may indicate that this room was built as a service room, for storage or stabling. The shallow cupboard at its south-eastern end, which is 1.60m long by 0.60 to 1m deep and juts out beyond the east wall into the neighbouring curtilage indicates that No. 16 itself having been a longer building.

Very curvy west wall plate indicating lack of good quality timbers

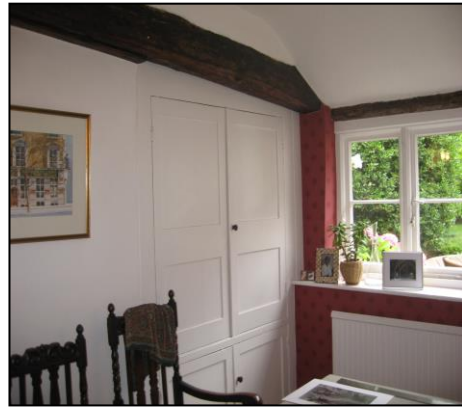
East wall with exposed, straight cut plate; below are the doors to the external cupboard.

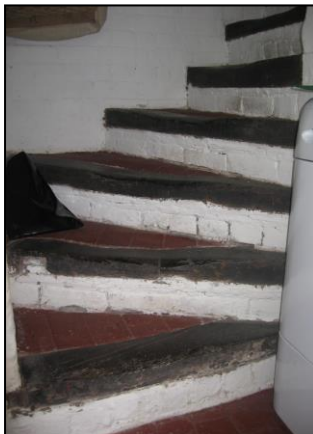
**Cellar:** This is a basement, rather than a cellar as half of it lies above ground with a delivery access directly from the street. It is 1.93m high, 3.45 m long and 2.95 m wide and its eastern corner is occupied by the brick relieving arch supporting the F.P. above. It has brick walls, of standard size bricks laid in English bond, a brick floor and brick steps with timber nosing.

Bottom of cellar stairs

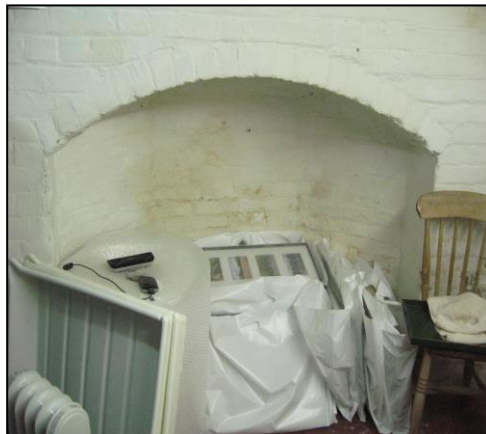
Brick stack relieving arch in the cellar

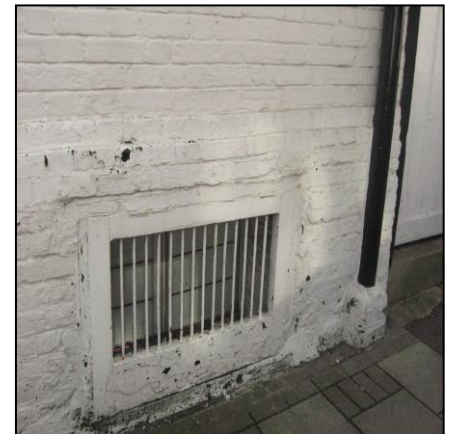
Barred delivery cellar opening

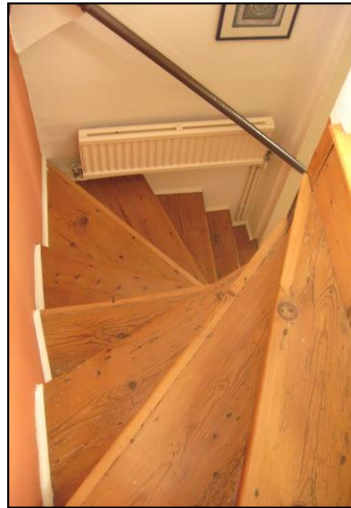
Rear newel stair, 1<sup>st</sup> floor to attic

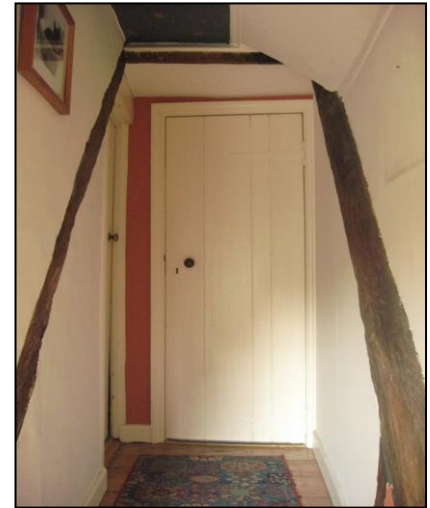
Attic landing in half bay

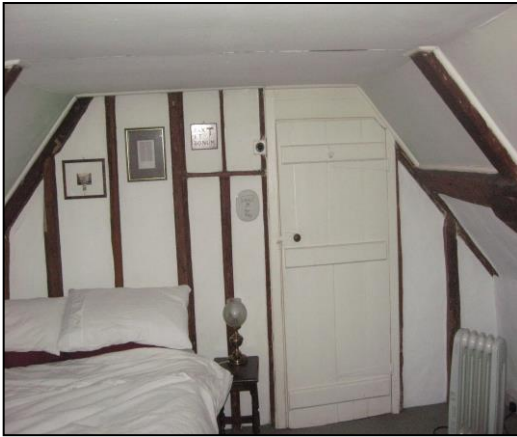
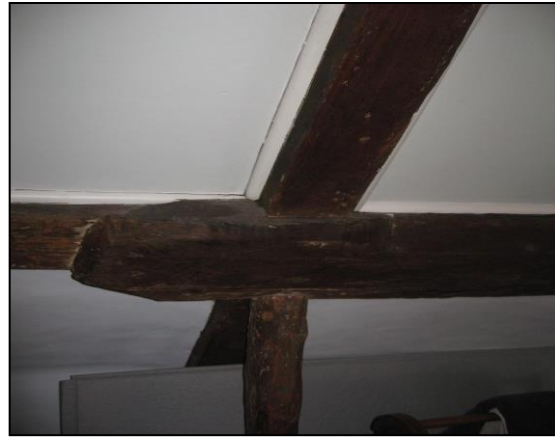
There are two attic rooms of 4.25 m length each with dormer windows to the front north elevation. These rooms are reached from a central landing, a narrow bay set between two roof trusses. These roof structures consist of principal rafters and purlins, which, where visible, appear to have been altered to allow for access throughout the roof space. The apex of the roof is hidden by a plaster ceiling throughout, which makes it impossible to assess further structural roof details.

Simple ledged plank doors give access to the two rooms. The somewhat crudely altered purlin with supporting strut can be seen in the picture on the right.

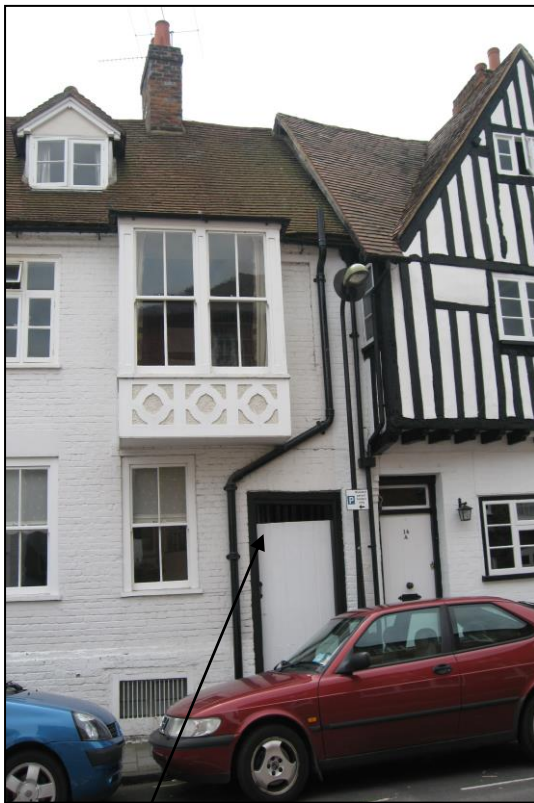
Passageway between Nos 16 and 14

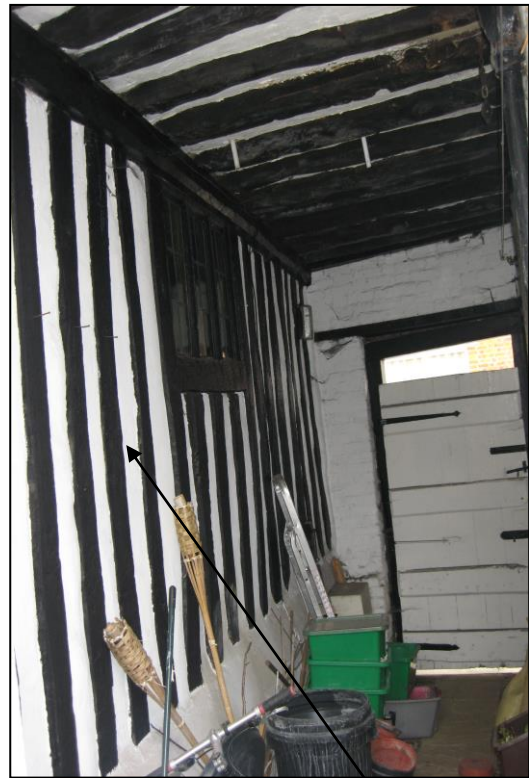
Interior of passageway with the close studded timber frame and early C17<sup>th</sup> mullion window of No 14 on the left
