**VERNACULAR BUILDINGS RESEARCH  
HENLEY ARCHAEOLOGICAL & HISTORICAL GROUP**

**Parish/County:** Henley-on-Thames, Oxon  
**Street and House name:** 77/79 Bell Street  
**Formerly:** The Bear, Rear South range

**Listing grade and entry text:** Gd II  
*15-17<sup>th</sup> C. Timber framed building. Long rear range set at right angles, timber framed with brick infilling. Of 1, 1 ½ and 2 storeys.*

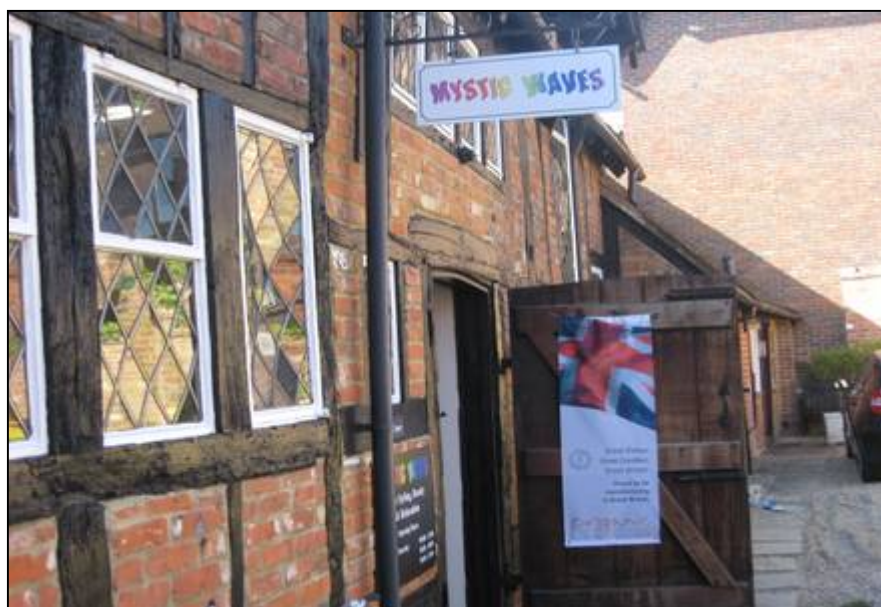
North elevation of 'Barn' and 'Stable' with lean-to roof behind.

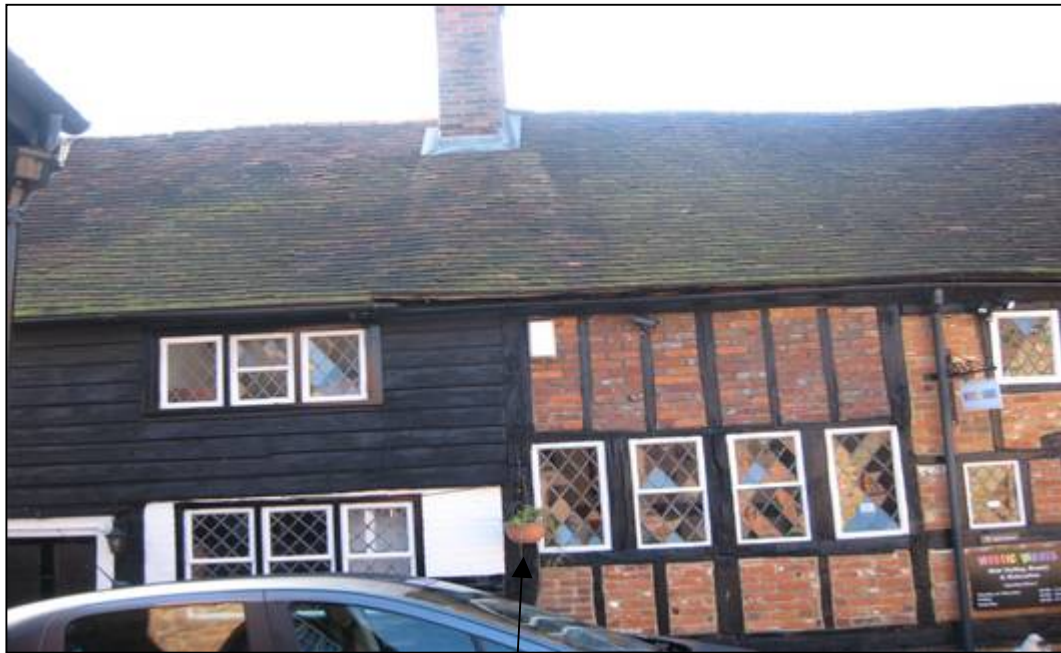
The continuous roof and single wall post (Truss A on plan) show that the weather boarded and the timber and brick sections are very likely of one build. Neither external walling materials are original; this would very likely have been wattle and daub making up the panels between wall posts, studs and rails.

Some of the framing has been replaced/repared and the sill beam appears to have been raised. All windows are modern and it is not possible to say whether any replace earlier openings. The entrance has a wide plank door, which may have served a stable, but is unlikely to be original to the building. There is a narrow hoist opening under a gabled roof, now filled with a 20<sup>th</sup> window. This appears to be a later addition, as its timbers are of narrow scantling and may reflect the use of the building as a stable with hay loft during at least part of its life when the demand for stabling was particularly strong. ( verbal information relayed by Ms. Koleva from her customers confirms that the building had a loft over part of it when the large room was used for public entertainment)

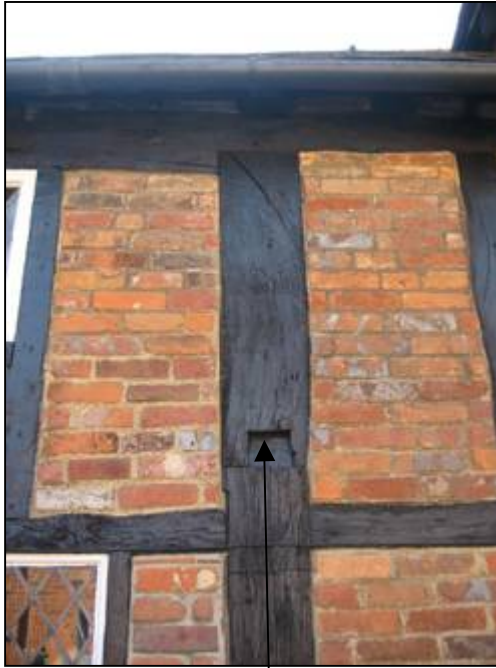
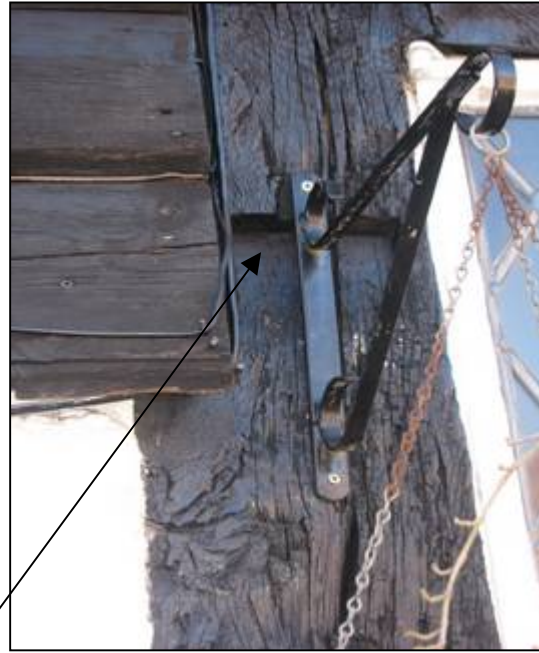
Two north facing wall posts of the Barn ( Truss B on the left and Truss A on the right). Both show the 'scotch' or raising marks on their front faces, essential to stabilize the building with props whilst the timbers, prepared by the carpenters beforehand in the framing yard, were put up on site.  
 N.B. The 1438 hall opposite (Bays VI and VII on plan) has the same type of 'scotch' mark on its two wall posts.

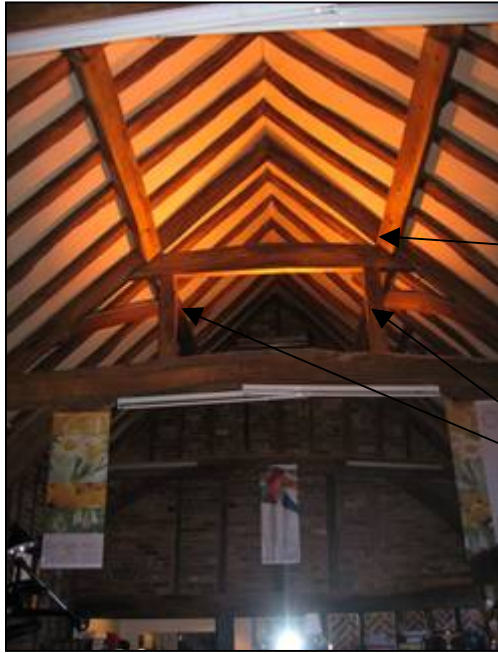
The 'Barn', looking west at Truss C and Truss D beyond forming part of the west gable wall.

This photograph illustrates the traditional queen strut truss with the collar clasp~~ing the purlins~~.; tie beams and collars are slightly cambered.

The only difference between this truss and truss A is that the single crown strut has now been replaced by the two queen struts, the rest of the truss and roof structure with its coupled and pegged rafters and curved wind braces mirrors that of Truss A.

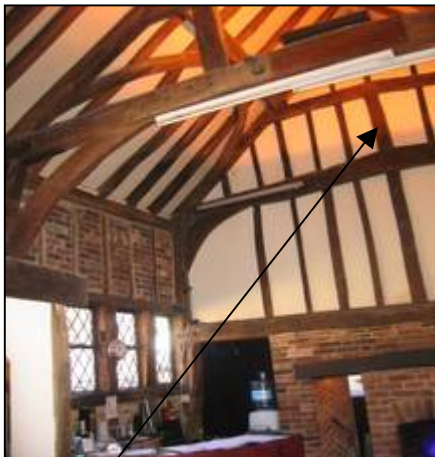
L. h. picture: Part of the east gable with fire place of the 'Barn' (Truss A and Truss B in the foreground). Note the central post which rises to the tie beam. Above it another central strut rises to the collar, also known as a crown strut. All other narrower studs are part of the wall infill, which support the wattle and daub panels.

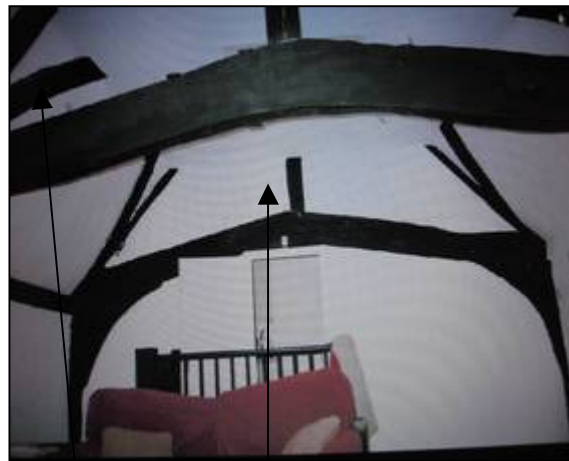
R.h. picture: Looking west in the flat of the south rear range, Bays V b and c. Here the cambered tie beam with its short arch braces and central crown strut are impressive features, unfortunately cut off by the modern ceiling, but originally designed as a large, open to the apex, built to impress. - Both roofs have wide, curved wind braces.

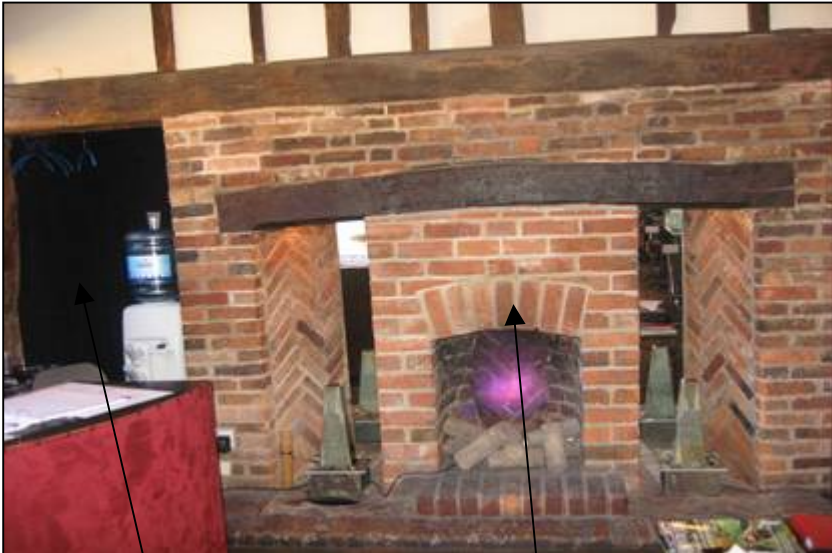
Fireplace inserted below eastern truss. This is part of a 2-flue stack, which also serves the first floor flat ( Bay V d). The central brick hearth is a 20<sup>th</sup> C. addition. On the left is the former access, now blocked, to the south lodging range, now the g.f. entrance to the flat.

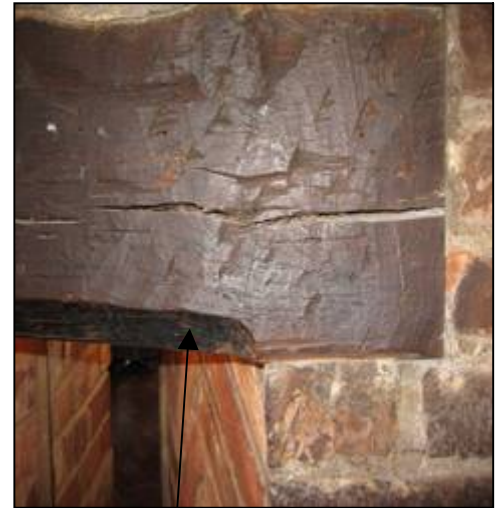
On the r.h. side is a close-up of the timber bressumer which has a chamfered and stopped lower edge. Its face has been hacked back and one can see the chisel marks. This was probably done to get a key for plastering when exposed timber and bricks had become unfashionable in the 18<sup>th</sup> century. The bricks are c. 2 ¼” thick and may be of 17<sup>th</sup> C. date.

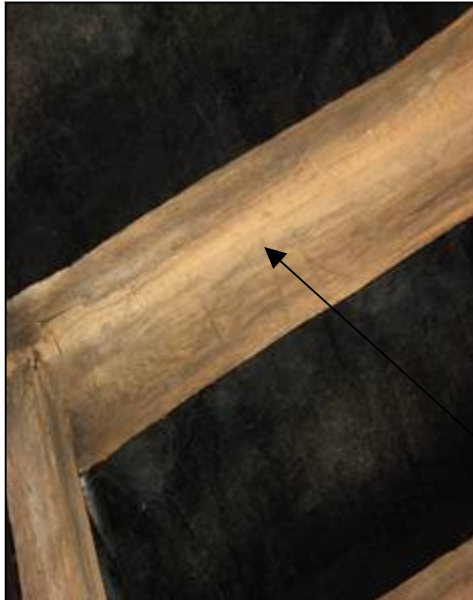
Above left: apex pegged rafters with scribed carpenter's marks.

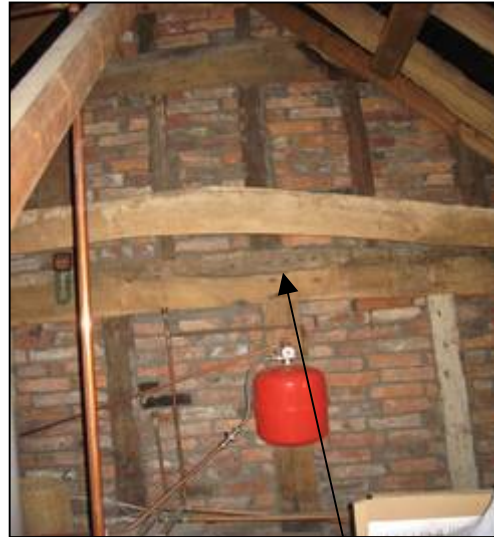
Above right: East gable truss, collar of 'Stable' in front of the west gable of the 'Barn'. The trusses are separated by a c.1 foot gap, clearly showing different bldg. dates

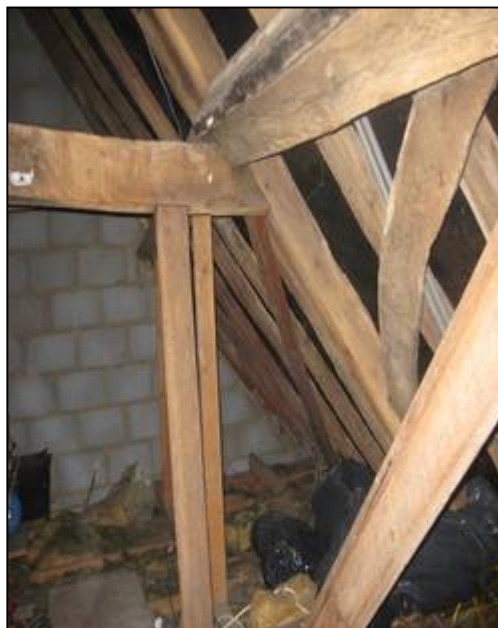
Left: Looking west beyond the queens strut truss where a new breeze block wall cuts off the western part of the building.

All traditional timber framing elements are present in this roof including the curved wind braces, but the timbers are of poorer quality scantling than those of the adjoining earlier 'Barn' range.
