Henley-on-Thames
9-11 Gravel Hill

Part of Gd. II listed row: 7 – 17 Gravel Hill

Synopsis

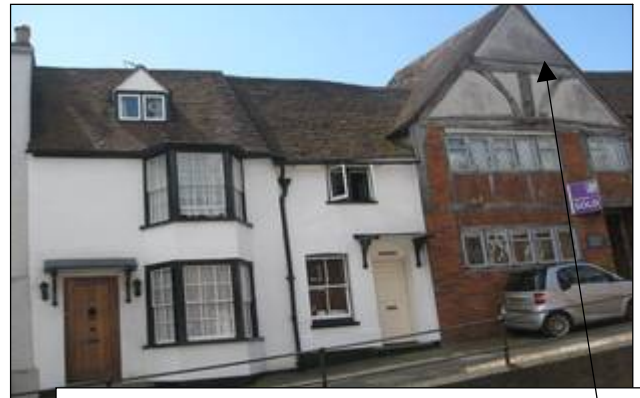
No. 9 No. 11 No. 13
 NB different roof heights of Nos 9 and 11 Original 1454 crown strut roof truss

- The roofs of Nos. 9 and 11 are of slightly different heights as seen from the outside, suggesting two separate frames, but there is evidence that the east truss in No. 11, see drawing and photographs below, also serves No 9 and is part of one roof structure.

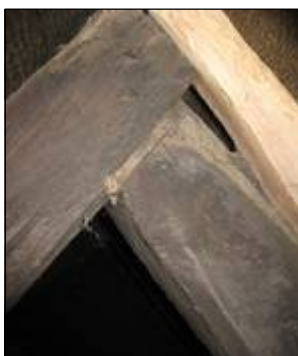
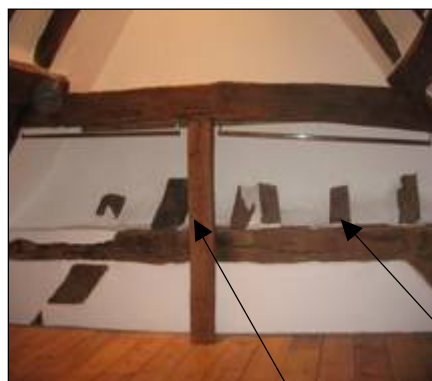
Sooted central truss at No. 9 No. 11. Left: Open western crown strut truss; rafter feet and purlin of No. 13 beyond NB. New rafter inserted above
Right: Eastern closed truss with wide, cambered collar; w & d infill.
 Does it increase the roof height? NB. Trusses were sooted before recent modernization

- The framing of the roofs is of the clasped side purlin type with cambered collars, supported by slender crown struts (both exposed at No. 11) and curved wind braces.

- No. 13, dendro-dated to 1454, was built as a chambered cross wing, apparently replacing part of No. 11 as the evidence of the projecting western purlin stubs suggests.

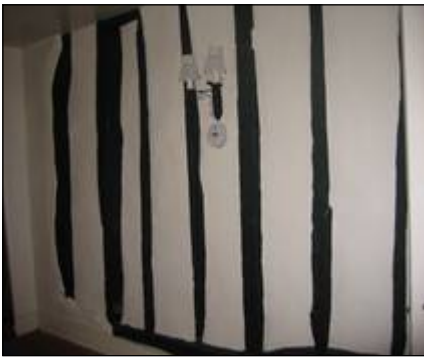
No. 9: East side wall of front room

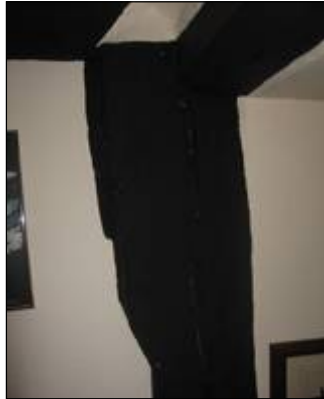
Jowl post, 1st floor, south-east corner

- All roof timbers show signs of sooting, with the w.&d panels between Nos. 7, 9 & 11 also sooted.
- The main posts, where visible, have heavy jowls; there is evidence of braces, both arch and tension braces. Early flat laid ceiling joists exist in the first floor chamber at No. 9. Those at No. 11 may be part of later alterations and use of second hand timbers, which exist in many areas of this house.

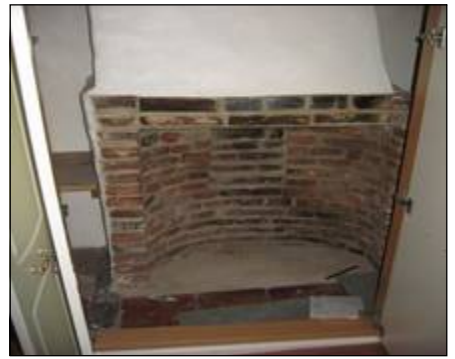
1st floor chamber fire place

- Two fire places were inserted at the back of both halls. Both 2” brick work and chalk rubble stone were used. Initials and date **AS 1795** at the back of the stack in No. 9 is unlikely the date of the first construction of the large inglenook here, but may be the date of alterations and insertion of the first floor brick F.P.

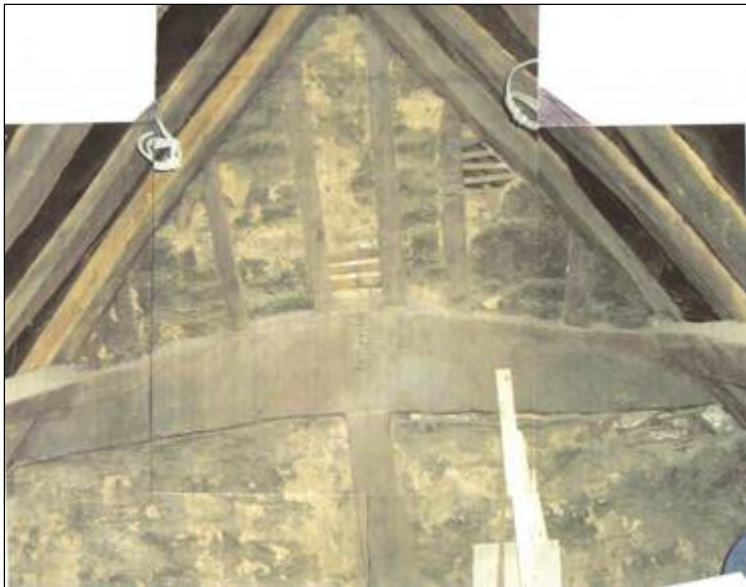
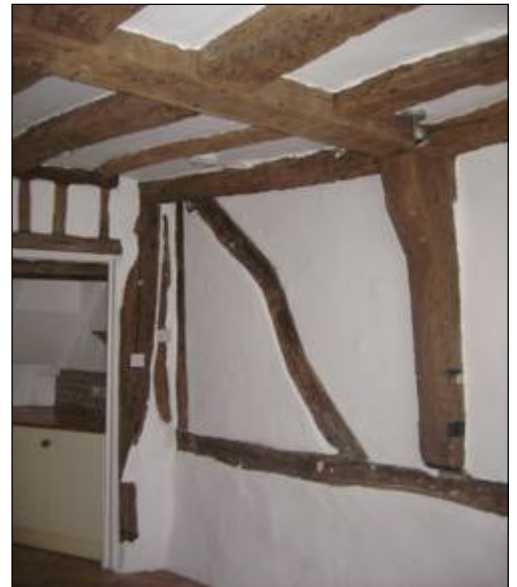
Sooted timbers and wattle & daub panels of the closed east truss of No. 11 (photographed prior to the renovation work of 2007).

The cambered collar is unusually wide, measuring 35 cm (14") in the centre and reducing to 25 cm (10") at both ends. It is only 10 cm (4") thick – almost a plank. The truss at the western end, see photo p 3, is of more usual proportions; both have slender crown struts echoing the crown post shape, which they seem to be replacing, but which was still being constructed in Henley (see Baltic Cottage, Friday Street, dendro date 1438)

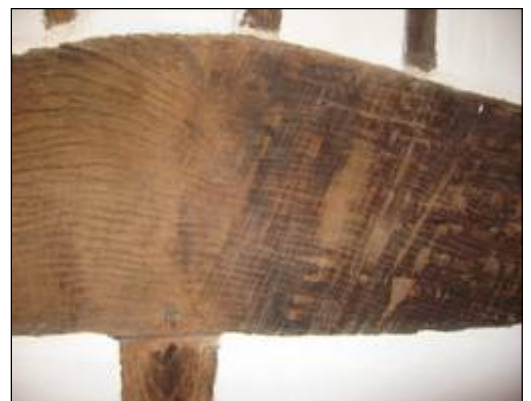
Close-up of east collar. NB the angled saw marks are typical of pit sawn timbers; also soot still ingrained in the wide tree rings of this fast grown oak (only c 30 rings, too few to dendro date)
