## Henley-on-Thames

**Address: 93-95 Bell Street**

**Grade II listed:** Listing entry: ‘Early C18<sup>th</sup> façade of stucco. No 95 has altered C19<sup>th</sup> shop front’

**Dendro dated in 2016 by Dr. Dan Miles, Oxford Dendro Laboratory, to 1436-44**

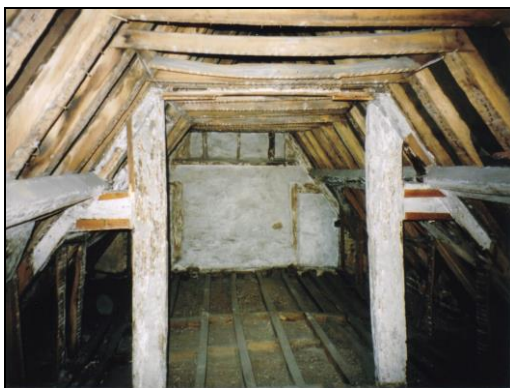
Above left: view of north attic looking south

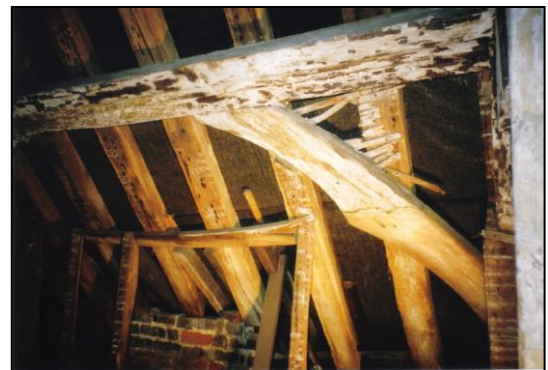
Right: roof with cusped wind brace

- Cusped wind braces between principals and purlins
- An arch braced truss – now removed – in the attic of No. 93. Was it an open hall or a grand, two-bay first floor chamber ?

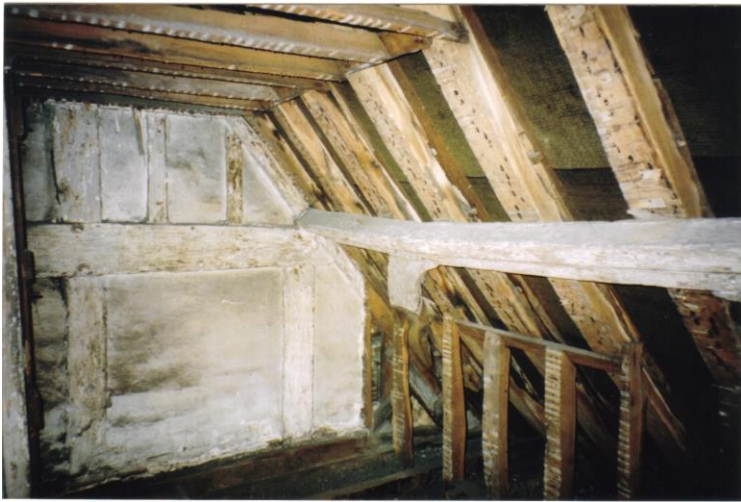
View of north end gable wall in attic of what is now No.95. NB no other equivalent of the original framing of a cross or end wall survives in the building.

- Queen strut trusses with side purlins, shown in the closed north gable truss.
- The central trusses have stub collars tenoned into two tall queen struts, allowing uninterrupted access throughout the attic – an alteration once the open hall had been floored over.
