## Discussion and summary on building dates, alterations and additions

### at 'THE BEAR', 77/79 & 81 Bell Street, Henley-on-Thames

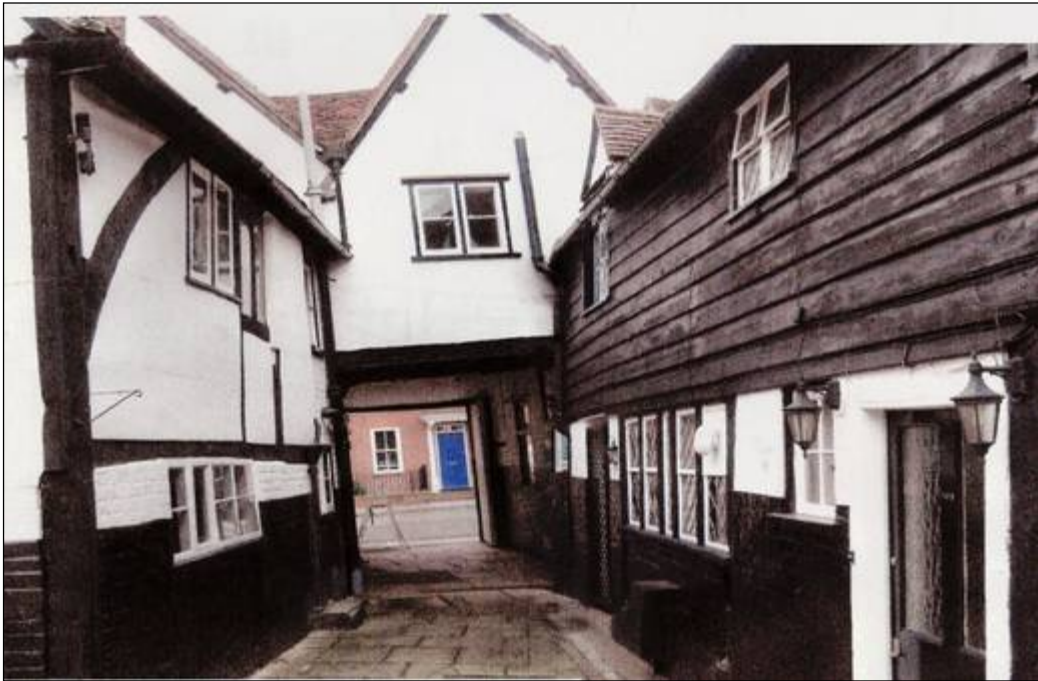
Rear yard of 'The Bear', looking east towards the carriage archway and Bell Street. On the left is the medieval hall or detached kitchen located behind No. 81. It has been dendro dated to 1438. When it was built it would have looked 0.40 m (16") taller; the ground level having risen by that much over the past 570 years. On the left is the long range, which retains an impressive first floor parlour. The lodging ranges, as described in the inn holder's inventory of 1683 are located along the street frontage under four tall gables. The one visible here is described as 'The Chamber over the Gatehouse'.

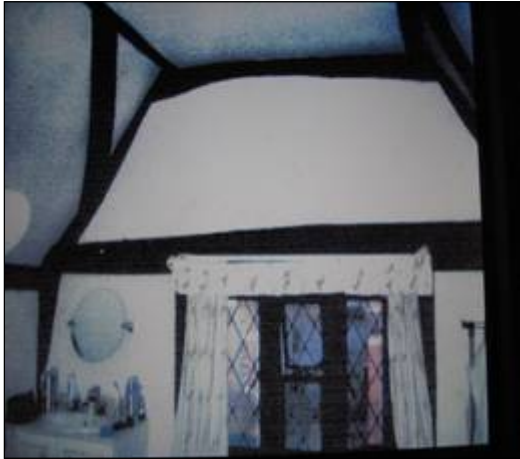
1<sup>st</sup> Floor chamber, Bay I a on plan.  
Tie beam and collar only visible

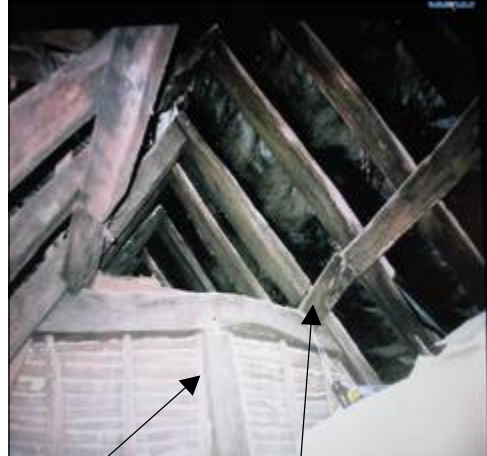
Attic above Bays II a & b, with the crown strut rising from the here hidden tie beam to the cambered collar. The purlins are clasped between principal rafter & collar.

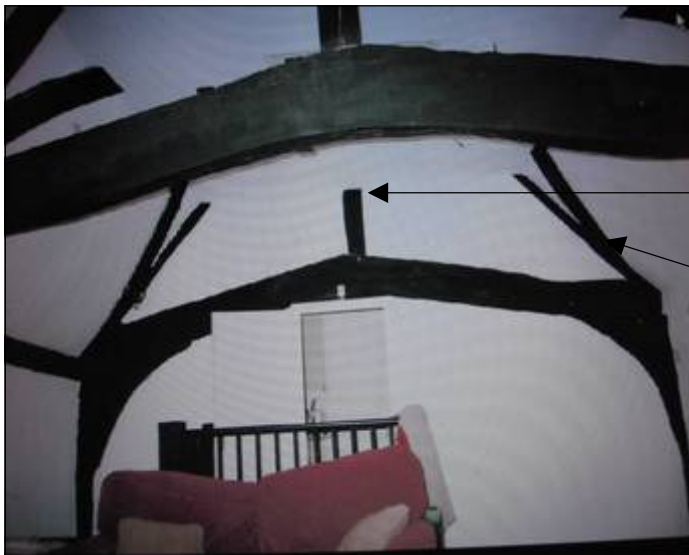
View of half of the long first floor chamber ( Bays V a – d). Formerly the arch braced and cambered tie beams supporting the single crown struts would have been open to the apex of the roof and very impressive.

The collars and upper parts of the curved wind braces are also hidden by the inserted ceiling.

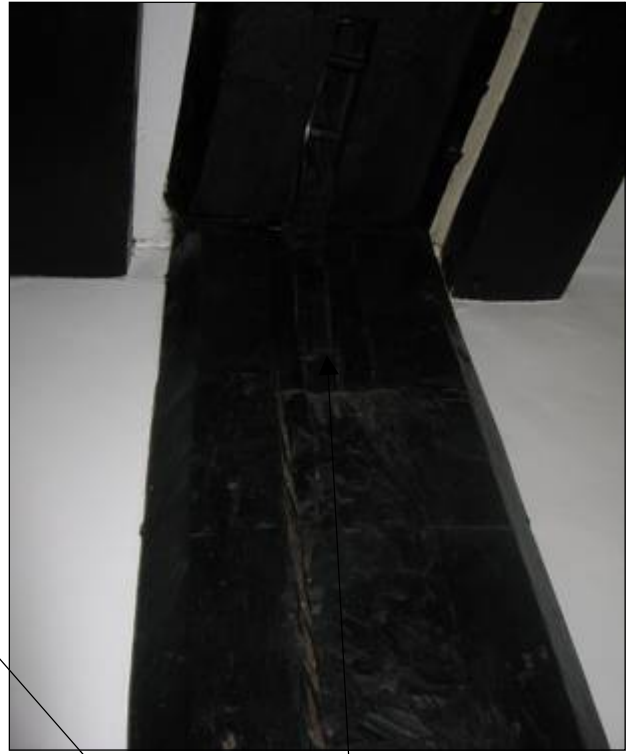
Two photographs of the South wall post of the truss which divides Bays I a and I b.

The left hand picture shows a close-up near the top of the post with a wide chamfer and stop on the right. Next to it on the left is the hacked back area of what probably was a carved pilaster on the face of the post.

The r.h. picture shows the shadow of the missing pilaster and above it (hardly visible) the cut off knee brace between post and transverse ceiling above.

The remaining posts and ceiling beam are of large scantling; especially the central south wall post between Bays I a and b. This post retains shadows of mouldings on the front face as well as evidence of a large brace, not dissimilar to that of the 1405 hall at No. 76 Bell Street.

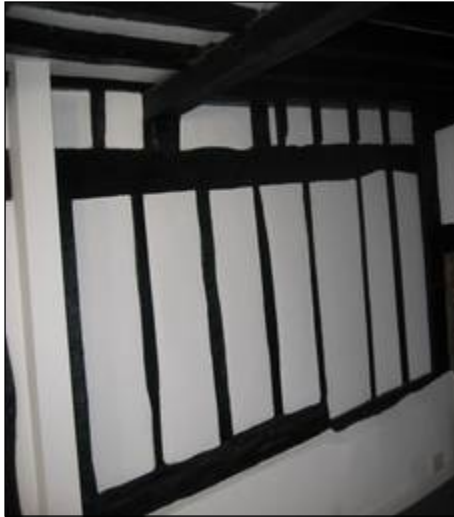
G.F. south range, south wall, Bay V a on plan. The ceiling beams support an impressive 1<sup>st</sup> floor chamber

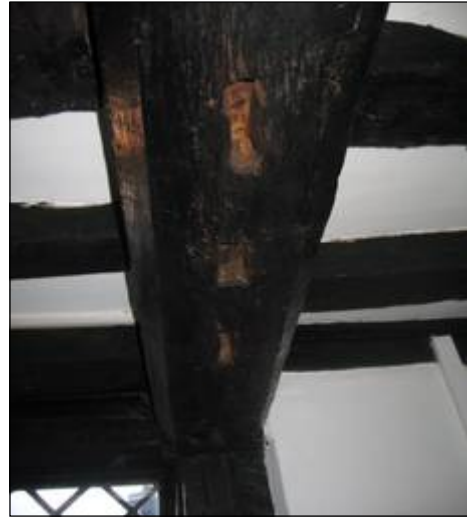
G.F. transverse joist between Bays V a and V b, formerly divided into two rooms.

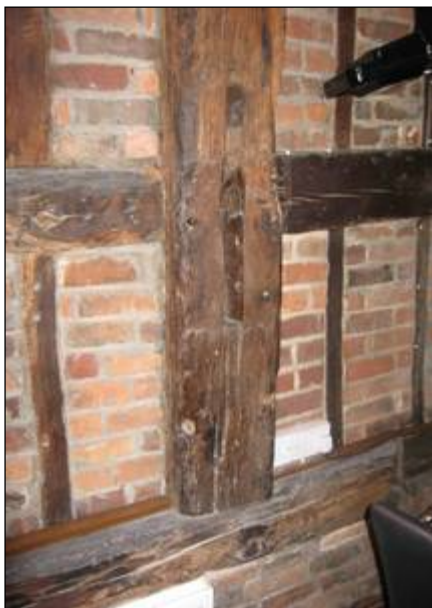
The south wall post of Truss C showing a brace slot and empty mortise of a former rail dividing the room.

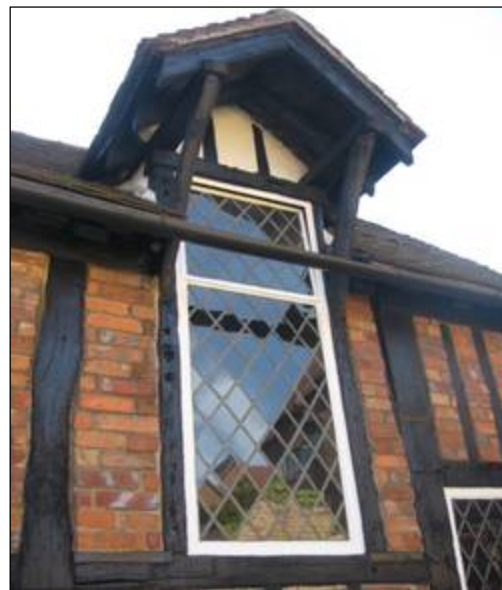
The former hoist door, now a high window. This appears to be a later insertion. The window is C 20<sup>th</sup> as are all other windows.

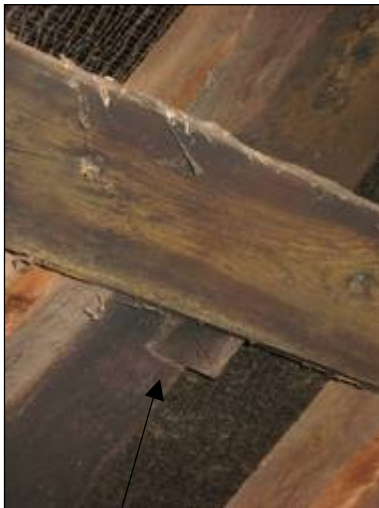
Rafter extension in 1590 through a simple lap joint for the new, taller roof. NB still smoke blackend
