**VERNACULAR BUILDINGS RESEARCH
HENLEY ARCHAEOLOGICAL & HISTORICAL GROUP**

45/47 Market Place 'The old Broad Gates'

Recorder: Ruth Gibson
& members of the HA&HG

Dendro Dated to 1353/4 29.10.2019 by Dr.Dan Miles, Oxford Dendrochronology Laboratory

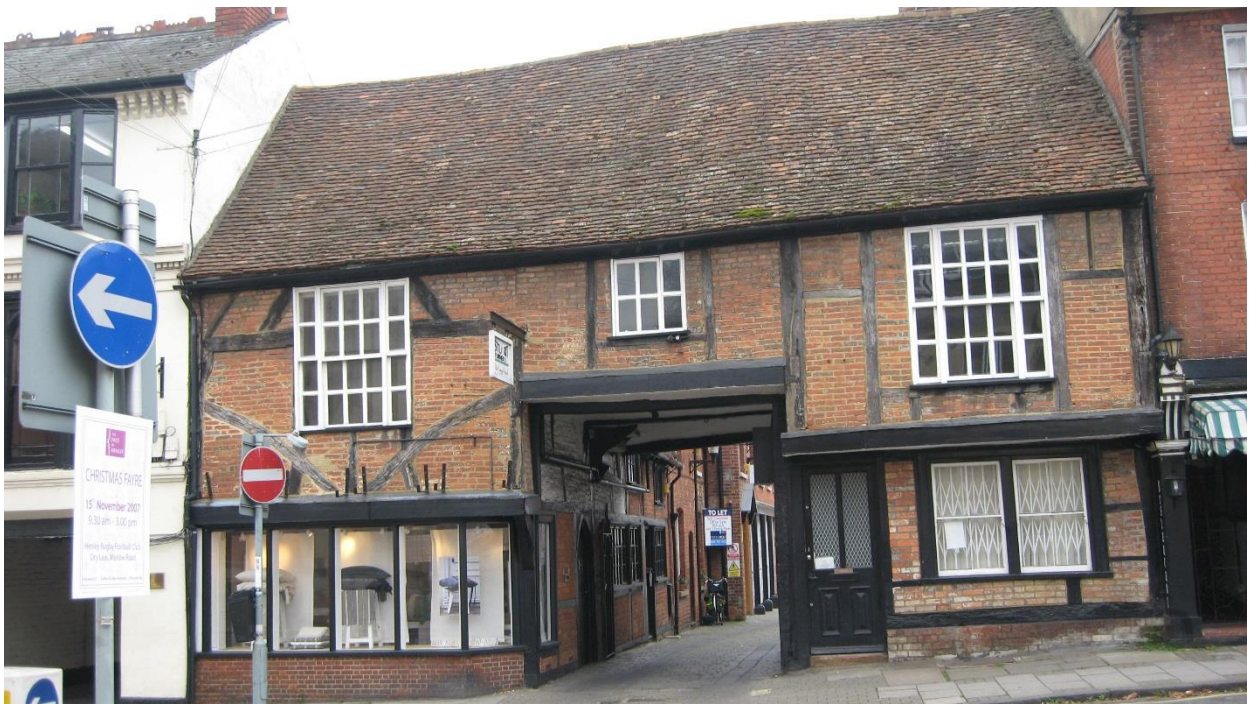
North front elevation of Nos 45 /47 Market Place, formerly the 'Broad Gates'

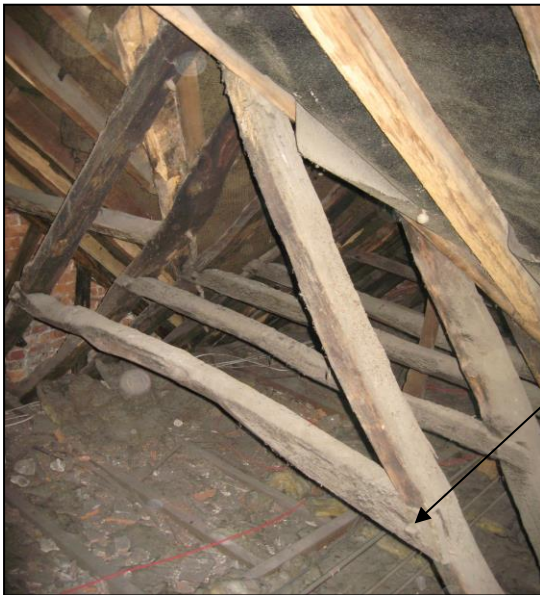
The now redundant crown post roof structure above the area of Bay II. Only the paired rafters and their collars, connected to them by simple lap joints, survive as evidence of this fine medieval roof form.

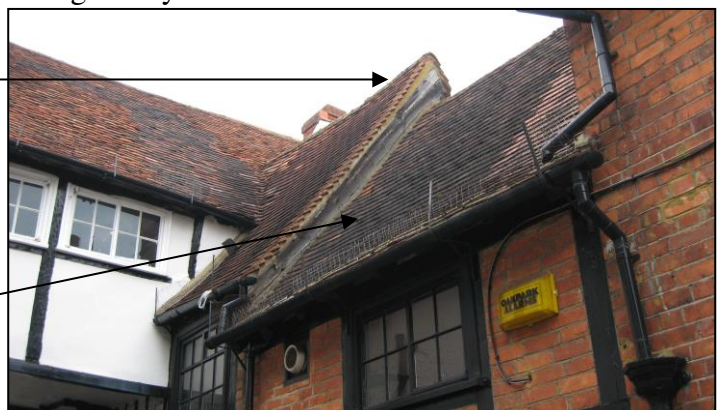
Steep roof pitch of the original cross wing, now cut back at the front elevation. The rafters of the former crown post roof still form the steep pitch of the rear roof.
Adjoining lower roof of a formerly separate timber framed building of similar age.

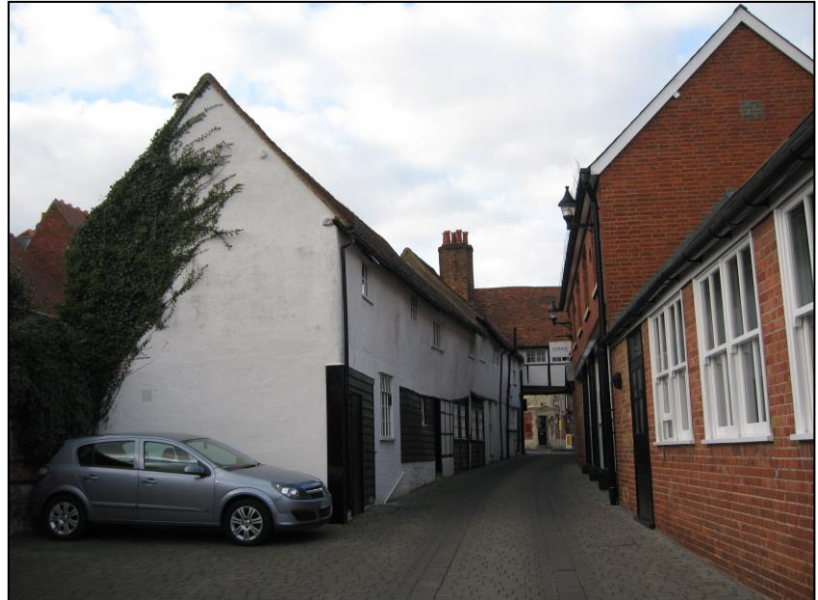
The exception is the two-bay building at the very end of the plot shown on this photograph, which preserves traditional timber framing under the render. The north gable shows signs of having been an outside wall originally, ie. a separate building.

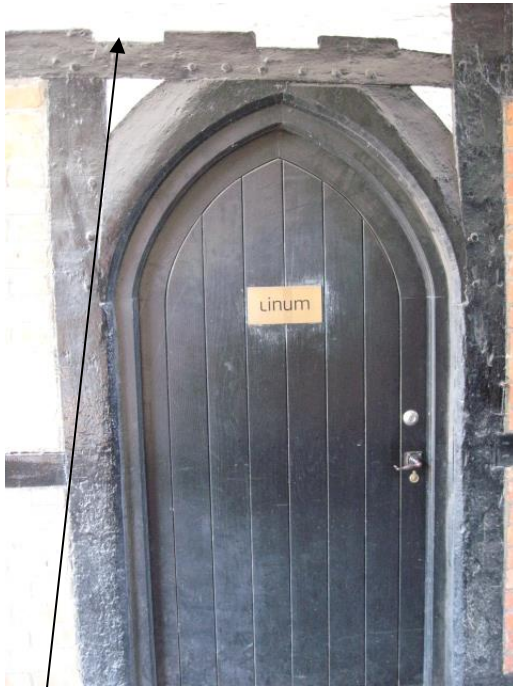
Two-centred door opening on the east side of the passageway. The short braces forming the arch are pegged into the posts and mid rail above and are part of the original framed construction. The r.h. post is the principal western wall post of the central truss and still supports the tie beam and roof.
NB the housings of former ceiling joists spanning the passageway can be seen as 1" by 8" deep recesses cut into the mid rail.

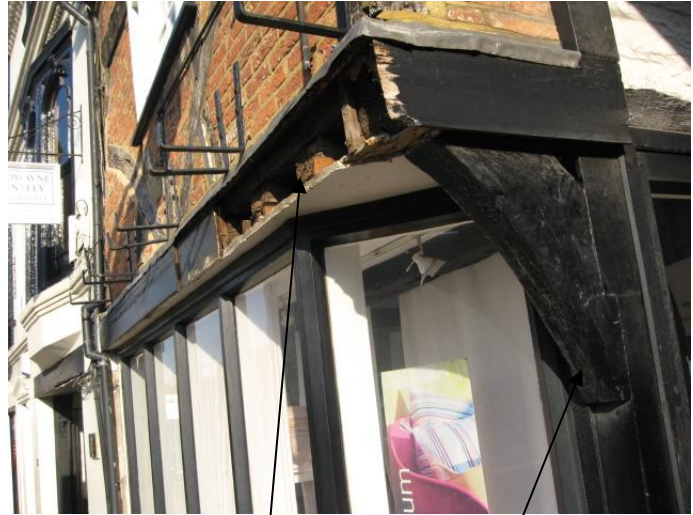
The jettied floor joists are just visible above the shop window behind the missing fascia board. The 0.60m long joist ends are heavily weathered, demonstrating their long exposure to the elements.
The wall post with brace supports the projecting corner joist, now mostly hidden behind boarding. N.B deep chamfer reducing sharp edges of low brace.

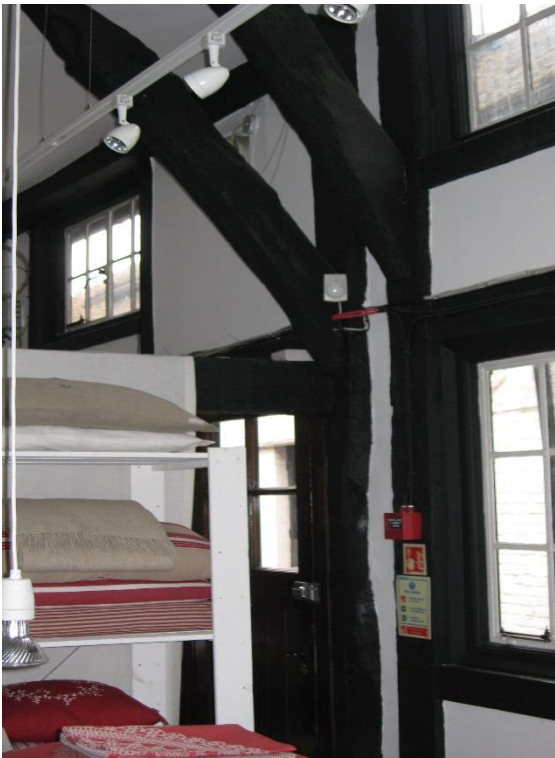
West wall with two separate trusses of bays II and III. Both have long arch braces between wall posts and tie beams

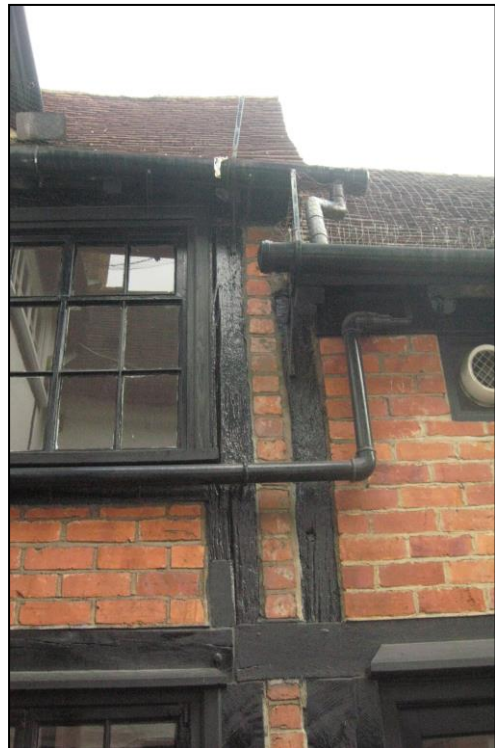
External view of the two structures, separated by a gap of c. 12 cm, now infilled with header bricks.

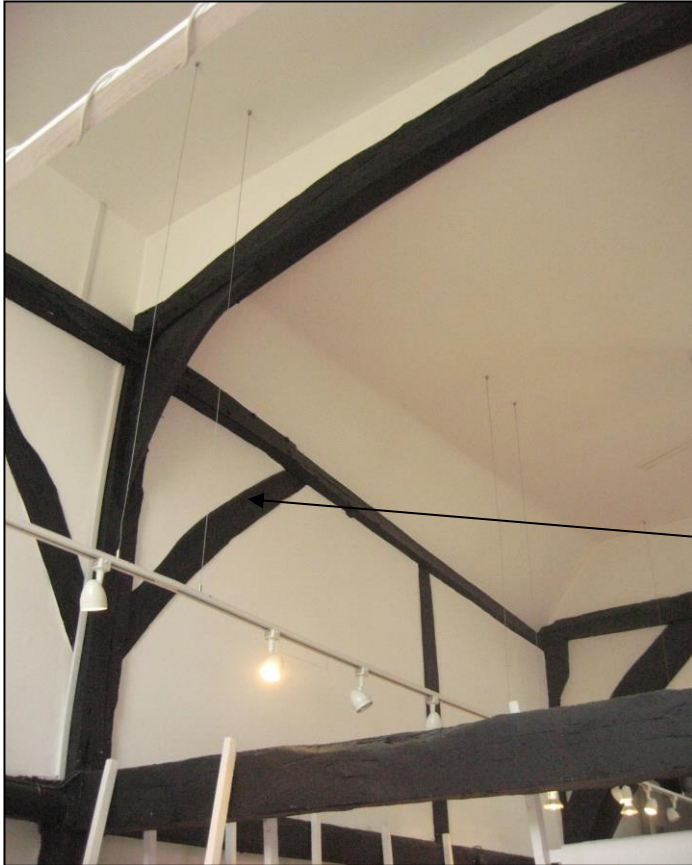
View of central truss, looking east, with pronounced camber of the tie beam; neither the north nor south ties appear to have a camber, indicating that they formed end walls and that the central truss was the visually important one.

There are short knee braces between central posts and tie beam and long arched braces at the end trusses, where the posts have jowl heads. Two long raking struts, also slightly arched, rise from the central post to the eastern wall plate.

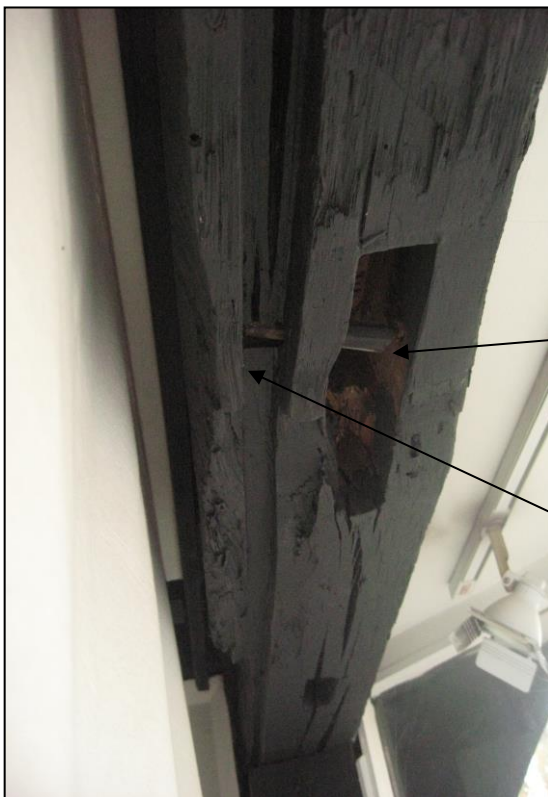
Close-up view of soffit or underside of the jetty plate in the north front wall, which supports the jettied first floor. This beam can be seen at the back of the 20th C. shop bow window. All vertical posts and studs of the former front wall have been removed, but their empty mortises and pegs still testify to their former existence. The large studs (three in total) would have formed the main g.f. front wall supports and may also have framed former openings. The smaller 75mm by 45mm mortises may have supported the former wattles of the daub infill panels.

The long, continuous, empty slot, which is 20mm deep and 35mm wide, and set back from the inside edge by 35 mm is an unusual feature. It suggests a groove for a stud and panel wall; with the peg going right through both, showing a sophisticated and strong infill panel. This in turn seems to exclude former window openings in this gable wall, suggesting a secure storage space.

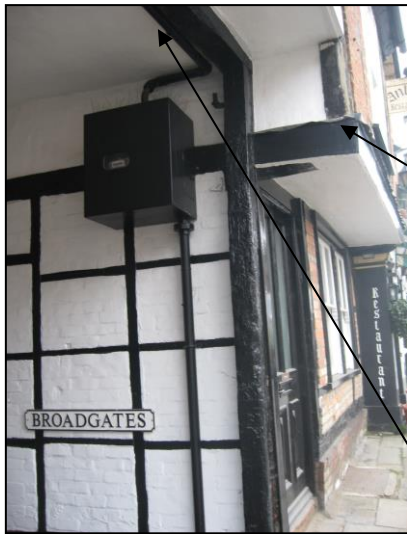
West wall

The difference in the wall framing between the medieval east wall and the c.18th C. west wall visibly illustrates centuries of changes.

Mid rail supporting jetty of west range at a height of 2.42 m

The earliest ceiling joists were located in the east wall supported by the mid rail, only 2.06 m above ground level.

Now the entrance gate way is 3.12 m high.

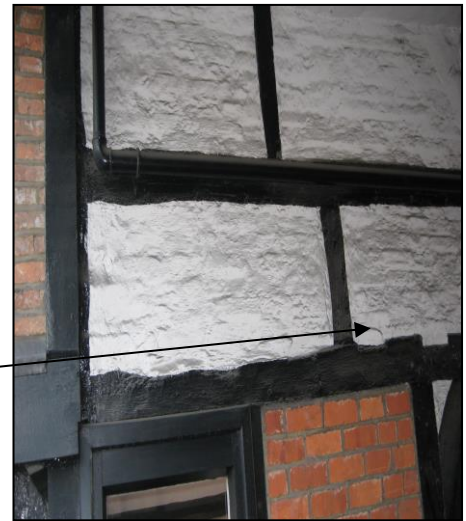
East wall

The mid rail on the east side of bays I & II is of 6” (15cm) scantling and supported an earlier ceiling. It has 19/20 cm wide and 2.5 cm shallow recesses cut into its top, where former ceiling joists would have been lodged (also photo on p.5), but the evidence for these joists disappears toward the front of the building, where the mid rail has suffered from weathering.

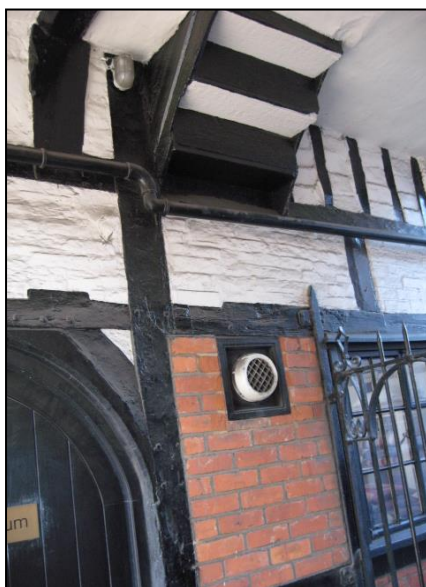
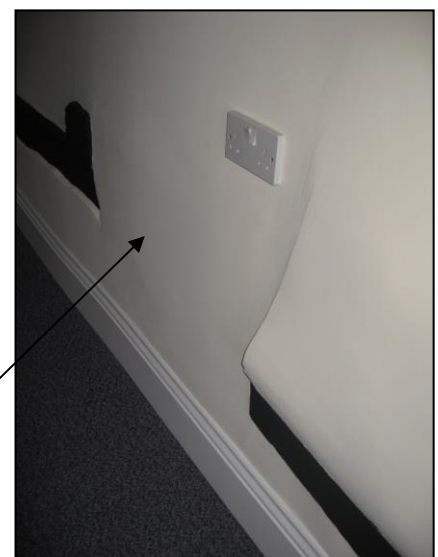
Left: Stairs rising from east range to room above the gateway. The framing consists of wide, rectangular panels below and close studding above the mid-rail.

Right: Room above the gateway. Gap cut into beam for stair access from the adjoining medieval chamber in the east range.

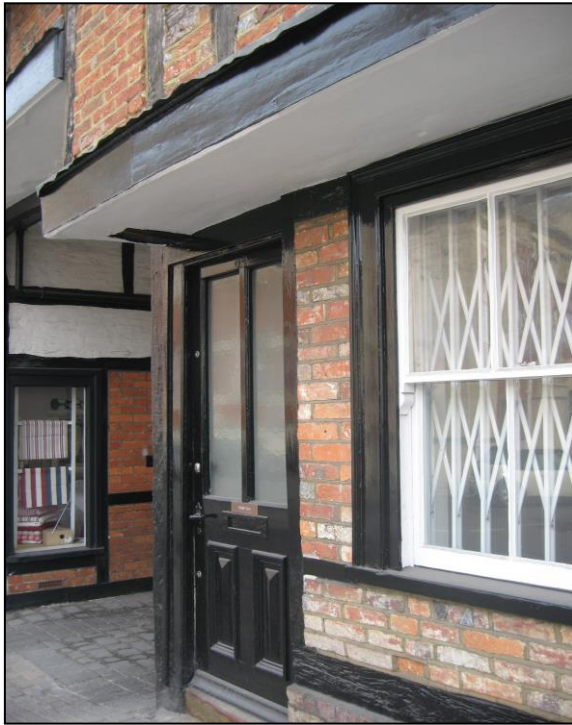
The front elevation of the west range preserves some of its large rectangular framing at ground floor level and most of it at first floor level. The jettied ceiling joists are enclosed behind a fascia board and plasterwork below.

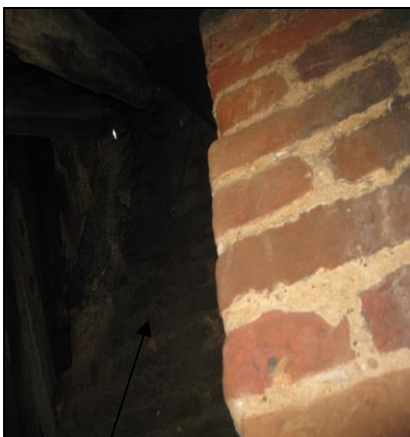
Attic: Main brick flue measuring 2.27m by 0.69m, blocked F.P. opening is 1.08 wide by 0.96 m high. Behind the main flue, just visible on the left is an additional flue of 2" bricks, probably inserted to serve the later rear extension.

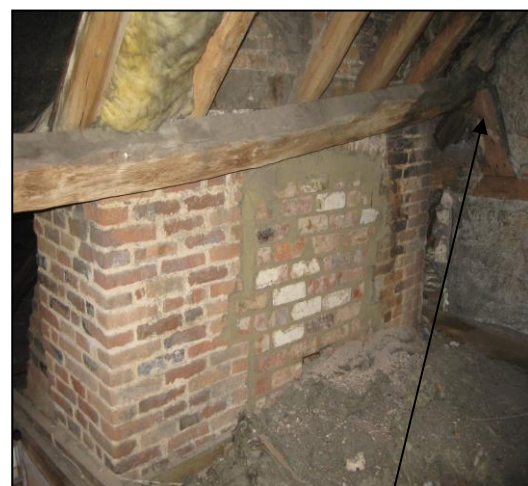
Attic room fire place (Bay V on plan) rising behind the lower south purlin which is supported by the queen strut and stub collar of the western end truss (also see photograph below).

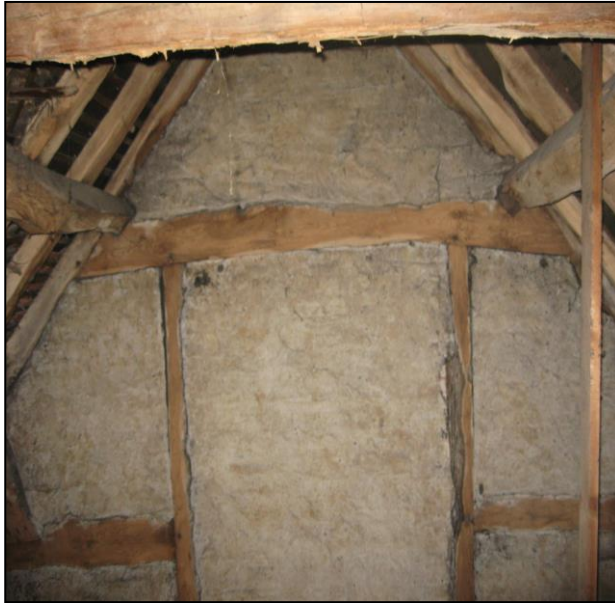
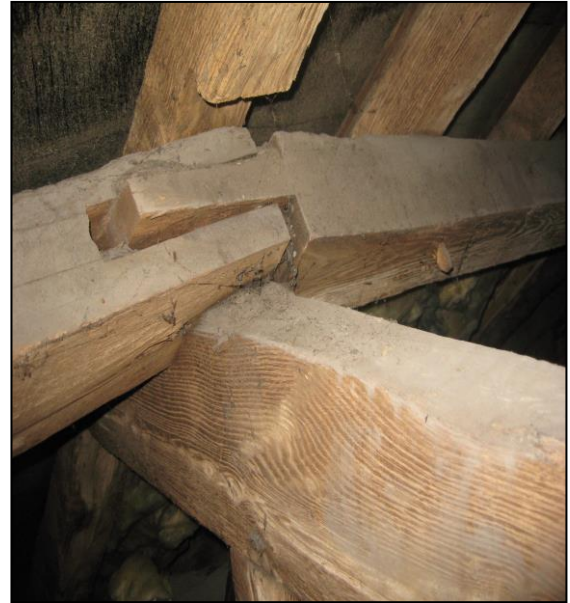
View of the west end gable of Bay V showing the truss construction with its tall queen struts and cambered collar above, which looks like a former doorway beyond the existing building. The right hand picture shows the central truss and the purlin clasped between collar and principal rafter. The purlin was extended with a bridled scarf joint just above the collar support.

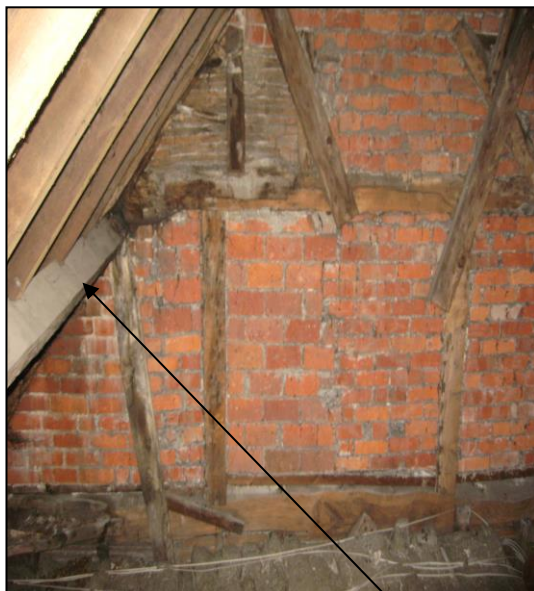
East gable end with earlier roof structure of an adjoining building (now replaced by a 19th C house). The present Broad Gates side purlin roof can be seen on the extreme left and right of both photos.– On the right one can just see the first two surviving rafters and one of the collars of the crown post structure. They are quite dark and may be sooted. Here they are redundant but their southern end still supports the roof & gable visible from the yard.

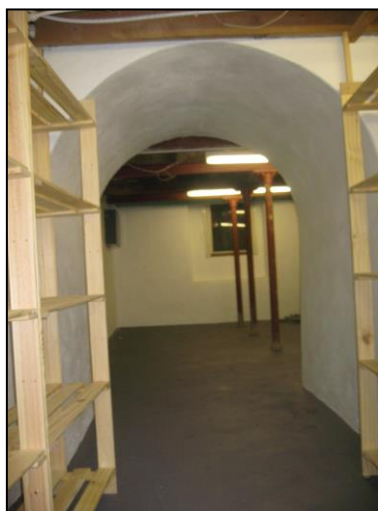
The most interesting feature of the cellar is a large arch. It appears to be brick work, but is now under a thick render & supports the stack above. It is 2.24 m wide by 1.80m tall and 1.58 m deep; the arch inside is 1.46 m wide. It is a truly impressive structure. If it is original, it would link the construction of the cellar and that of the stack, which in turn seems contemporary with Bay V.

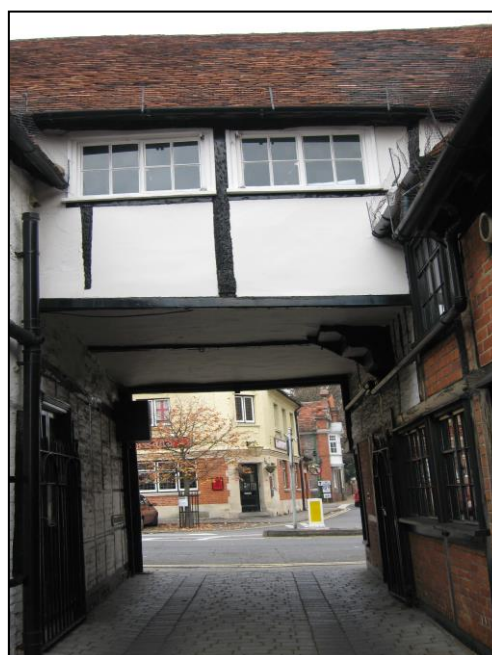
The west rear range is 28.85m long from the south gable to the edge of the rear face of the archway. Up to the front street edge of the jettied overhang the entire range measures 36.10m. The rear part consists of several late timber framed buildings, most of which appear to have served as stables and open fronted storage buildings.

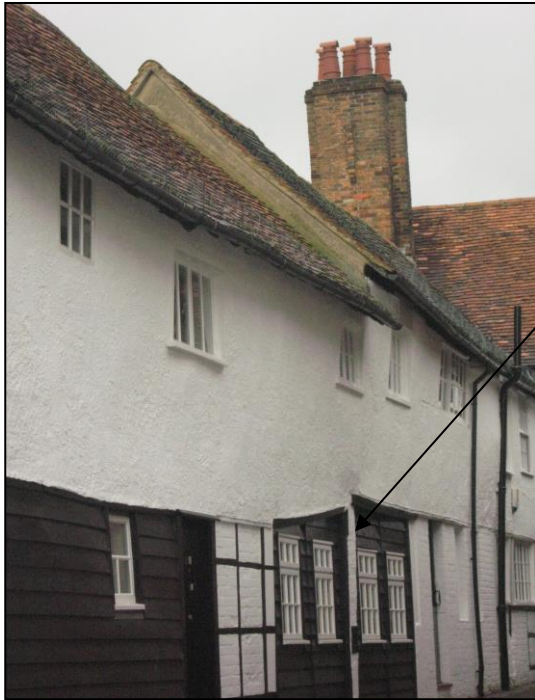
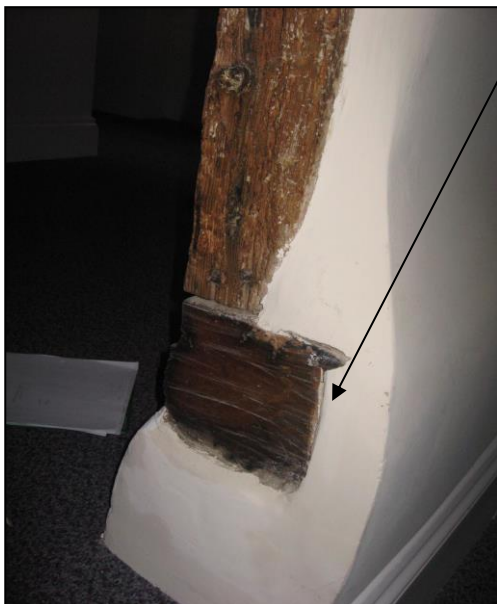
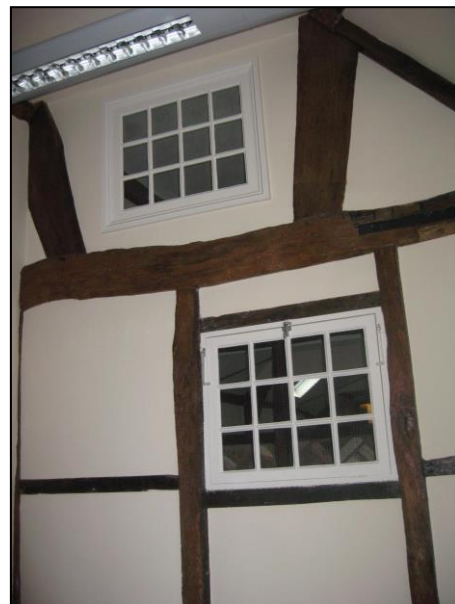
Left: Break in roof line denotes different building phases.

The two slightly recessed, weather boarded areas with very uneven upper edges were probably open fronted originally as there is no plinth below the boarding.

Below right: north gable of two-bay timber framed building (area IX). Its framing is traditional with the tie beam supporting raking queen struts. The framing consists of square panels with a long raking strut below supporting narrow, closely spaced studs. The cut sole plate stands on a projecting masonry plinth, the sign of an external wall.

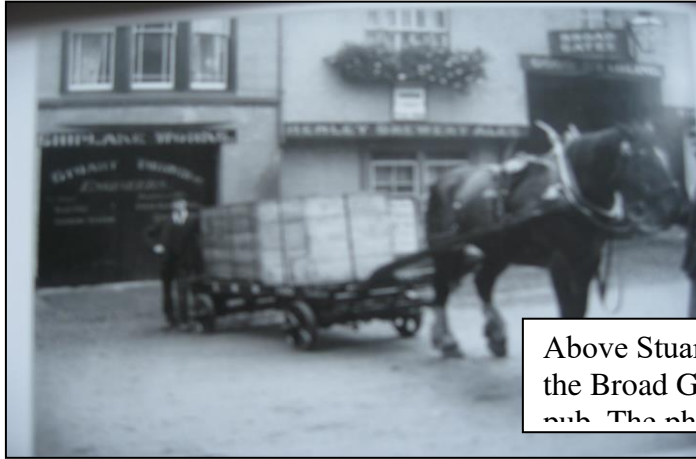
Market Place south,
 photograph taken
 between 1908 and 1917

Stuart Turner's works on
 the left, the Broad Gates
 Inn, still a Brakspear P.H.
 on the right, before the
 render was removed to
 reveal the medieval
 timber framing.

Whilst there are signs of a larger archway being constructed as part of this 16th C. building work the present very tall and wide archway appears to be of a later possibly 18th C. date. This would have meant that the floor of the chamber above as well as its ceiling had to be raised, reducing the attic accommodation space to bay V only. The construction of additional rear ranges would have more than made up for this small loss, which allowed the profitable coaching and carting trades full access into the large rear yard and ground behind. The early 20th C. photograph above still advertises GOOD STABLING on the fascia above its broad gateway.

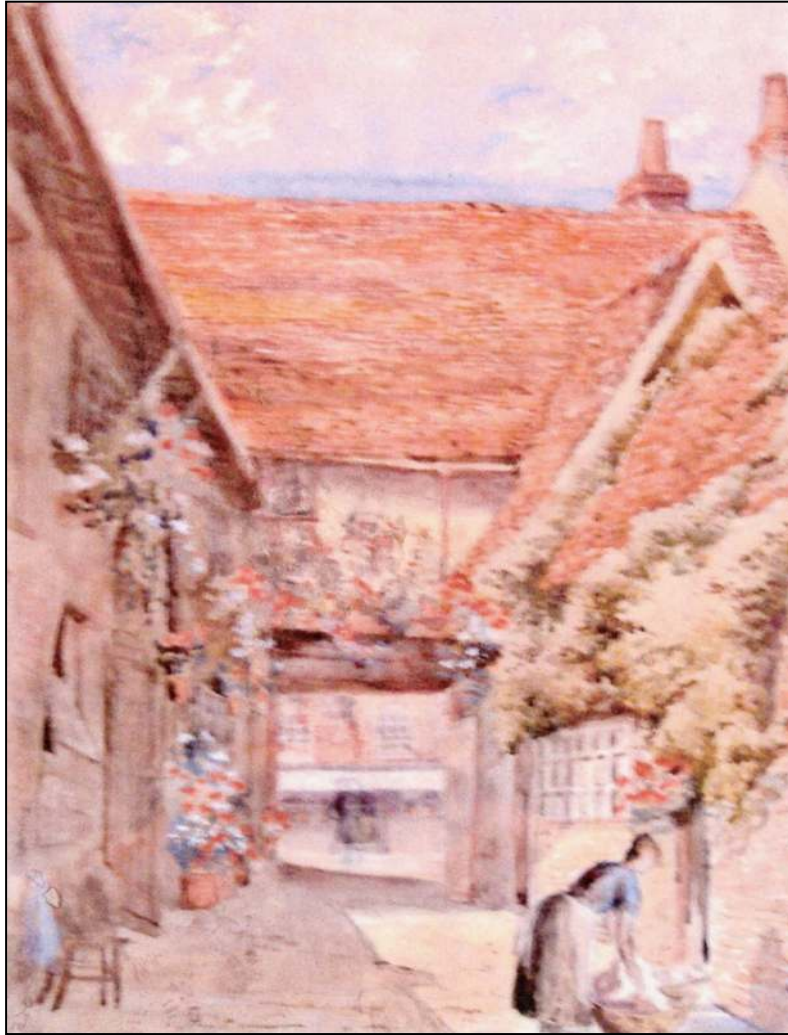
Local painter Lucy Cooper painted the yard of the Broad Gates Inn looking north towards upper Market Place. The date is before 1898, before the Kings Road had been created, as one can still see a building through the gateway, before this had to make way for the new road.

On the left is an open stable window and door; on the right the steeply pitched roof of the medieval range. This painting belongs to Henley Town Council and it has been reproduced here with the kind permission of the Mayor.

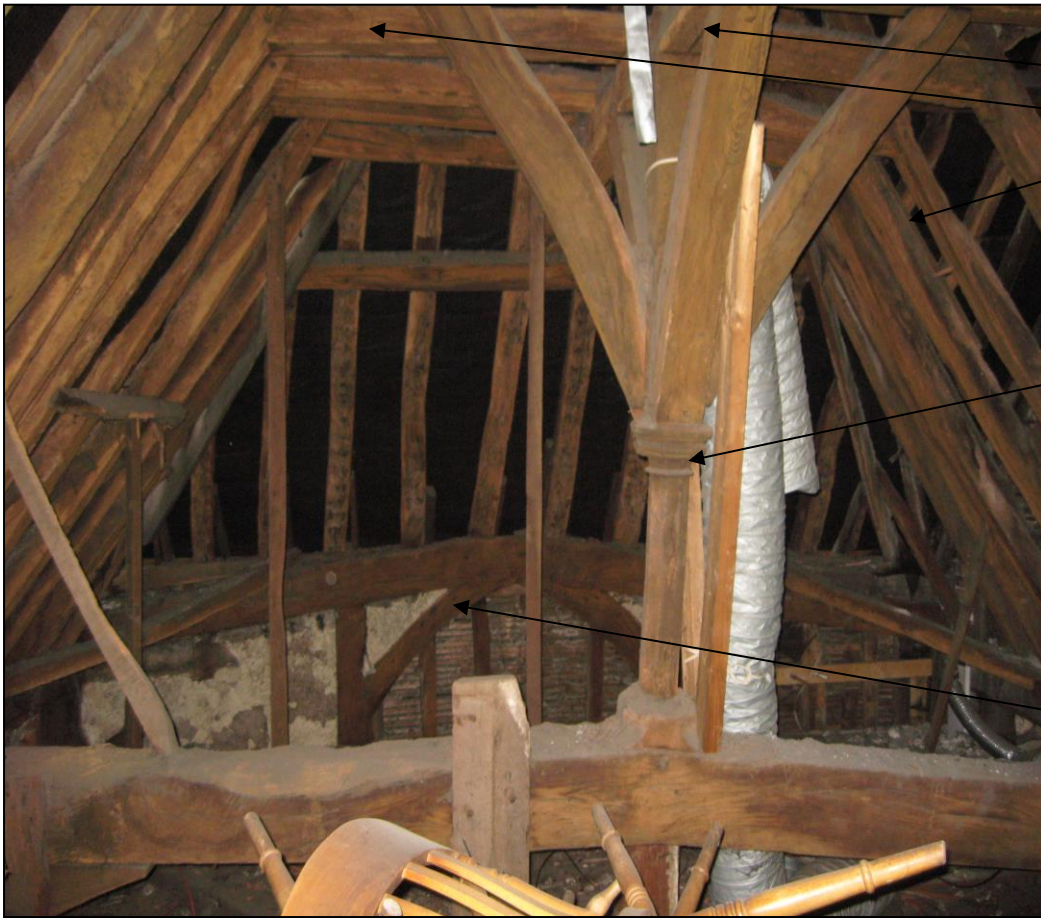
Purlin
Collars
Rafters

The octagonal shaft, which is the lower part of the post, the capital and base are beautifully carved and as crisp as when first crafted by the medieval carpenter.

At the back the top of the two-centred opening, similar to the door head at the old Broad Gates

The crown post stands on the central tie beam; its up braces support the collars and purlin, which in turn support the rafters of the roof.
