**VERNACULAR BUILDINGS RESEARCH
HENLEY ARCHAEOLOGICAL & HISTORICAL GROUP**

Parish/County: Harpsden , Oxon
Street and House name: Highlands Farmstead

Recorder: Ruth Gibson

Date: 24/11/2011

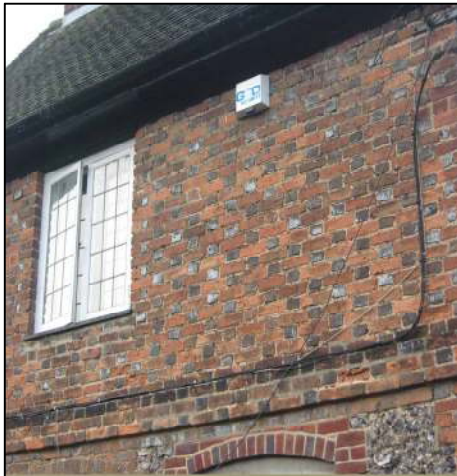
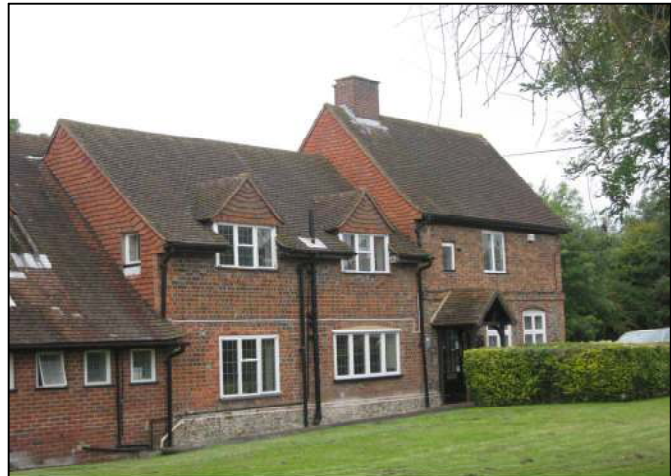
East front of C18th brick work of tall, right hand building; a ‘Parlour Wing’ ? The central building has later brick walls encasing a two-bay timber framed structure. The dormers are modern, as are the roofs.

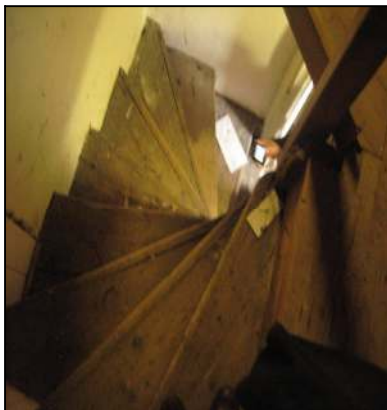
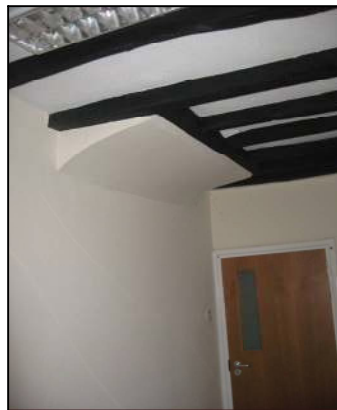
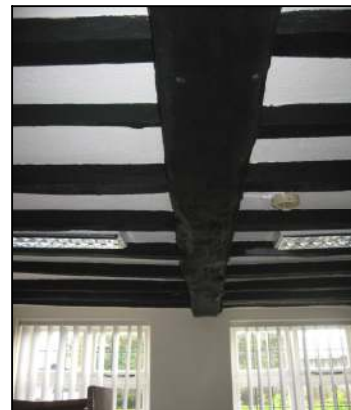
Left: Newel staircase seen from the attic; Centre: ceiling beams and coving for upper chamber fire place; Right: spine beam and ceiling joists. All above photographs are of the ‘new parlour wing’.

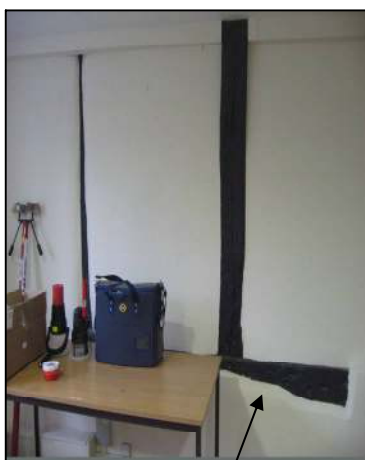
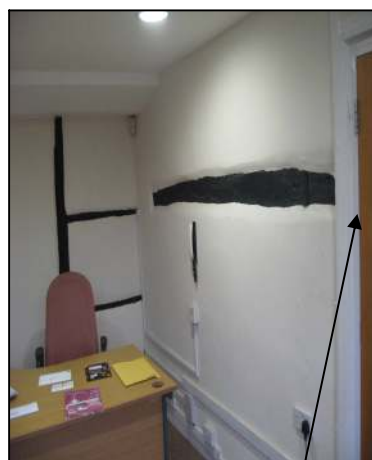
View of the exposed timbers of the 1 ½ storey building. This is the 1st G.F. room on the left, lower than the later entrance lobby. This also confirms their different building dates.

Rubble stone plinth and sole plate in the south wall. West & north walls, here a beam was cut through to allow for the later doorway from the entrance lobby in the ‘parlour wing’.

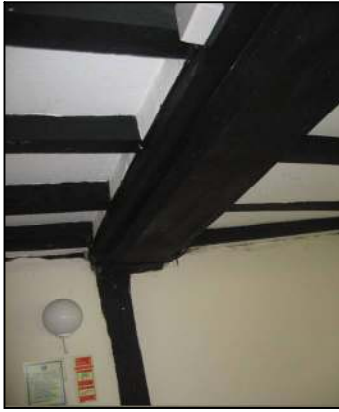
Above the ceiling timbers of the 2nd timber framed g.f. room. The wide spine beam has chamfered edges with simple run out stops. Additional trimmers have been added to each side of the main beam to support the square laid joists, some of which have moved exposing parts of their tenons. - Adze marks are visible on the soffit (underside) of the beam, showing how it was converted from the tree.

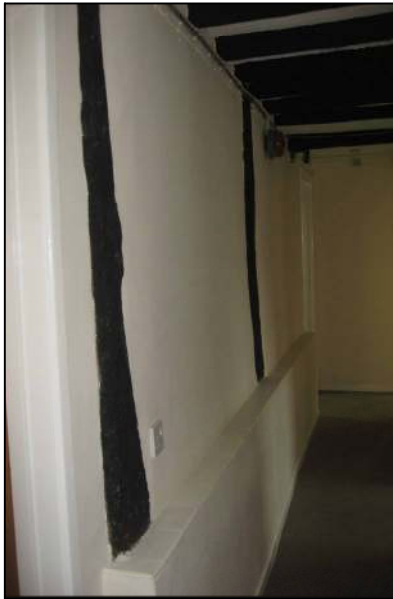
Left: The rear wall with posts rising from the much modernized plinth, but remnants of an earlier plinth are probably still in situ underneath.

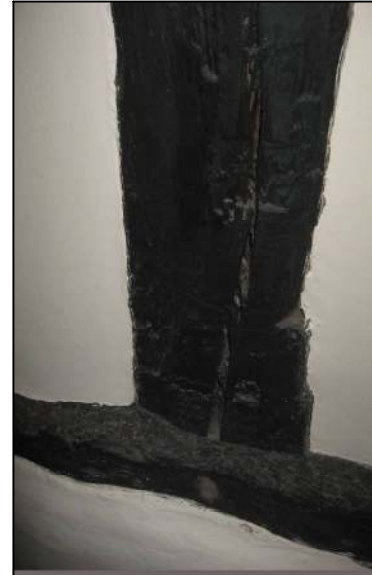
Right: Plinth, sole plate and post detail in the cross wall between the two rooms.

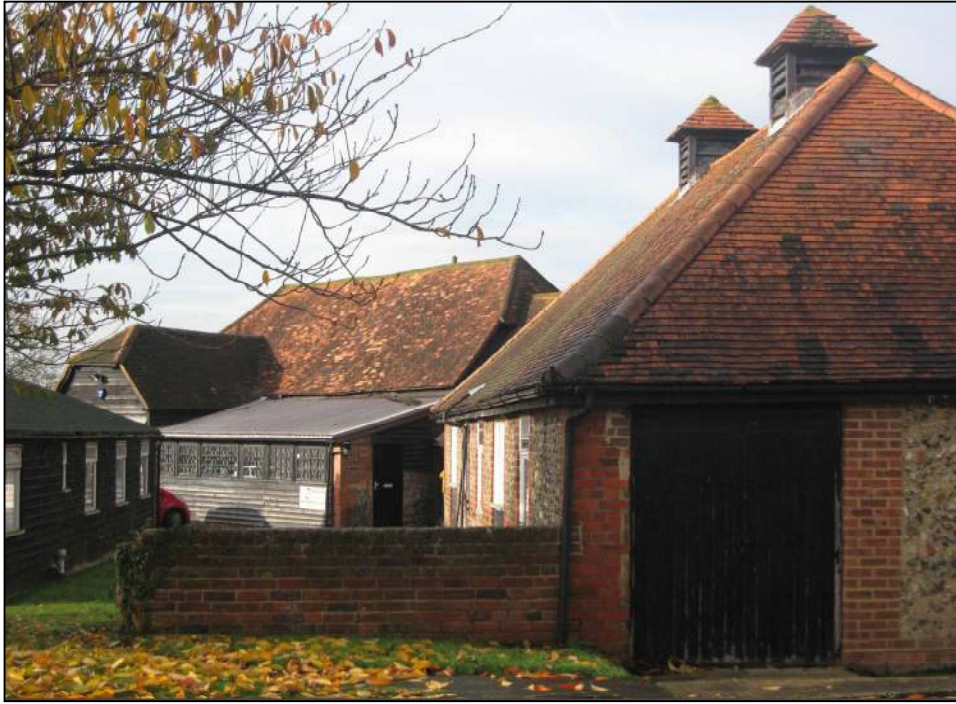
Barn and stable/cowshed group seen from the east gable of the stable, looking west towards the barn. The wide plank door in the gable suggests that the adjoining interior space once held the bull pen, (a very similar bldg. exists at neighbouring Cowfields Farm) Note louvered ventilation turrets on the roof.

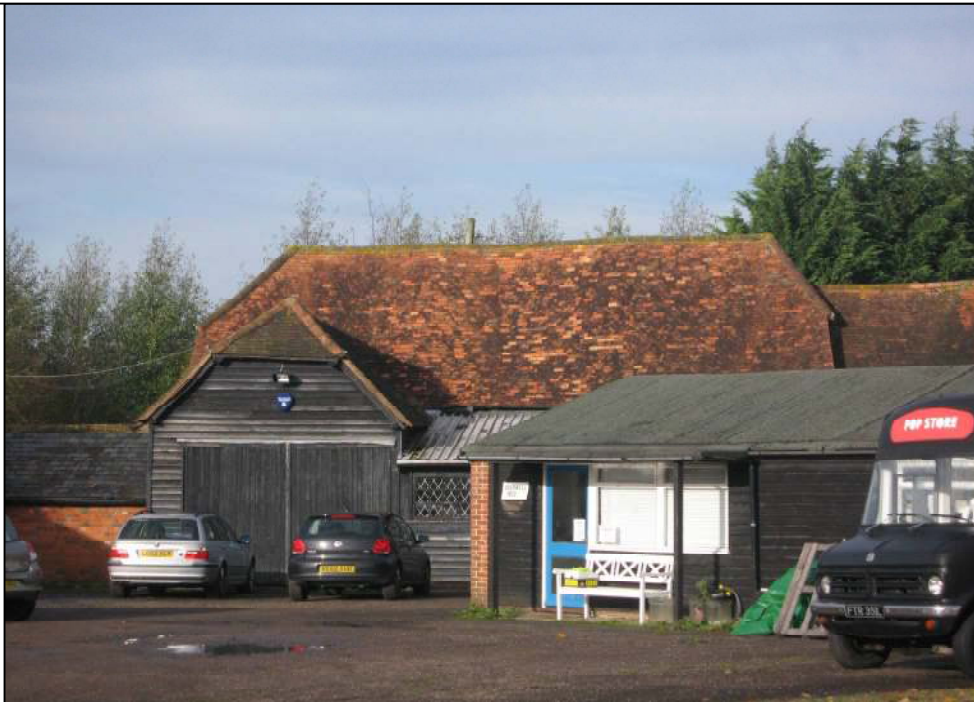
South front of three-bay timber framed and weather boarded barn with porch and half hipped, tiled roof. The lean-to, just visible behind the modern shed, appears to be a later addition or a re-built animal shelter shed, often found attached to the exterior of barn walls on Chiltern farmsteads.

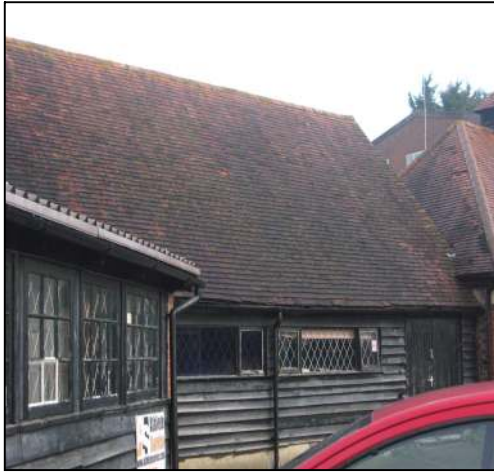
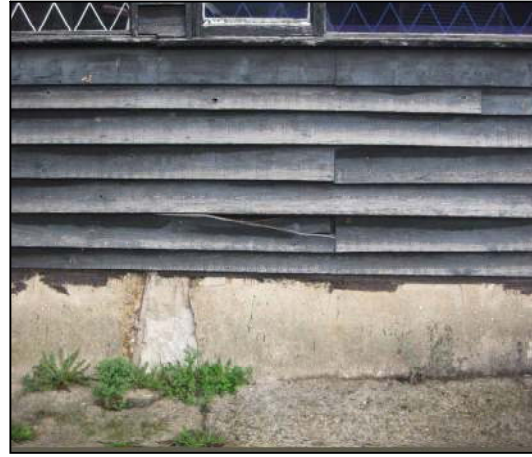
Small link building between barn and stable. The survival of several staddle stones within the later concrete dwarf wall just below the inserted weather boarding shows that this building was open fronted; the staddle stones are there to support posts, which in turn support the wall plate, allowing open animal access to the shelter from the farmyard.

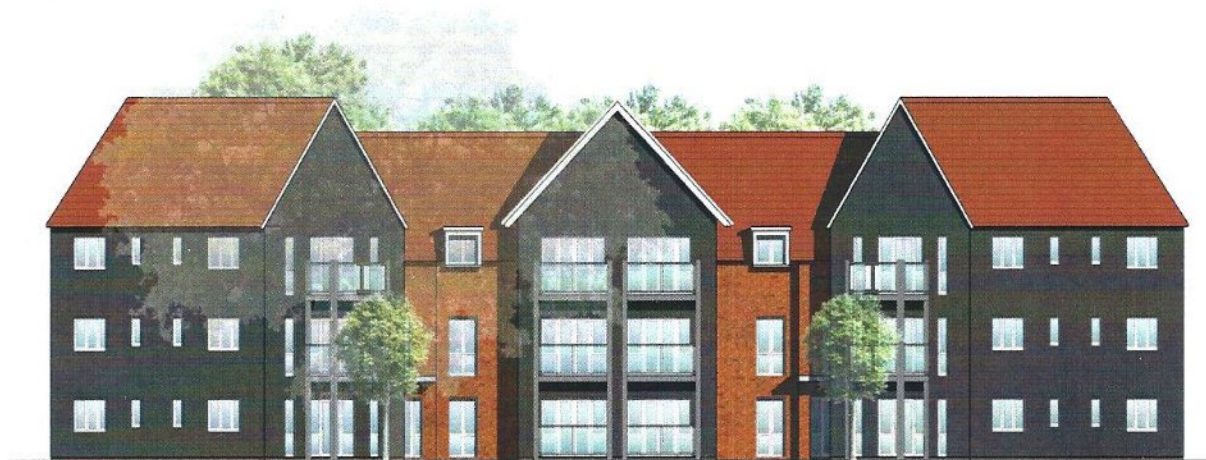
Indicative design of flats

The massive three-storey Crest Nicholson building, see below, has no place in the Chiltern AONB, neither at Highlands nor anywhere else in the Chiltern. One tree in front of it will not make an iota of difference.

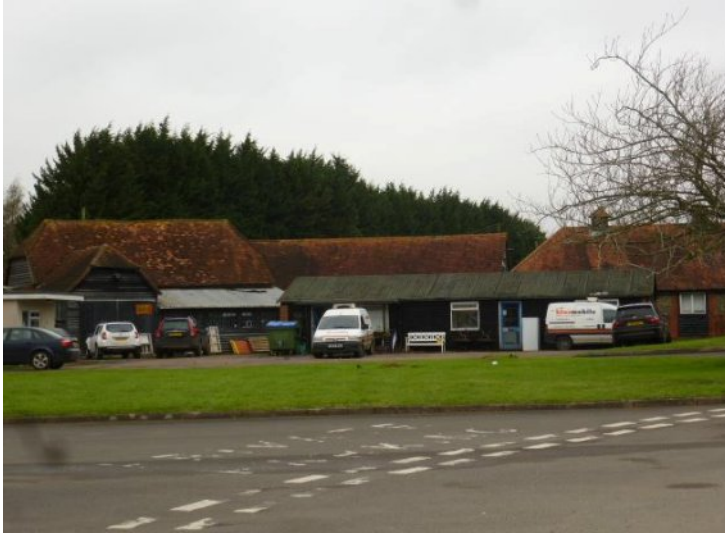
Existing Barn Group (behind modern sheds) protecting the north side of the farmyard. These barns are to be demolished under the proposed scheme and replaced with the above block of flats.

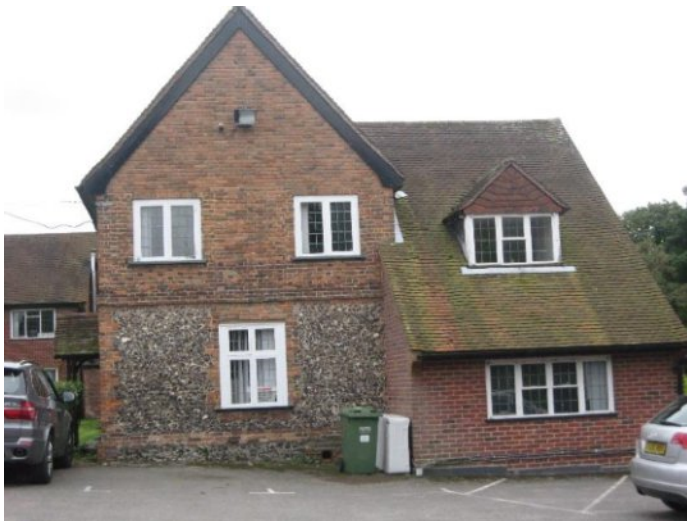
Highlands Farm House, b & f. parlour extension to timber framed house behind; with modern extension on the right. To be demolished to make way for modern 5-bedroom house and garage.
