**VERNACULAR BUILDINGS RESEARCH
HENLEY ARCHAEOLOGICAL & HISTORICAL GROUP**

Parish/County: Henley-on-Thames, Oxon

Street and House name: 73 Bell Street

Recorder: Ruth Gibson
Date of visit: 21.3.13

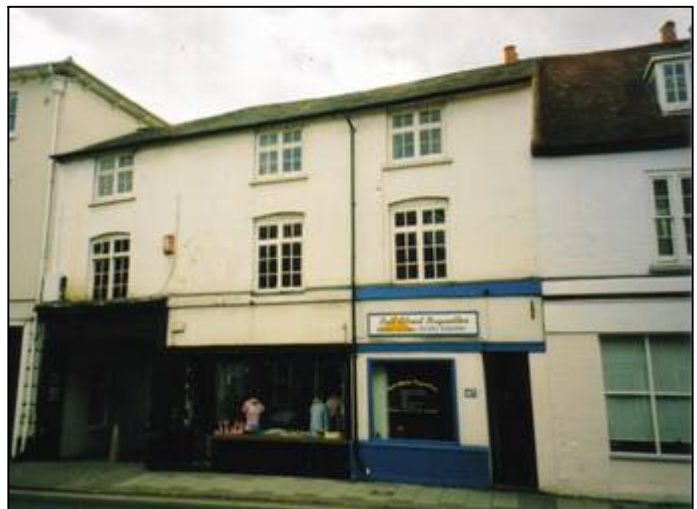
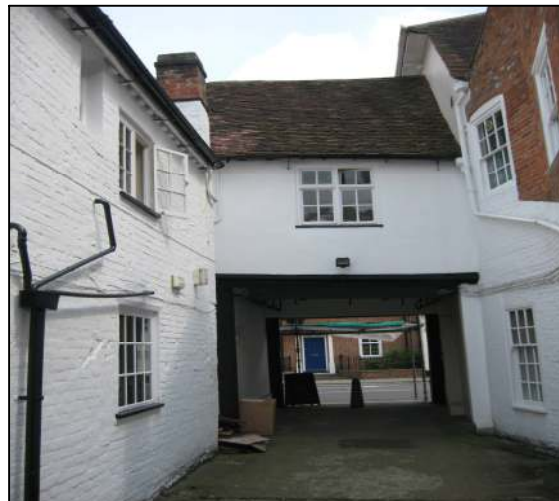
Description of the building: The List description only tells us what the building now looks like seen from the street. The rear elevation shows a steeply pitched, tiled roof as well as a long, brick built rear range. – There is a wide and tall carriage way accessing the rear yard. The substantial iron rails in the roof of the access passage are witness to the former use as a butcher’s premises.

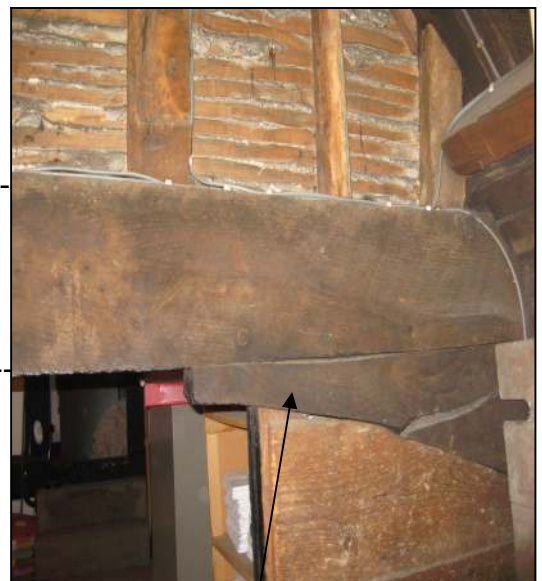
The central roof truss located between bays II and III) consists of large arch braces between principal rafters to collar. All timbers are of excellent scantling and quality; they are sooted, but without any decorative detailing such as chamfers, despite having been visible from the floor of the medieval hall.

collar extends across the attic

These two photographs show parts of the central truss, which still exists in its entirety, but is partly hidden behind shelving stacks and boarding. The horizontal collar is supported by arch braces, which rise from the principal rafters.

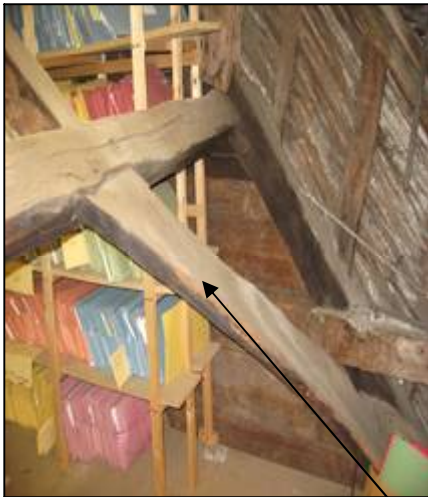
Medieval roof with purlin and wind brace preserved under the modern, shallow pitched roof of the front/east elevation. The medieval timbers are sooted, a sign of the use as an open hall of at least two bays of the building

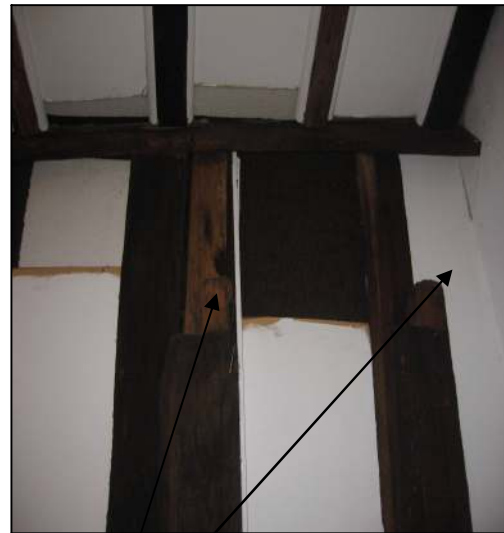
The two sooted, short rafters in bay II with their long tenons exposed. (NB these are not sooted as they would have been housed within the mortises of the louvre structure they once supported)

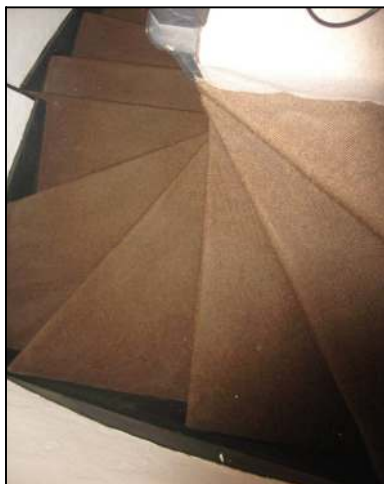
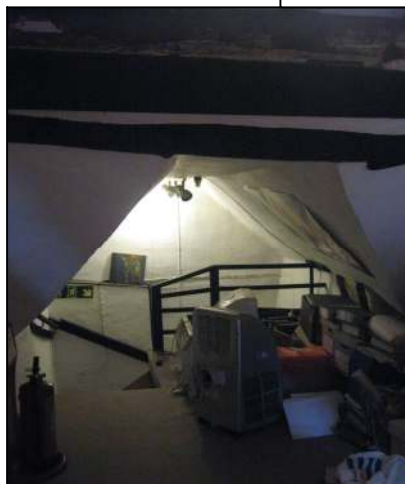
View of turned stairs at the back of Bay II. Access was gained into the attic by the removal of most of the rafters at the back/west side of Bay II of the roof. One of the horizontal timbers was probably the purlin, but additional timbers seem to have been added to make up for the loss of a large part of the rear roof of the central bay.
