**VERNACULAR BUILDINGS RESEARCH
HENLEY ARCHAEOLOGICAL & HISTORICAL GROUP**

Street and House name:
22 Hart Street
Magoos Bar

Listing grade and entry text: Grade II

16th. Timber framed house with plastered infill to exposed timbers. Old tiled roof, 2 storeys and dormer, 1 window – leaded casement. Ground floor underbuilt with brick & modern shop window with leaded glazing.

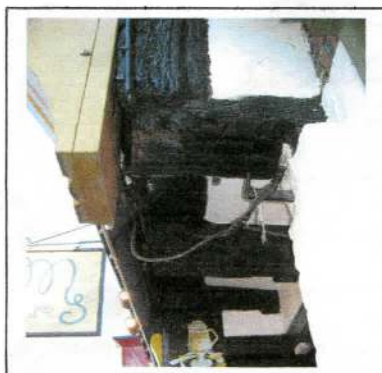
Timber framed first floor; wide tension braces, close studding up to tie beam, which now acts as wall plate to the roof. The jettied, c. 8" wide joists are laid flat and are now only visible above the doorway. Internally the joists show the recesses cut into their undersides, which formerly accommodated the jetty beam. The former timber framed front wall has been removed and replaced with brick work and a bow window; see photographs below for views of the former jetty with heavily weathered joists supporting the first floor post and sill beam.

Above: NB recesses cut into underside of joists show the location of the former front wall.
Right: Cellar – stone and brick & flint walls, heavy ceiling joists.

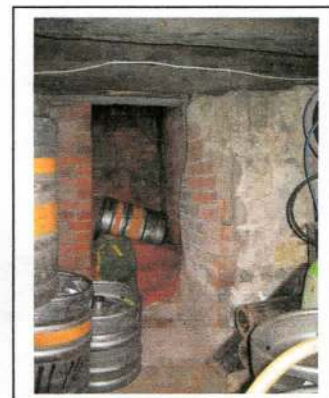
The central bay houses a trap door with steps leading down into a cellar, built against its east wall. The **cellar** walls show the use of different walling materials and alterations carried out over long use. There is part of a chalk block corner with just a hint of moulded stone work – may be the remnant of the medieval cellar?

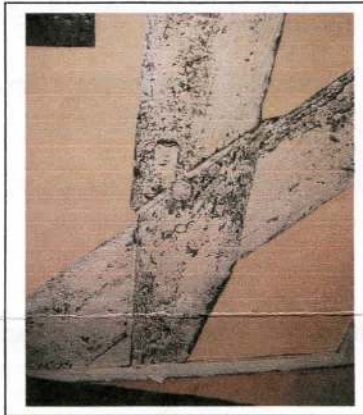
One original window survives in the east wall in the form of a cusped, trefoil window head set between the corner post and a stud. Both uprights have shutter grooves down to the floor. The window is 0.44 m wide, simply made from two planks fret cut into the appropriate shape and jointed at the top. Its location in the north/east corner of the building shows that it pre-dates the now adjoining timber framed No. 24.

Front chamber with trefoil cusped window set into the close-studded frame of the east wall. NB the tension brace in the north/front wall; this is lap-jointed and pegged across the stud in the front wall.
