**VERNACULAR BUILDINGS RESEARCH
HENLEY ARCHAEOLOGICAL & HISTORICAL GROUP**

Parish/County: Henley-on-Thames, Oxon
Street and House name:
No. 21 Friday Street

Owners: James & Morag
Lambert
Ruth Gibson
Date: 19.7.09 & June 2010

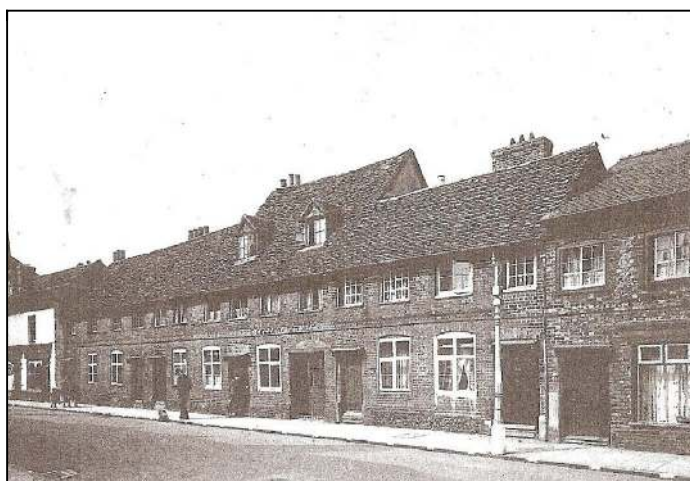
17 – 29 Friday Street c. 1940

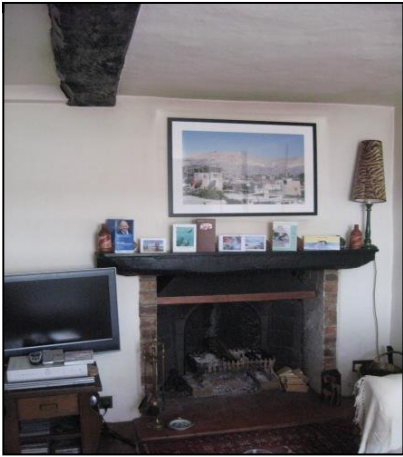
The front room. This is accessed directly from the street via a step of some 23 cm above street level (was there a cellar?). The brick lined fireplace with timber lintel is located in the back wall. The central transverse joist consists of an approximately 26 cm wide timber with rounded side, which still allows us to see the sapwood edge of the tree from which it was cut. There are three narrow studs of between 5 - 10 cm width visible in the east wall. All other wall and ceiling timbers are hidden. The square panel timbers forming the west wall are only visible in No. 19 (see report 54/1989). The small size scantling and method of construction represents a very late phase of timber framing, only used for internal walls and not meant to be seen.

<p>Ground floor front room, north wall with 1.06 m wide and 0.58 m deep FP</p>	<p>East wall with three narrow studs</p>
------------------------------------------------------------------------------------	------------------------------------------

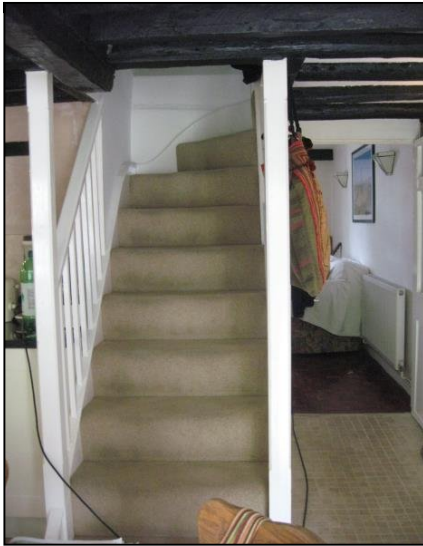
The **rear room/kitchen** was an essential addition to the one-bay front. Here all ceiling as well as wall timbers are exposed; most are of slight and uneven scantling. The turned staircase is also accessed from the rear kitchen. The former kitchen fireplace, at the back of the living room one, has been blocked in.

Rear bay with turned staircase

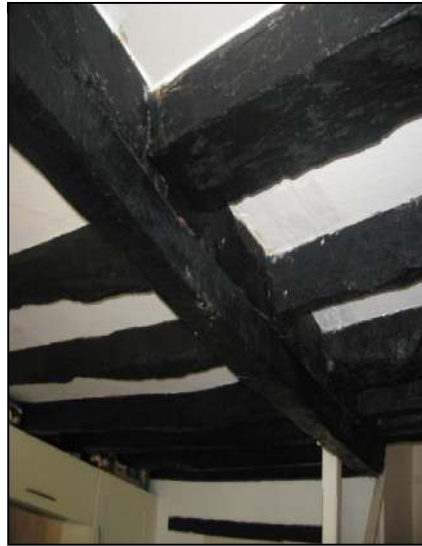
and central axial beam with uneven joists

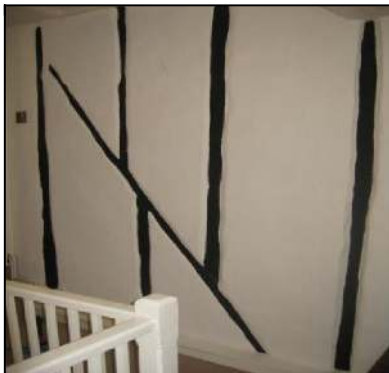
The **First-Floor** landing is reached by the 18th C. turned staircase rising from the kitchen in the rear bay. There are a small bedroom and bathroom in the rear wing. The landing wall on the west side is constructed from narrow scantling studs and a diagonal timber and forms the shared boundary wall between Nos.19 & 21⁴.

East first floor side wall of the landing in the rear extension
