**VERNACULAR BUILDINGS RESEARCH
HENLEY ARCHAEOLOGICAL & HISTORICAL GROUP**

**‘Countess Gardens’, 88 Bell Street
86 in separate ownership – for Sale**

Recorder: Ruth Gibson

Date: 12.5.06

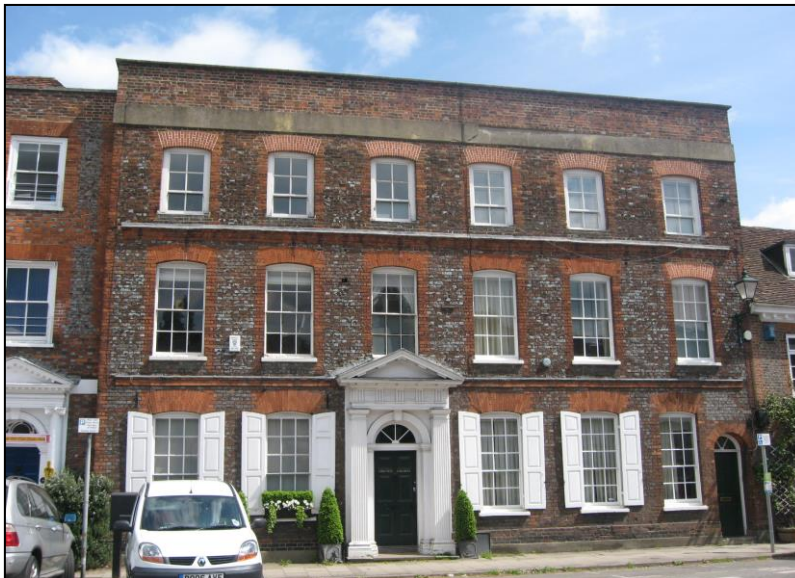
West front of ‘Countess Gardens’, No. 88 Bell Street.
The simple fan light doorway on the right is the former service entrance, now No. 86.

No 86 had been the service end with its own separate service entrance, although the door opening with only a semi-circular arch without any kind of door hood gives it a 19th century feel. The brick work and its reveal on the left-hand side and rubbed brick arch shows some signs of disturbance with disturbed brickwork in the right-hand reveal. Alterations to this service doorway, which might have been wider originally, could have been carried out, when the house was subdivided.

A simple, four-panel timber door (a modern replacement?) under a segmental arch, with fan light, gives access to what is now No. 86. This would have been the side door to a passageway leading to the rear service area of the building. The brickwork around the door shows some disturbance on the right-hand side and could have been wider originally. The way the 3 ground floor windows are arranged very close together, upsetting the symmetry of the front elevation somewhat, seems to show that a doorway in this position was put in at the time of construction, providing access to the rear of the building for services. A bell pull survives in fragmented form attached to the wall above the right-hand side of the door.

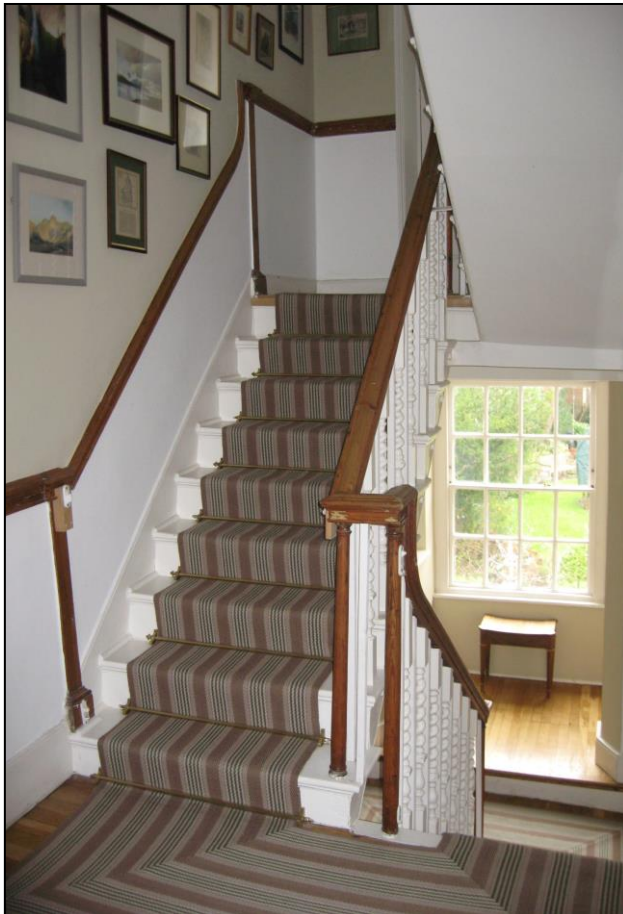
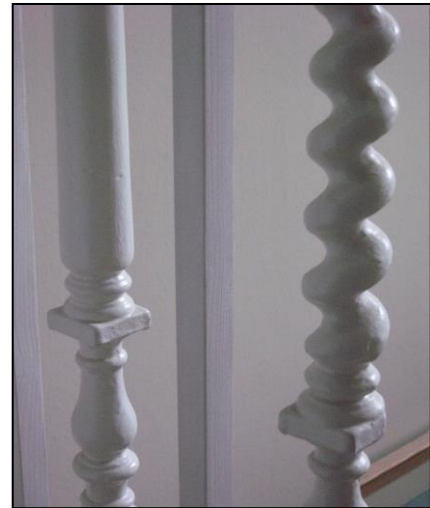
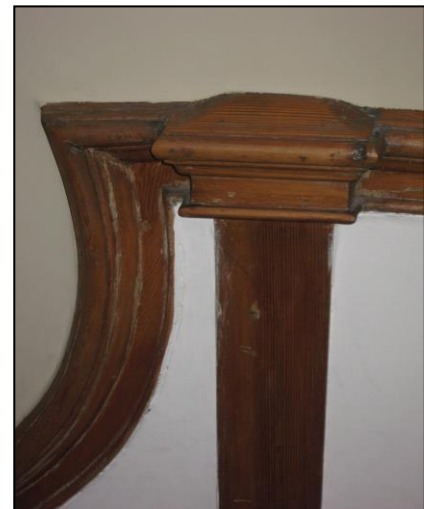
Stair case at first floor landing; details of two types of balusters (right above); toad-back hand rail ramped over newel post halved into the stair wall (right below)

It is of the dogleg with landing type; open string with scroll carved decorated brackets and barley twist balusters – set very far apart, one per tread only, so that it has been necessary to insert simple stick balusters between the original ones for safety reasons (information by the owner,2005). The handrail is of the ‘toad back type, very much in use from 1691 (first

introduced at Kensington Palace) and throughout the first half of the 18th century and possibly later. The rails are ramped over the newel posts creating a very elegant whole. (The earliest dated example for this ‘ramped’ handrail I can find is 1752, but this is not conclusive dating evidence, as there may well be earlier examples). The wall side also has half rails and half newel posts attached to it, which enhances the whole impression of the staircase.

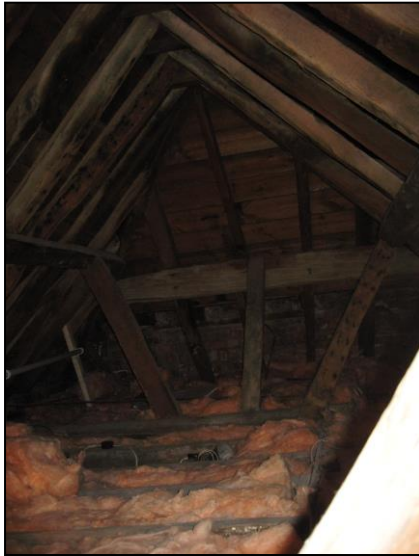
Views of roof structure.

View of rear hip

Roof Structure over 86 and 88: The roof forms three low ridges, tucked behind the brick parapet, ending in hips. The structure consists of common rafters, single purlins, supported by irregular struts. There are timber plank lined valley gutters with evidence of flat laid bricks below. No signs now visible of lead lining.

The entire roof structure has now been protected by a modern flat roof above it. There is evidence of second-hand timbers being used in the original roof construction, but matching carpenters' marks also exist. Some rafters have been dated to 1611 (see below dendro report)

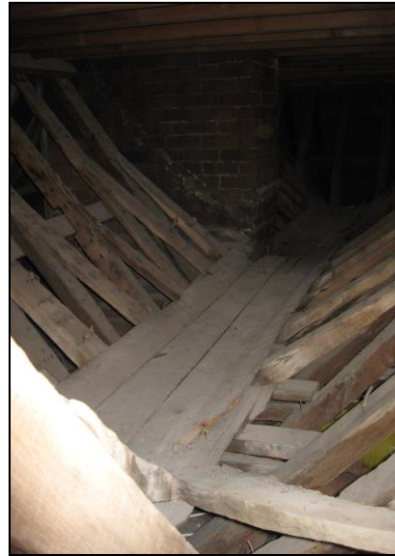
Valley with rafter sprockets overlaid with planks.

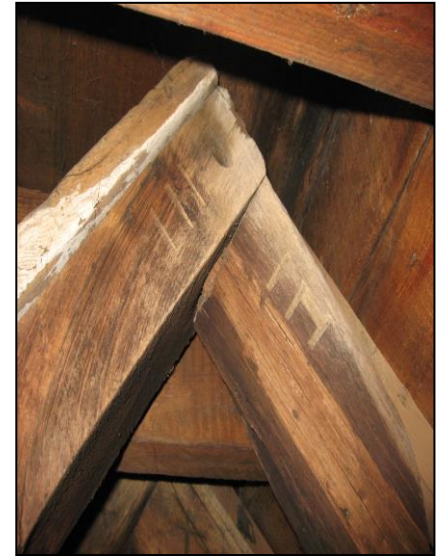
Pegged and marked rafters.
