**VERNACULAR BUILDINGS RESEARCH
HENLEY ARCHAEOLOGICAL & HISTORICAL GROUP**

Parish/County: Henley-on-Thames, Oxon
Street and House name: 60 & 62 West Street

Recorder:
Ruth Gibson
Dates: 8.2.08 and 18.4.13

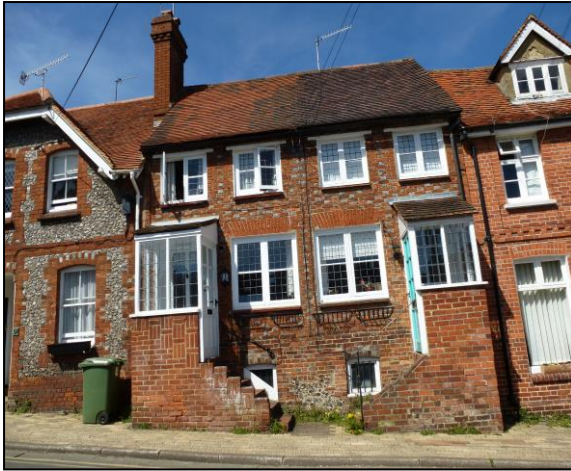
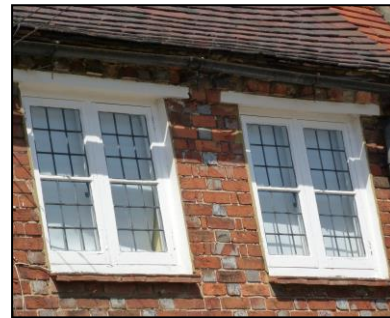
17th/18th cottage with altered façade. Red brick with grey headers, steeply pitched old tiled roof with rendered gable end. 2 storeys and basement, 2 windows each, western one on first floor blank. Sashes to No. 62 and leaded reproduction casements to No. 60. Flights of steps to side doors, No. 60 has wooden porch.

Description of front elevation (height, windows, entrances, shop front etc): See listing entry for main features. – The most unusual feature of the building is the fact that the ground floor is located c 1 m above a tall basement. This basement has a narrow front window for each of the houses, partly behind the brick steps, which lead up to the porches. Both the B&F work and the steps with porches are later than the main brick work, which mainly consists of 2 3/8” bricks. The blue burnt headers and red stretchers of the front façade are laid in Flemish bond and produce a chequer work effect. The flat window arches of the mezzanine floor are of fine gauged red bricks; the first floor windows are located directly below the dog-toothed eaves brickwork.

The brickwork, which dates to approximately 1800 appears to cover or replaces an earlier timber framed front wall. The basement windows and flint work around them very likely replace doors accessed directly from the street (there is no sign of an original access to the basements in either house – the present ladder steps in the back bays are accessed by small hatches in the floors, which are little suited to serve a major storage facility).

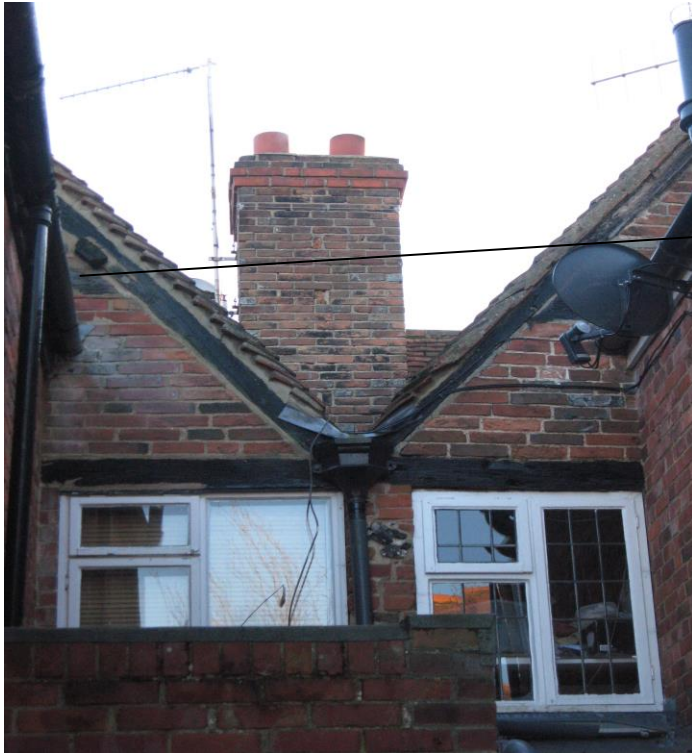
Rear gables and central stack of 60 and 62 West Street

Description of rear elevation: The rear are dominated by 20th century 2-storey extensions, but one can glimpse the earlier, one room, 1 ½ story rear wings behind both. These rear gables show traditional queen post trusses with clasped purlins with stretcher course brick infill.

Stacks: A large central stack rises from the rear roof and serves both properties, probably serving 2 fireplaces per house originally.

View looking south showing the two rear gables of the back extensions with their traditional tie beams, collars and clasped purlins.

The wide stack, which rises from the back of the front roof appears to be of a size to have accommodated four flues for two fire places per house.

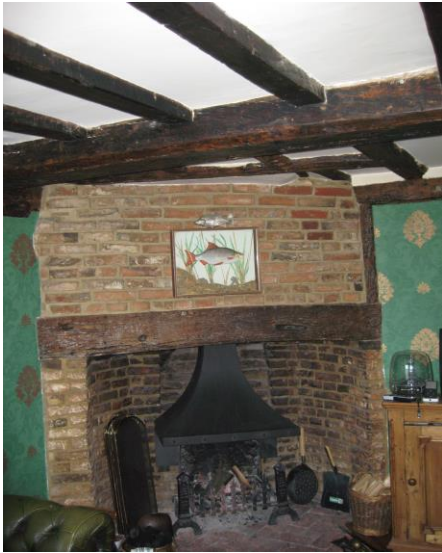
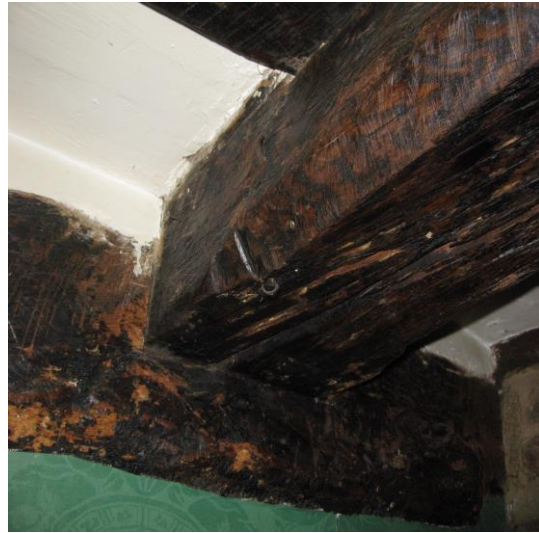
Ground Floor is a mezzanine floor: Small brick porches are located c. 1 m above street level, accessed by brick steps. Inside the ceiling joist and axial beam are of substantial scantling (7 ½ by 8 “) with an 1 ½” chamfer and lambs tongue and bar stop. Some changes to the joist in front of the F.P. show later alterations or that they are second hand.

There is a large brick fire place set diagonally across the rear corner of each of the ground floor rooms, together forming a square (see ground floor plan below), mostly of 2” bricks. The ceiling joists next to the brick stack area are showing a re-ordering, which indicates changes to the location of the fire places The timber bressumer across the F.P. at No. 60 is a second-hand timber with unrelated mortises from a different use, however that at No. 62 may be original .

No. 60: Corner brick fire place in G.F. Axial ceiling beam with chamfer and stop

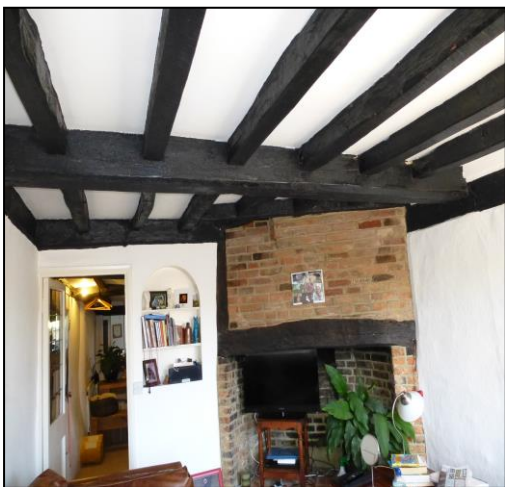
Front room of No. 62 with corner F.P.

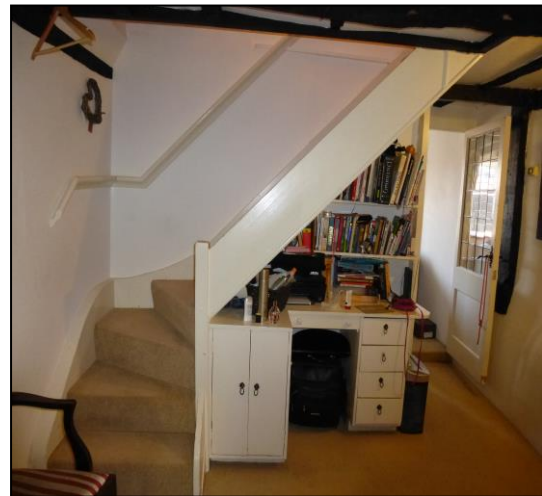
Rear room; stairs built against the stack

The rear extension contains a further room on both floors. The modern companion ladder type stairs rise from there. Next to it is a probably rebuilt brick stack, which appears to form the rear of the front room fire place, but may also have contained a F.P. for the back room.

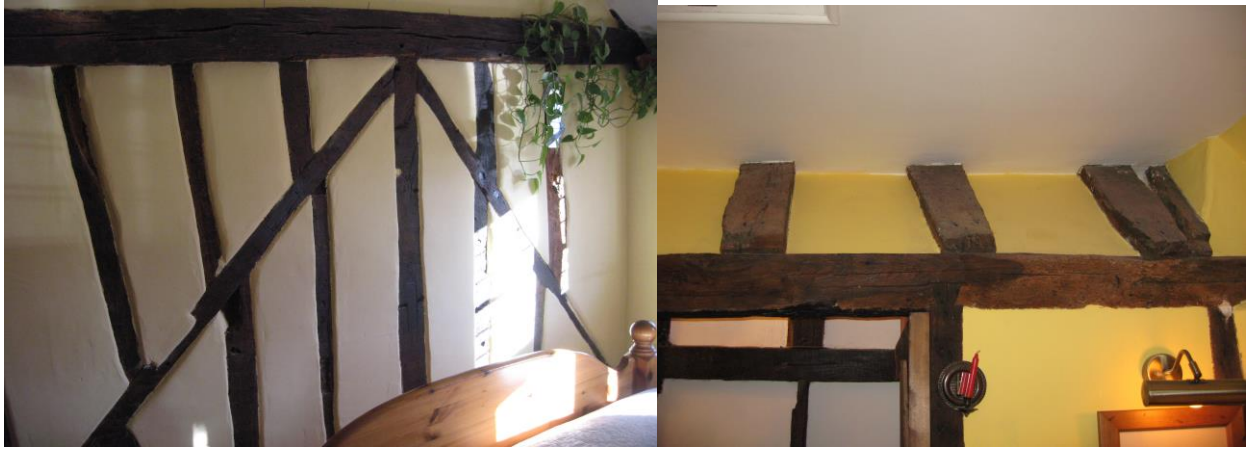
No 60, left: First floor, front bedroom. Stud wall between Nos. 58 and 60 West Street
 Right: First floor, view of roof rafter of front range resting on the wall plate, seen from the back bedroom.

Upper Floors of No. 60: The front bedroom allows a view of the framing in its east wall, which adjoins No. 58 West Street directly. This consists of thin, tall studs with long diagonal braces, some re-used, usually associated with lack of good quality timbers and 18th century framing. – The visible small area of roof exposed, however, shows part of a traditional timber frame with a wall plate and flat laid rafters.
