**VERNACULAR BUILDINGS RESEARCH  
HENLEY ARCHAEOLOGICAL & HISTORICAL GROUP**

**Parish/County:** Henley-on-Thames  
**Street and House name:** The Row Barge PH

**Nos 35 (formerly The Cottage) and 37 West Street (The Row Barge)**

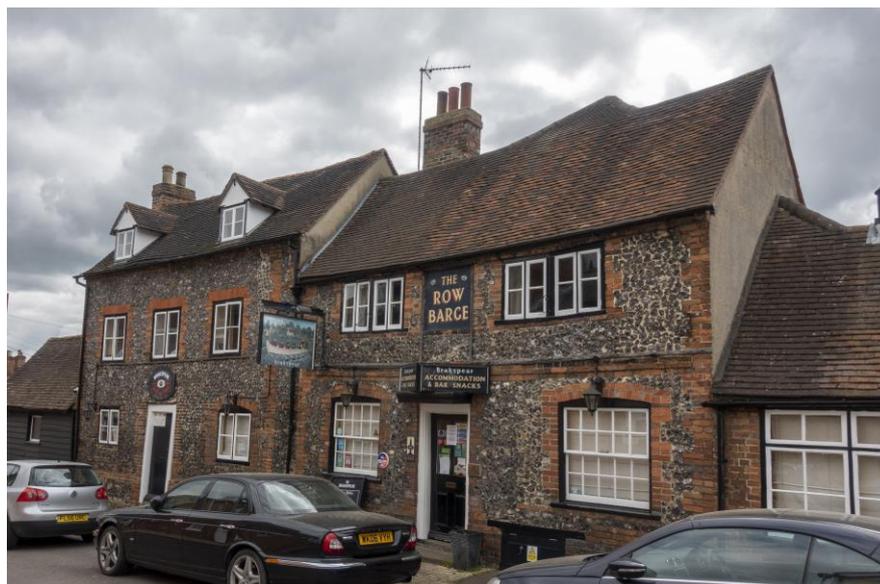
**Listing grade and entry:** Three separate Listing entries ( summarized): Grade II, C 18, flint walls with red brick dressings. Old tiled roof, 2 storeys. No 35 has 2 dormers, central door with small flat hood on brackets. No 37 has central door with moulded architrave and flat hood. Weather boarded outshut to east of No. 35. The garden wall of No. 35 is also listed.

The ground floor front elevation of the PH certainly has the look of an 18<sup>th</sup> century house with its Georgian sash windows and almost central door, whilst the taller No. 35 looks later with its 19<sup>th</sup> century fenestration. However, windows are not a reliable dating tool, as they were – and still are - most easily replaced and updated.
