**VERNACULAR BUILDINGS RESEARCH
HENLEY ARCHAEOLOGICAL & HISTORICAL GROUP**

Street and House name: 'The Old Bell', PH No. 20 Bell Street: briefly called La Campana'; since 1920s 'Ye Olde Bell', before this 'The Duke of Cumberland' .
SU 761 827

Owners: Brakspear Pub Company
Tenant: Bill Dobson
Recorded: Ruth Gibson & members of the HA&HG and OBR
Dates: June-October 2009

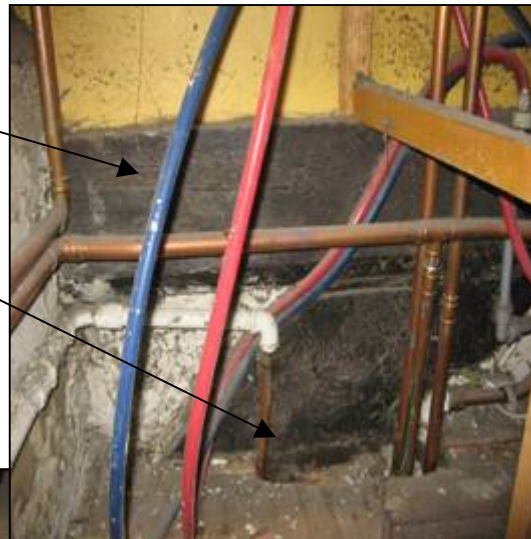
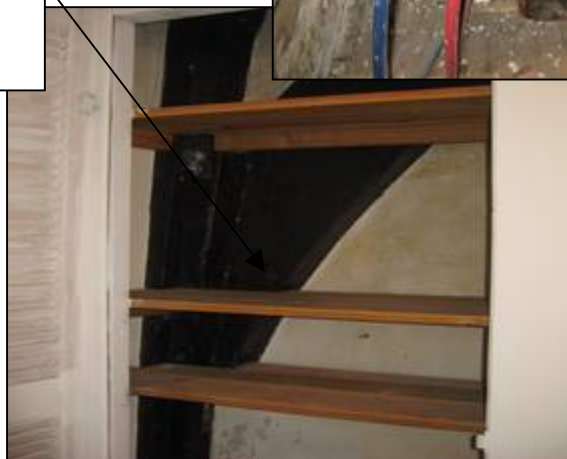
Low tie beam of Truss 4 in east wall of Bay III, attic; the brace is also just visible behind the pipe work.

In the first floor, rear bedroom one can see the lower part of the arch brace springing from the north-east corner post, now partly hidden behind shelves and cupboard doors.
