**VERNACULAR BUILDINGS RESEARCH  
HENLEY ARCHAEOLOGICAL & HISTORICAL GROUP**

**Parish/County:** Henley-on-Thames, Oxon

'Old Timbers' 67/69 Friday Street

**Date:** May 2010

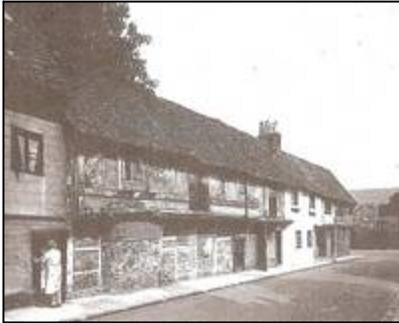
The 1940s picture below shows the building in a very similar run-down condition, probably condemned by now, as had been the case with Barn Cottage and the Thameside, Granary Cottage, before being purchased in 1925 from the Mackenzies by Lady Burke and subsequently repaired and modernized.
