**VERNACULAR BUILDINGS RESEARCH  
HENLEY ARCHAEOLOGICAL & HISTORICAL GROUP**

**Street and House name:**  
61 Market Place

**Tel No:**  
**Recorder:** Ruth Gibson  
**Date:** 9.7.07

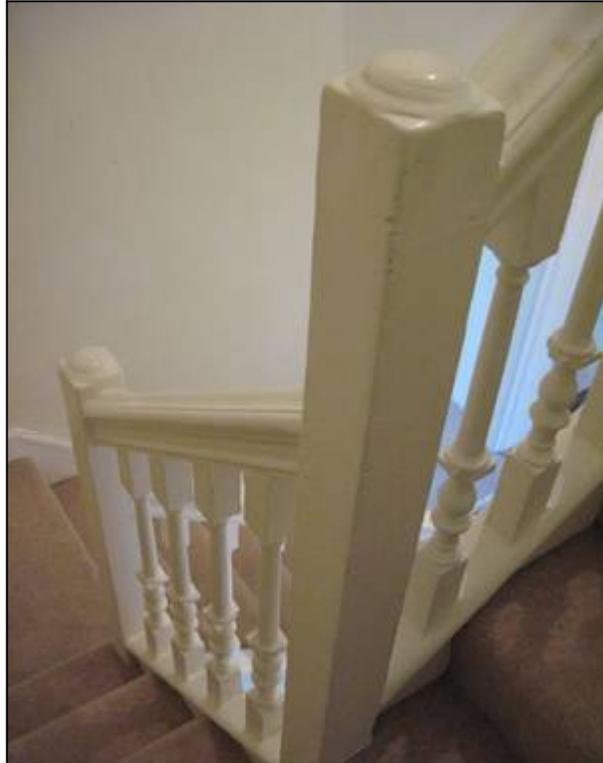
The stair case is of the open-well type, but rebuilt from g.f. to first floor and may not be in the original location. However, all the details of the earlier, upper stairs have been faithfully copied. These include turned balusters with tapering columns, on unturned square section per column, set into a closed string with square newel posts topped with round moulded caps, an unusually plain example of its kind.

The hand rail is of the toad back type, which was in use throughout the 18<sup>th</sup> century.

The photograph shows the upper part of the stairs.
