Henley-on-Thames

The Chantry House
Church Avenue

SU765826
Grade I

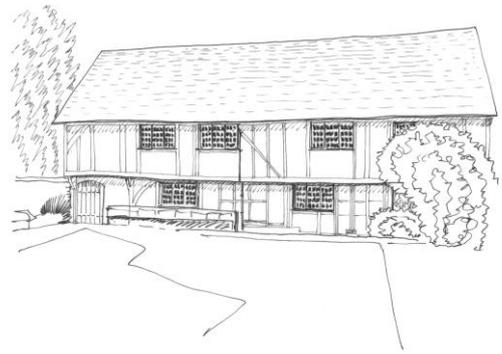
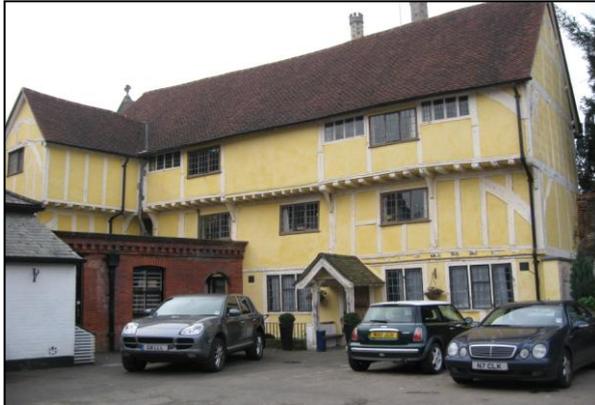
East, Thameside elevation. Lower ground floor was originally an open-fronted storage space under a jetty.

- A 5-bay, three-storey building plus storage loft originally. Small rear wing. Jettied on west and east sides; originally double jettied on the river side with the lower ground floor open fronted, supported by posts, but now underbuilt. Some original window openings survive on the top floor.

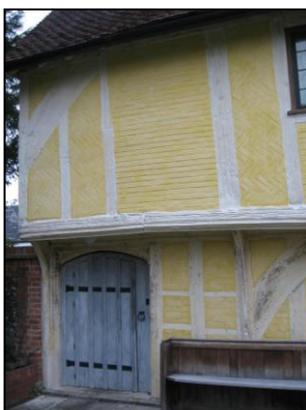
West elevation with principal entrance door; carved spandrels in four-centre arch. N.B. the location of the g.f. arch brace.

- Wide oak door at the north-west corner, now accessed from churchyard, formerly from a lane connecting New Street to Hart Street. Its surround has a four-centred arch, decorated spandrels, roll moulded jetty plate and bressumer; moulded bracket. Note large arch brace to the right of the door rather than in the more usual corner location.

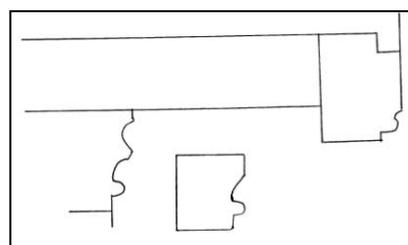
West side jetty profiles
